Micro Clinic

**Reports from Nick Beer
and Roger Burchett**

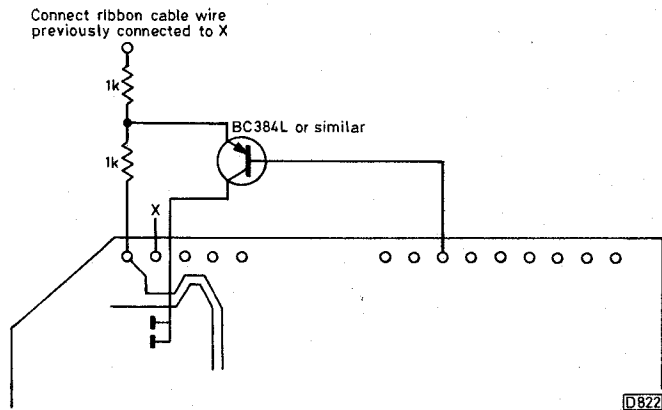
When I tried this the picture wouldn't lock. On examination I found that no sync pulses were being supplied to the monitor. A simple circuit (see Fig. 1) was added to pick them up from within the unit and feed them to the appropriate pin on the output. **J.deR.**

Fig. 1: Modification to the SPEM digitiser board to provide video source sync pulses to the QL's monitor.
