## Technics SLP8

This machine came into the workshop with the complaint that the tray operation was intermittent. It opened all right, so we inserted a disc. When the open/close button was pressed the tray shut partially then opened again. This happened several times before the tray finally shut. The TOC was read and all functions worked normally, including open/close.

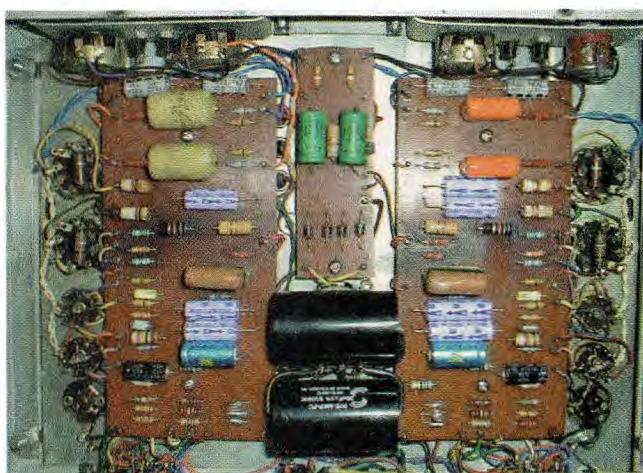
*Photo 2: Layout under the chassis. There are three PCBs, one each for the right and left channels and a small one (centre) for the silicon HT rectifiers and the bias supply components.*
