The Serviceman

No fault is simple — when it's three layers down!

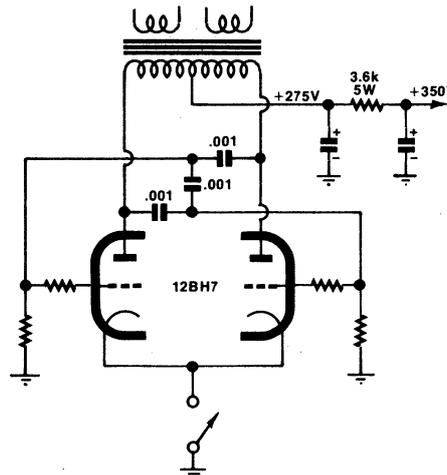
According to the circuit, the main HT supply was 350V in the record mode, and this was applied to the plates of the 12BH7 via a 3.6k decoupling resistor (the one which had overheated) and the centre tap of the coupling transformer. The HT voltage was close enough, but that on the 12BH7 plates was another matter.

According to the circuit it should have been 275V in the record mode but, in fact, it was only a little over 70V. No wonder the poor old 3.6k resistor was getting hot, it would have been dissipating over 20W! (At the same time, I calculated that it would normally dissipate only about 1.5W, which would make the plastic tubing more acceptable, even if the reason for it is not obvious.)

It seems only yesterday that circuits like the above were normal and commonplace — a tape recorder bias oscillator using a twin triode valve and three high voltage mica capacitors in the grid and anode circuitry. Valves? Mica capacitors?

And that proved to be about the only bright spot of the whole operation because, believe it or not, that was the faulty one — a dead short. I couldn't be sure which one it was, but it was most likely one of the two which couple to the grids. If so, it would have applied the full HT voltage to one grid, effectively preventing oscillation and causing that valve to draw several times its normal current.

Finally a colleague came to the rescue with a 1600V polycarbonate type which was also physically compatible. But then I had to fit it and this was obviously going to be even harder than getting the faulty one out. There was no way that I could hold the pigtail in position while I applied solder and heat; it was hard enough just getting a small soldering iron in there.

In the end I carefully trimmed the pigtails to the right length, tinned them, and loaded the end of each with a generous blob of solder. Then, working by feel as much as by sight, I managed to mate the pigtail and its terminal and coax the iron onto the junction. As far as I could tell, it made a solid joint.

With the first pigtail anchored, soldering the second one was a little easier, although still tricky enough. That done, I switched the recorder on and it worked. Voltages now matched the figures on the circuit and, more important, it would erase and record.
