The Serviceman

Just when I thought I knew all the tricks!

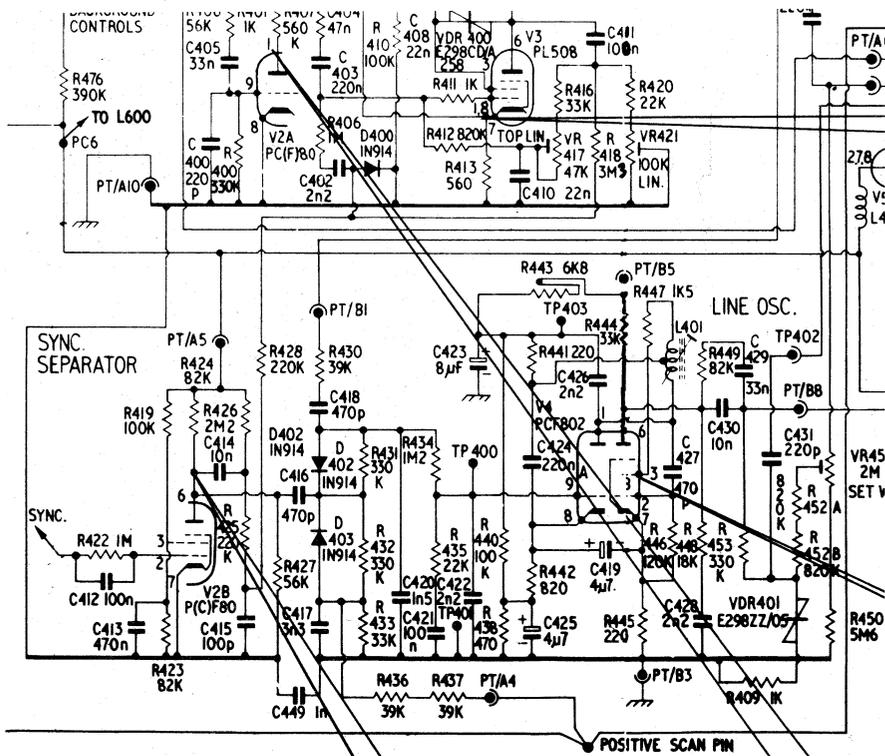
Frame oscillator and sync separator stages of the Decca 33 receiver. C415 had gone low in value, reducing the amplitude of the sync pulses.

When I looked at these waveforms there was no doubt in my mind; two differences were immediately obvious. One was the amplitude of the sync pulse, which was only about 10V p-p on the faulty set, as against 20V on the good set. The other was more subtle, but involved the outline of the frame pulse which could only be described as "mushy" in the faulty set, as against a clean outline on the good set.

I eventually established that this "mushiness" was really a pattern of line sync pulses which, somehow, were getting mixed up with the frame pulses. Just how much this was contributing to the fault I'm not sure, but it clearly indicated something wrong.

I put it on the bridge again and there was the answer. Whereas it had previously measured something like 105pF it was now down to 40pF. What was more, nothing I could do would change that value. I heated it, cooled it, even bashed it, but it stuck stubbornly at 40pF.

But it had to be something. So there was nothing for it but to go over these components again, replacing them all if necessary, until the faulty one was found. It so happened that the first one I chose was C415, which I pulled out and replaced.

And suddenly everything was back to normal. The pulse amplitude jumped to 20V, the "mush" disappeared, and, most importantly, the picture stopped rolling. But why? I had already checked that capacitor and could find nothing wrong with it. What had I missed?
