# VINTAGE RADIO

## Restoring a Tasma TRF receiver

**I had an interesting & most demanding repair to do recently, involving a 1931 model 65 Tasma console. The old Tasma is a very basic 5-valve TRF (tuned radio frequency) receiver & it was in a woeful state of disrepair.**

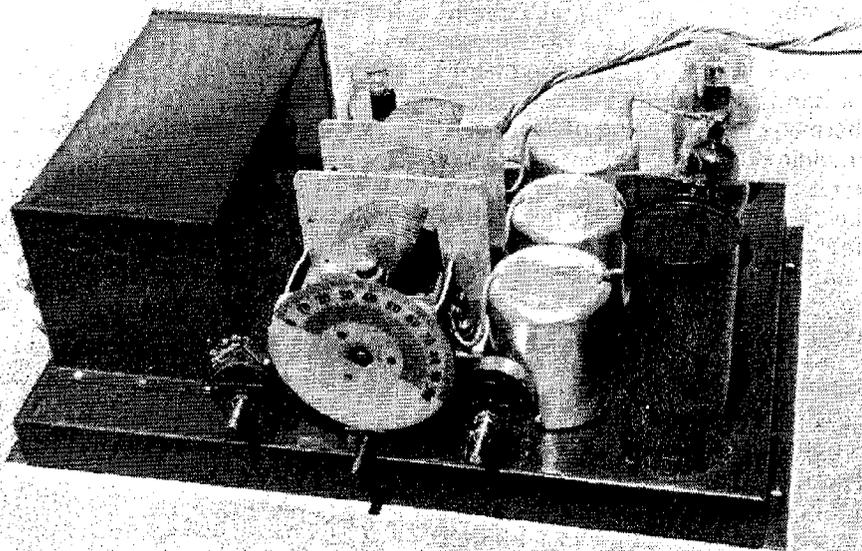
**After a complete strip-down & repaint, the derelict Tasma chassis looked as good as new. This particular receiver now works better than ever, following the discovery of a manufacturing fault.**

But there was a very good reason for the weak response. A close examination of the wiring underneath showed that the screen grid on one of the 24As had never been connected to the high tension supply. The screen had a bypass capacitor but no screen voltage. Running a wire from an adjoining screen grid connection to the unconnected screen gave a huge improvement to the set's performance, which improved even further when the trimmers were properly aligned.

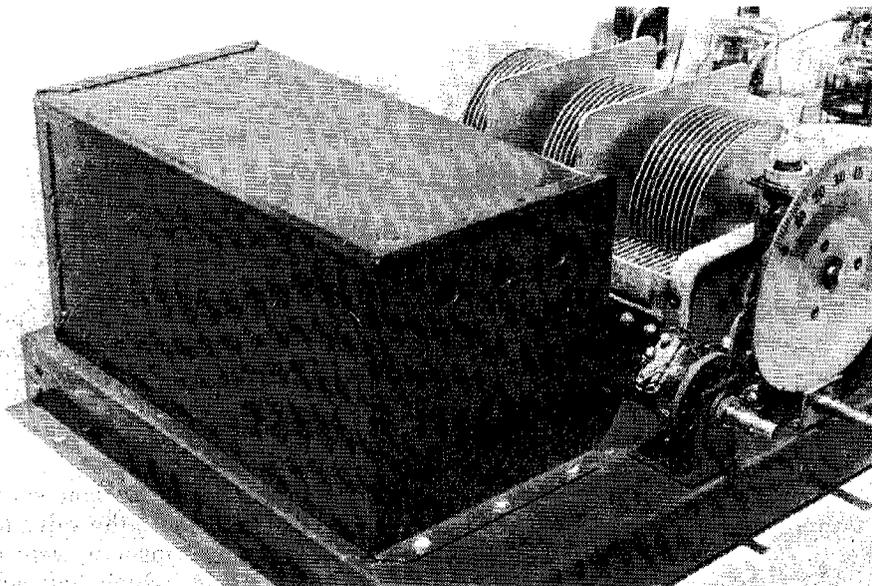
This close-up view shows the new power transformer cover. Made from light gauge sheet steel with spot welded seams, it is identical to the original apart from being 10mm higher.

There was another problem yet to be solved regarding the replacement transformer. As the substitute unit is about 10mm higher than the original, the transformer cover would no longer fit. No problems! The local sheetmetal man made up a similar but deeper cover and after a coat of paint no one would ever know the difference.

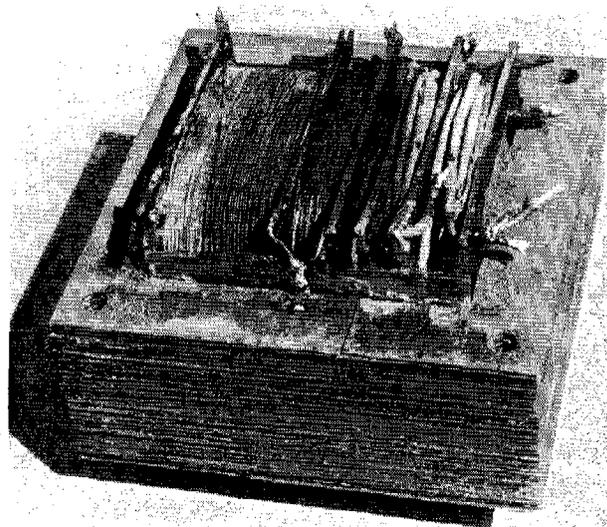
The burnt-out power transformer was interesting in that it was constructed more like a modern transformer rather than one from the 1930s. As shown in one of the accompanying photographs, each winding is placed side by side instead of one on top of the other, as was usually the case in that era.

Rewinding the transformer was considered at one stage but it was more than I could handle, as both the primary and high tension windings were open. And having it rewound professionally would be quite an expensive repair job – probably at least \$100.

The Tasma's original power transformer (left) had many charred windings & was a total write off. Removing & stripping the tuning capacitor (above) was the best way to clean it & lubricate the spindle bearings.

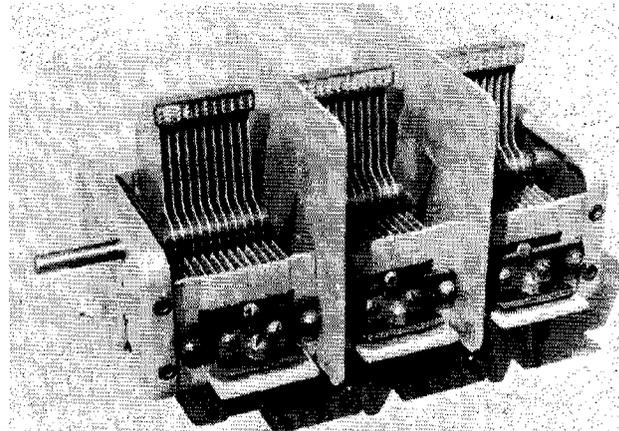
The 3-gang tuning capacitor had its problems too, with dry rusty bearings and the three sets of moveable plates about 45 degrees out of alignment with each other. In addition, all the paper capacitors were leaky and the large block capacitors used in the high tension filter were particularly bad. Some of the resistors had gone high too and the wirewound high-tension dropping resistor had several dead taps on it, indicating either poor connections or

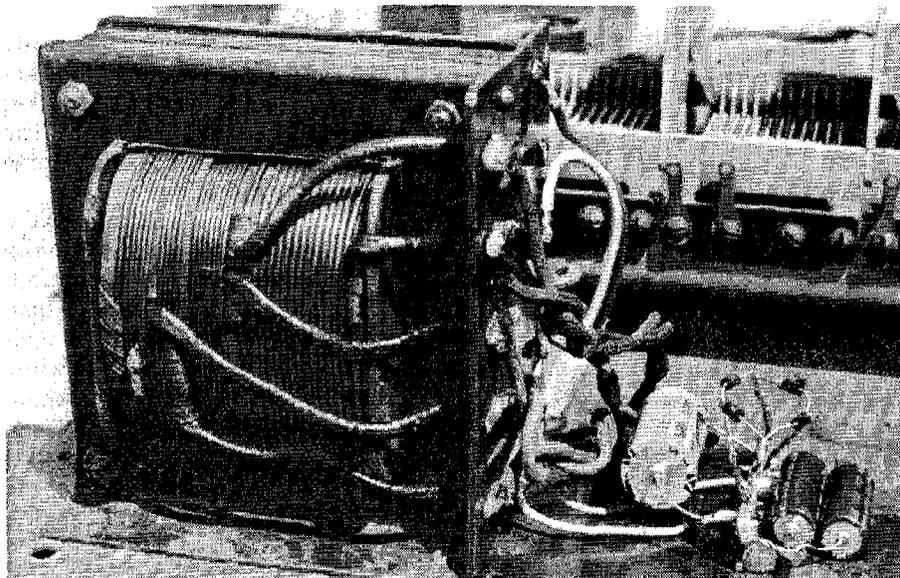
was a large 2.5V type, it was not the original. There was another set of bolt holes in the chassis that suggested there had been a transplant at some time in the past. Checking out the transformer soon revealed that it had suffered a coronary in one half of the high-tension winding. Repair prospects at that stage of the proceedings did not look very promising.

Although the replacement power transformer only had one half of its high-tension winding intact, it was still able to supply the Tasma's needs. Note that this photograph was taken with the experimental bridge rectifier still in place.

As the transformer was particularly large and robust looking, I thought I might try feeding the good half of the winding into a silicon diode bridge rectifier to supply the set's high tension. In fact, the bridge rectifier setup worked quite well except that it required a sizeable wirewound resistor to reduce the voltage to a level that

The next alternative was to use the half high-tension winding with the 80 rectifier connected as a half-wave unit. Surprisingly, this worked better than expected. It produced the correct voltage and is completely hum free while still using only 10μF electrolytics either side of the field coil.

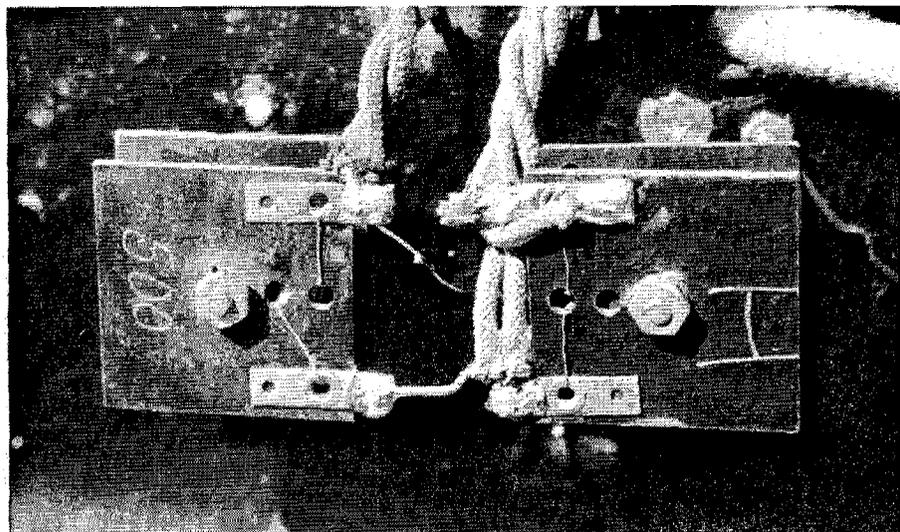
These odd looking square components are wirewound resistors. One (right) is the centre-tapped filament resistor (for the directly heated output valve), while the other (left) is the 500Ω cathode bias resistor.

One problem encountered is that the Tasma has a few odd looking original components in it that are a little different from normal. For example, there were a number of square shaped fibre formers bolted to the underside of the chassis (see photograph). These little units are either wirewound resistors or radio frequency chokes.

The two shown in the photograph are resistors. One is the output valve's centre tapped filament resistor and this is connected to the second unit – a 500Ω cathode bias resistor. These square shaped components are not the usual readily identifiable wirewound, centre-tapped and bias resistors.

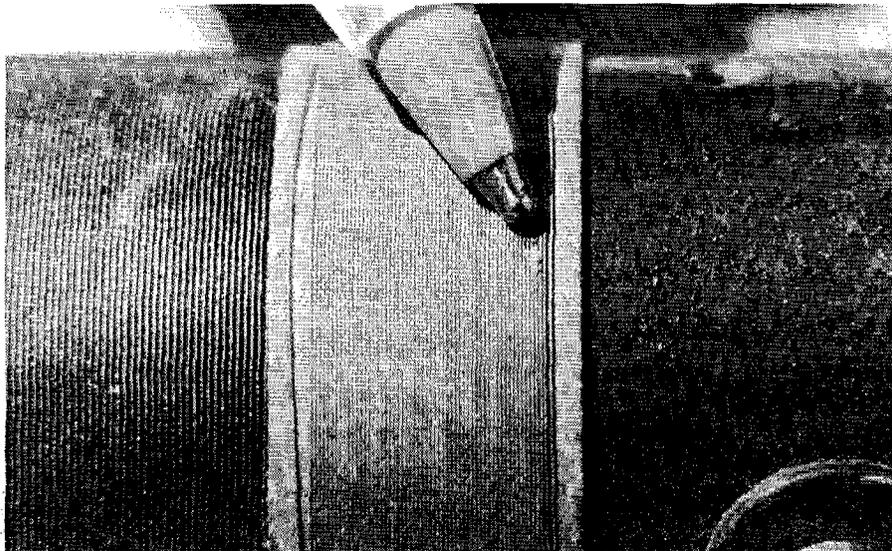
The RF coils are identical and they had the same fault. Fortunately, the open primary winding is wound over the top of the secondary which made the repair a good deal easier than if it had been the other way around.

The problem was the much dreaded "green spot". The fine silk-covered wire had several spots of corrosion in it which could be clearly seen as it

had come through the silk. The 60 turns of wire were counted before the damaged coil was removed.

**This microscopic spot of corrosion was sufficient to stop the receiver from working. In fact, the Tasma had two faulty RF coils due to "green spot" corrosion. Note that the primary winding is wound on top of the secondary winding, which made repairs much easier.**

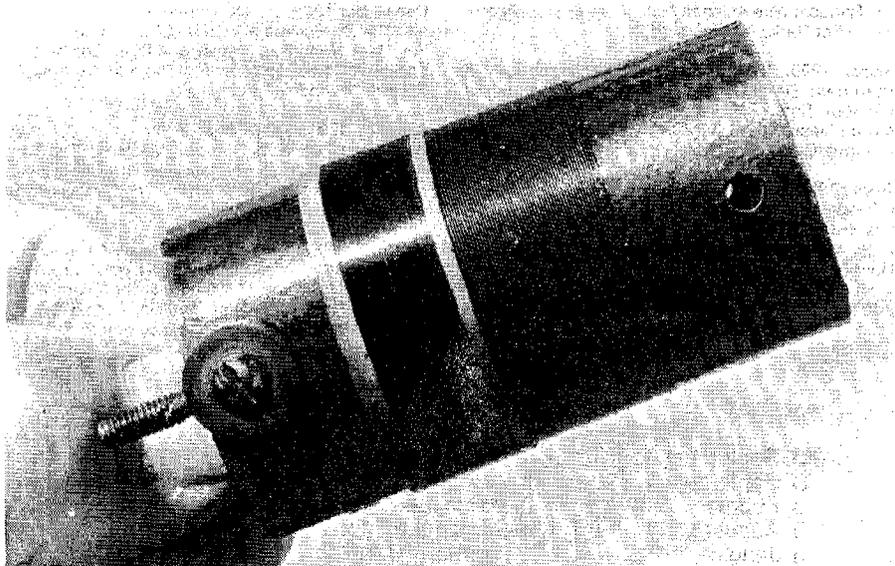
**This photo shows the rewound RF coil, prior to installation in its metal cover. It was hand-wound with enamel-covered wire of a slightly different gauge & this restored it to full working order.**

Not having silk covered wire, I had to compromise. Enamel covered 0.125mm wire is about 0.01 millimetres larger than the wire originally used. It would have to do!

Disaster struck at about fifty turns when the wire broke. A strand of copper wire a mere eighth of a millimetre in diameter is not very strong and coil winding requires a reasonable amount of tension. When winding, one always hopes that the coil does not break or slip out of one's aching fingers. If either happens, it's a case of "oh well; start again"!

In the end, the outcome was quite successful although rewinding RF coils is always a tedious job.
