# VINTAGE RADIO

## A couple of odd receiver repairs

**I recently had two radio receivers to repair for a collector and, in each case, there were unusual problems. Both radios were small postwar 4-valve Bakelite cabinet types – one a Kriesler & the other a little Philips Philipsette.**

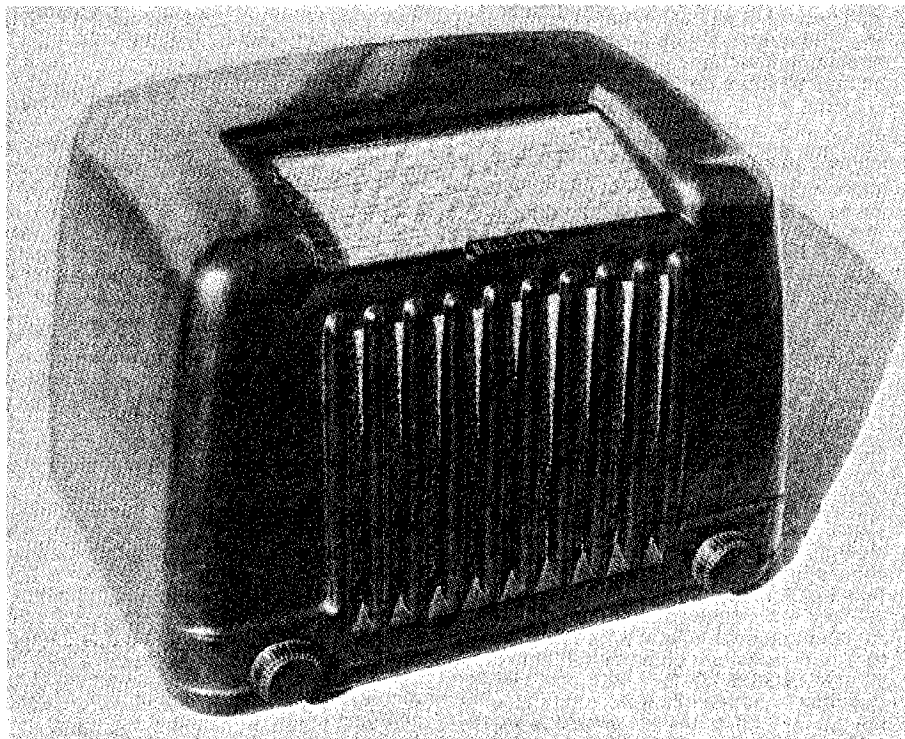
This photo shows the 4-valve Kriesler that had the missing component. It also had other problems – mainly faulty paper capacitors.

It does show, however, that one must look beyond the broken down component and locate the real cause of the problem. The real fault in the old Kriesler was four ailing capacitors, not the obvious overloaded resistor.

After disconnecting the suspect capacitor (an original paper capacitor I might add), it was found to have a complete short circuit. Replacing this faulty capacitor restored the set to working order once again. But although the set was now working, the high tension voltage was still only 150V at the output side of the filter.

Checking the capacitors with a voltmeter revealed that three of them had high tension voltages across them and these were replaced with modern polyester equivalents. This step saw the high tension voltage rise to 210V.

The remaining paper capacitors were all replaced with 100V green-caps.

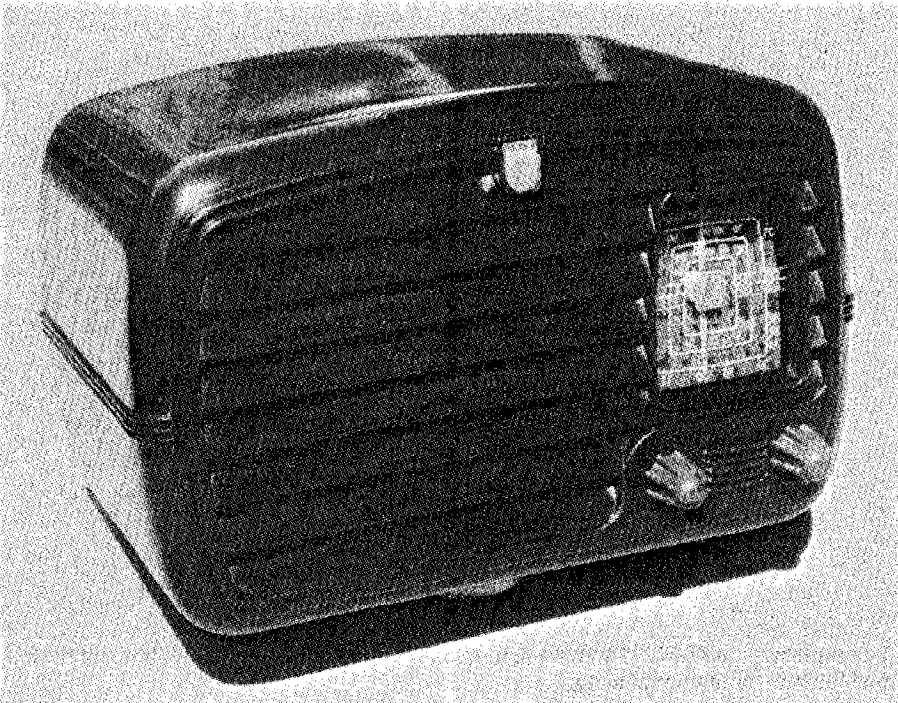
**This small Philips 4-valve receiver is a mighty performer for its size. It had a number of problems, including a faulty valve, faulty capacitors & power transformer faults.**

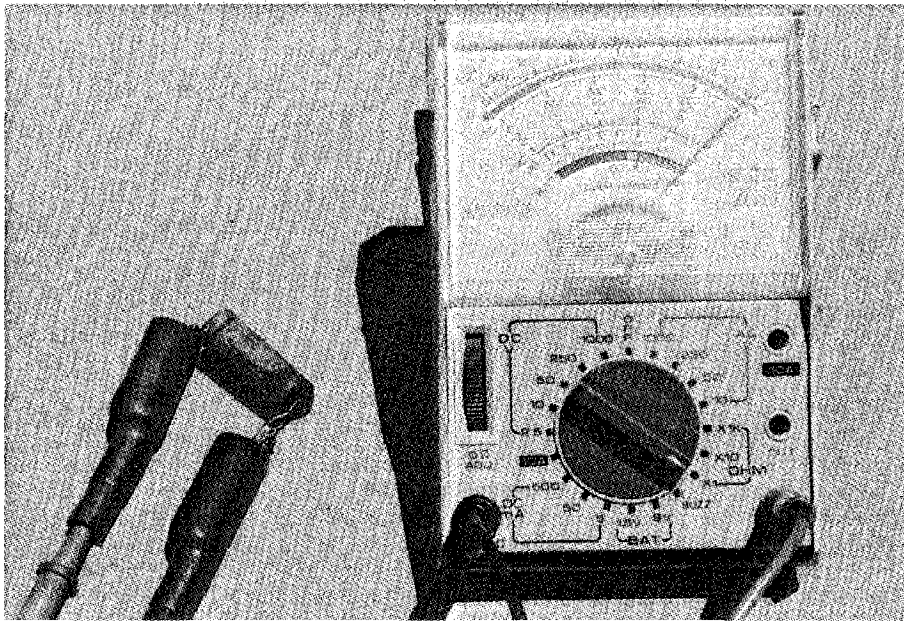
By this stage of the proceedings, the fault was fairly obvious – a short circuit at the point where the screen voltage of the IF valve is applied to the 6AN7 frequency converter socket. As the socket connection at that point had a 0.05 $\mu$ F bypass capacitor to chassis, it seemed likely that this component could be faulty – and it was.

**A short-circuited 0.5 $\mu$ F capacitor was one of the problems encountered with the Kriesler repair. The routine replacement of paper capacitors can automatically solve many obscure receiver faults.**

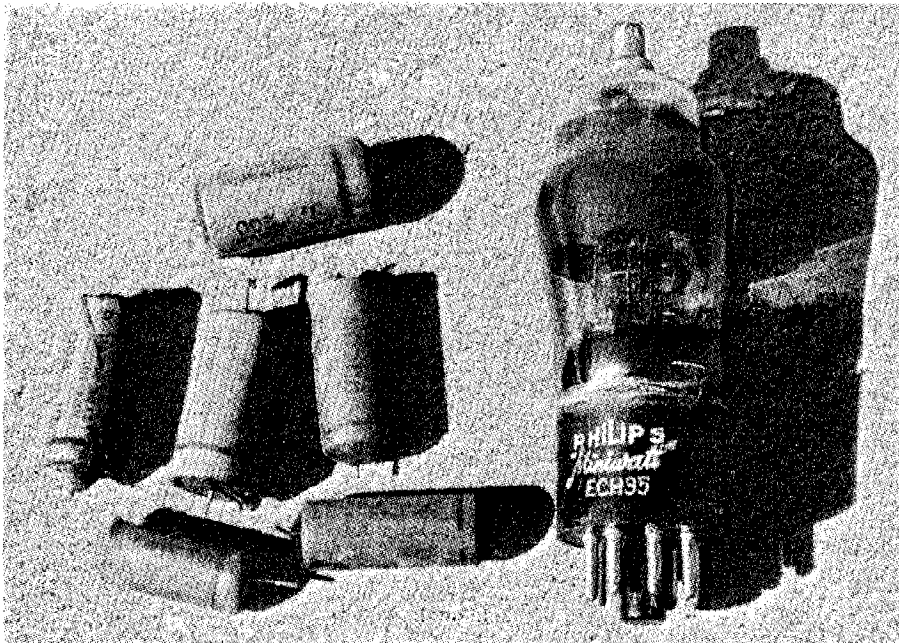
A completely dead ECH35 valve & a few sick capacitors were all that prevented the Philipsette from working.

The little Philips had a valve problem – the ECH35 frequency converter was very dead in the heater department and needed replacing. The remaining three valves tested OK.

Replacing all the paper capacitors cured the distortion problem. The exact fault may have been a leaky coupling capacitor to the grid of the output valve. A leaky capacitor in this position is bound to cause distortion. The high tension voltage rose by about 20V after the capacitor replacement job was finished.

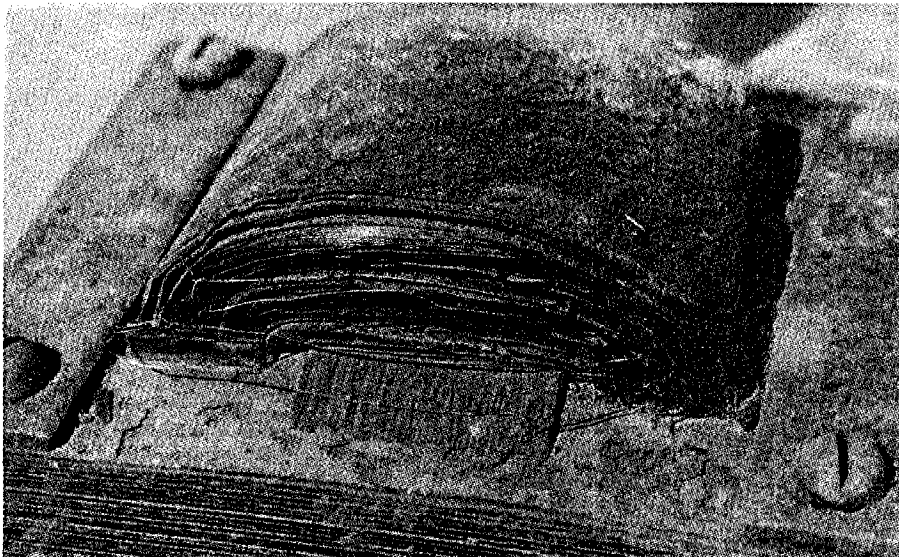
The power transformers used in many Philips & Mullard receivers share this common fault – an exposed high tension winding. The winding protrudes outside the paper insulation that separates the layers (probably caused by the paper shrinking with age). This is not the transformer used in the Philipsette in the story but a similar one in worse condition, to show the problem more clearly.

In addition, it was noticed that some of the high tension winding was exposed and a couple of turns were hanging out in the open. This is a common fault with this make of transformer because the windings come quite close to the edge of the paper that separates each layer. The loose wires were coaxed back in place and held in place with silicone sealant.

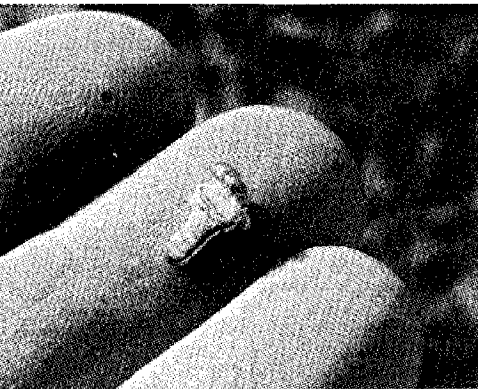
**This small blob of solder was shorting out the high tension winding of the Philip's power transformer. The short-circuit only occurred when the transformer became hot enough for the expansion of the high tension winding to sandwich the solder against the core laminations. There's always something different that can cause trouble.**

A close inspection of the power transformer revealed a blob of solder wedged firmly between one side of the high tension winding and the core laminations. A molten drop of solder could have only fallen in there when the chassis was upside down. As I had done my work with the chassis on its end, I didn't put it there!

Removing the solder returned the set to normal operation. The solder was acting like a thermal switch and only caused trouble when heat expansion of the windings caused the solder to short the HT winding to the laminations.
