VINTAGE RADIO

Restoring a sick Radiola

Getting an old receiver working again and having it working well are two different things. This month's story is about a 1938 model 5-valve Radiola that didn't really make the grade with its initial restoration.

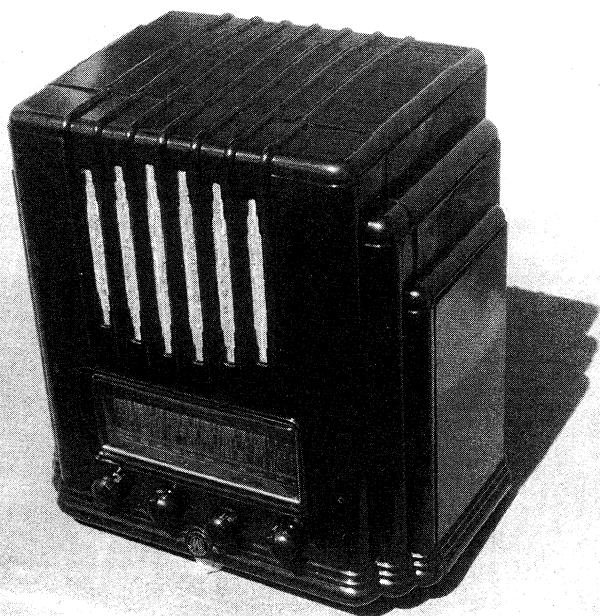
This late 1930s Radiola had two serious faults: a defective IF transformer and a loose voice coil winding in the loudspeaker which produced less than perfect results.

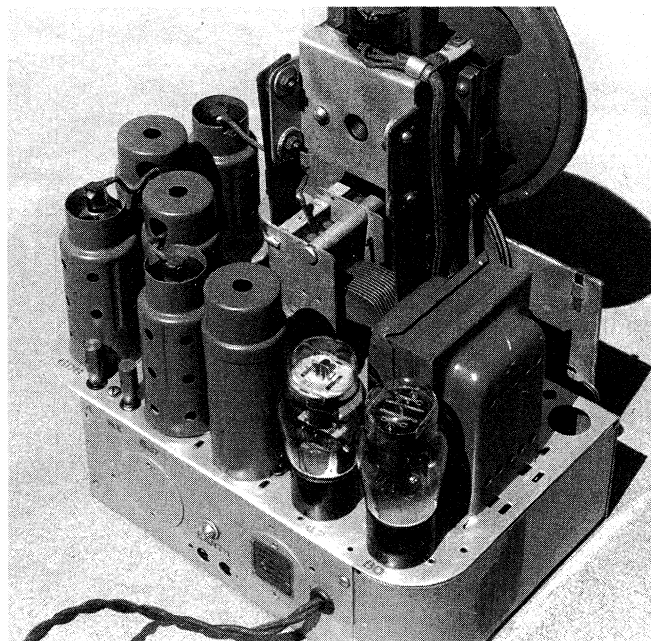
The old Radiola was a fairly compact receiver for its era, as this top view of the chassis shows. The set had been reasonably well restored using mainly secondhand parts.

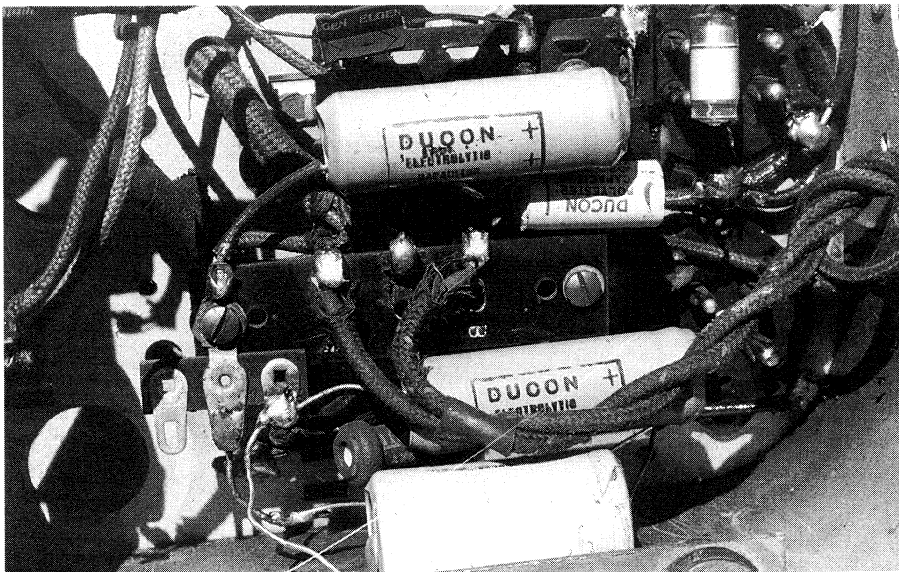
While there are lots of serviceable secondhand capacitors about (and I have used plenty myself over the years), the ones fitted to this old Radiola would have to be considered suspect until proven otherwise. These capacitors had been removed from junked black and white TV sets (where he found these I'll never know) and installed in the Radiola without being tested, so a faulty capacitor looked like a good possibility.

Unfortunately, in order to test such capacitors they must first be isolated, which involves unsoldering one connection on each capacitor. Each capacitor was checked in turn with a megohmmeter set to the 500V range. As it turned out, however, all the old polyesters tested perfectly without the slightest hint of leakage. The electrolytics also checked out OK.

The restoration had been done using secondhand capacitors stripped from an ancient TV receiver. Although initially suspect, they all tested OK.

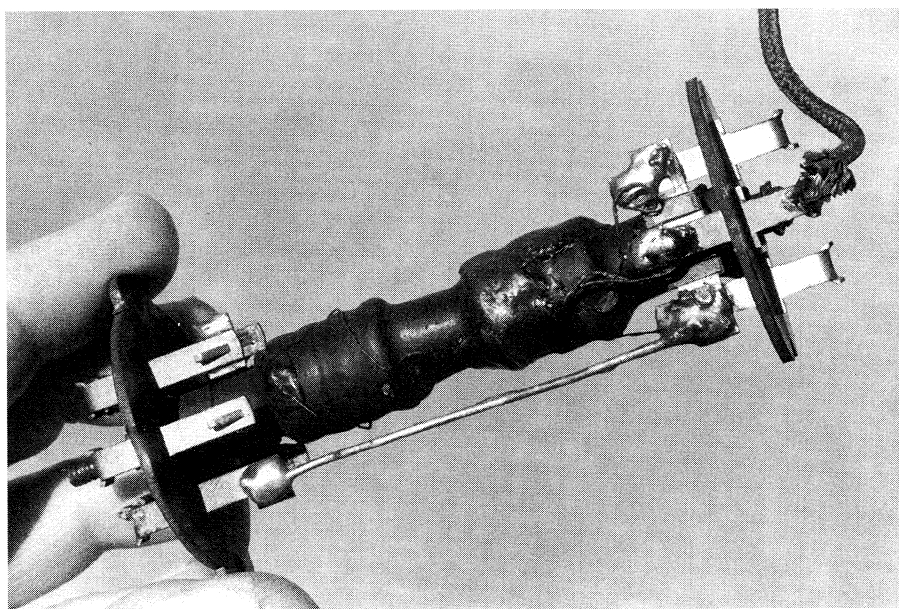
Sure enough, a major fault was soon located. The first IF transformer secondary winding was open circuit. This malfunction reduced the radio frequency signal to the IF amplifier valve, so it was no wonder the set performed so badly. In fact, it is a miracle it worked at all!

A closer inspection revealed that the iron core adjustment for the transformer secondary had also been adjusted fully in. This would be part of the reason for some RF transfer to the IF amplifier valve.

This is the repaired IF transformer. Corrosion breaks can often be reconnected, thus restoring the transformer to working order.

The transformer windings were of multi-strand (Litz) wire and one end of the secondary looked very suspect where the wax coating had cracked open due to aging. Several turns had to be removed before the break was found and testing with an ohmmeter revealed continuity from that point to the other end of the winding.

Fortunately, a few turns less on the secondary winding would have little affect on the IF transformer operation.

Because the transformer had an adjustable iron core, it would be easy to compensate for the lost turns. What's more, no special winding technique would be required to replace the unravelled wire. All I would have to do is remake the termination and reseal the exposed wire with wax.

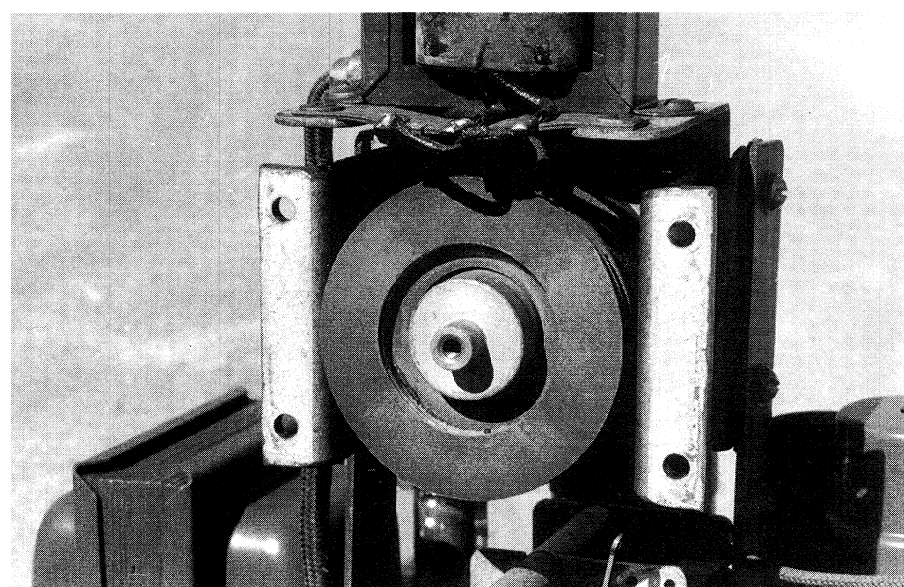
When the volume was turned up, there was a distinct rattle from the loudspeaker. This is a common problem in old speakers and is often caused by the cone separating from its outer rim. Alternatively, the rim can come adrift from the speaker frame.

However, after checking these possibilities the rattle was still there. This can leave only a few other possibilities: either a loose voice coil or voice coil winding, or the voice coil polling on the magnet.

After removing the speaker cone (with minimal damage) the trouble spot was clearly visible – the voice coil winding was loose. It had also been rubbing on the close fitting frame and the enamel insulation on the wire had been worn away from the outside of the coil.

This view shows the defective loudspeaker with the frame and cone removed. Shown is the central pole piece (electromagnet) surrounded by the hum-bucking coil. The output transformer is mounted on top.

The remedy was simple. The voice coil was given a couple of coats of Shellac (although any lacquer will do) and the close-fitting ring in the frame that encloses the voice coil was slightly enlarged (in a lathe) to give the coil a little more clearance.

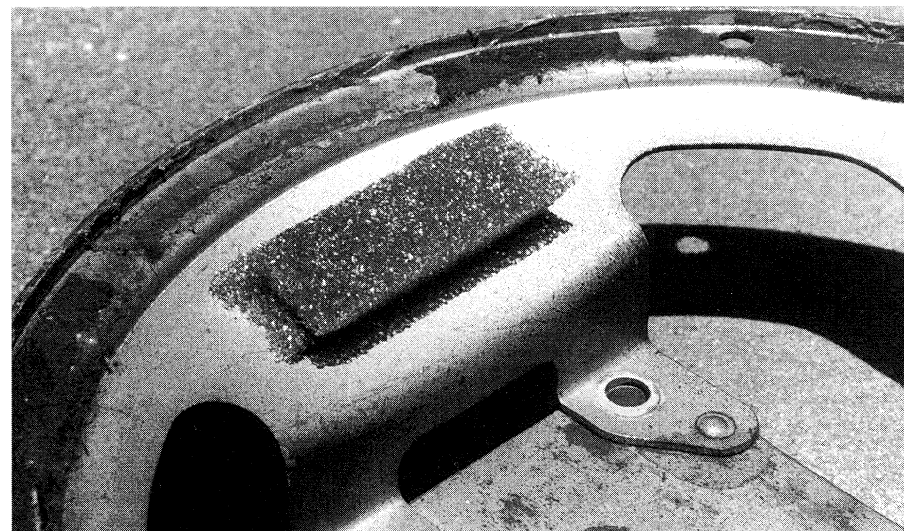
This piece (and several other pieces) of foam plastic behind the speaker cone indicate a previous attempt to eliminate the cone rattle. Because the voice coil assembly was loose, the attempt was unsuccessful.

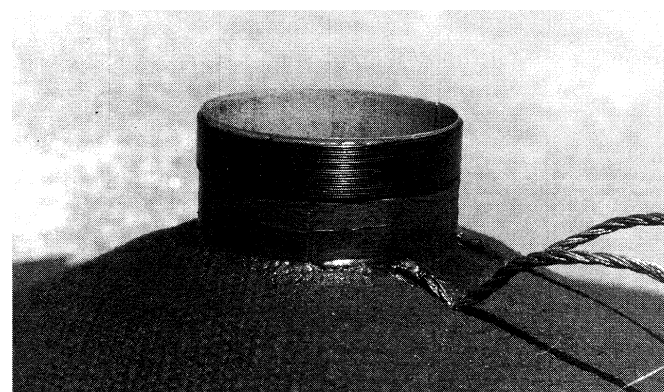
A few coats of Shellac solved the loose voice coil problem. The voice coil is wound on a thin cardboard former which is inclined to go out of shape over a long period, thereby loosening the coil.

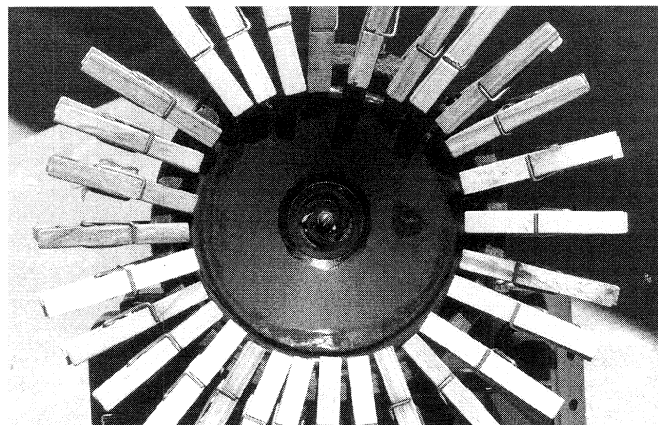
Regluing the cone required many clothes pegs to hold it in position. Several thin strips of shim brass were used to centralise the cone.

The cone was then glued back in position and held in place with clothes pegs until the glue dried. Three strips of "five-thou" shim brass were used to centre the voice coil around the electromagnet central pole piece prior to clamping the rim of the cone with the pegs.

It was a totally successful repair. The cone was quite free at the centre and the irritating rattle was completely cured.

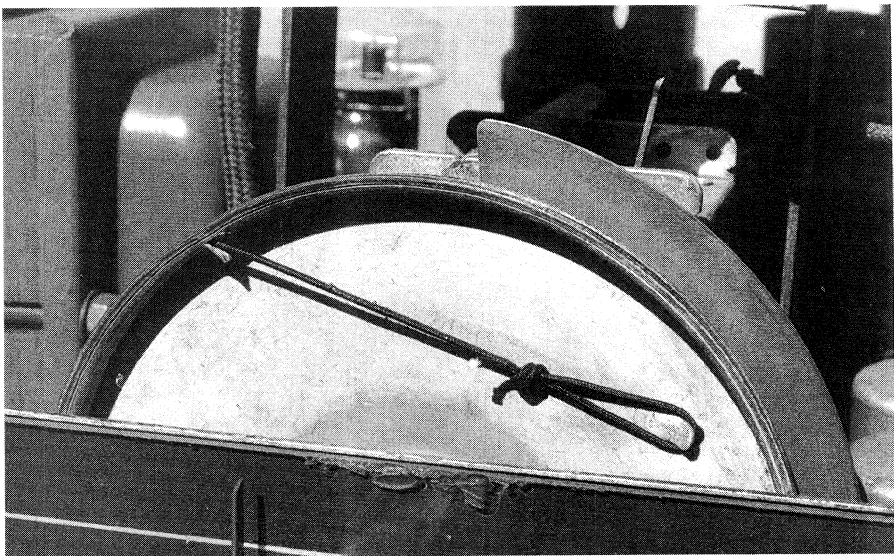
The friction drive dial mechanism had been previously modified to a cord drive. Note the cord drum in front of the old drive plate.

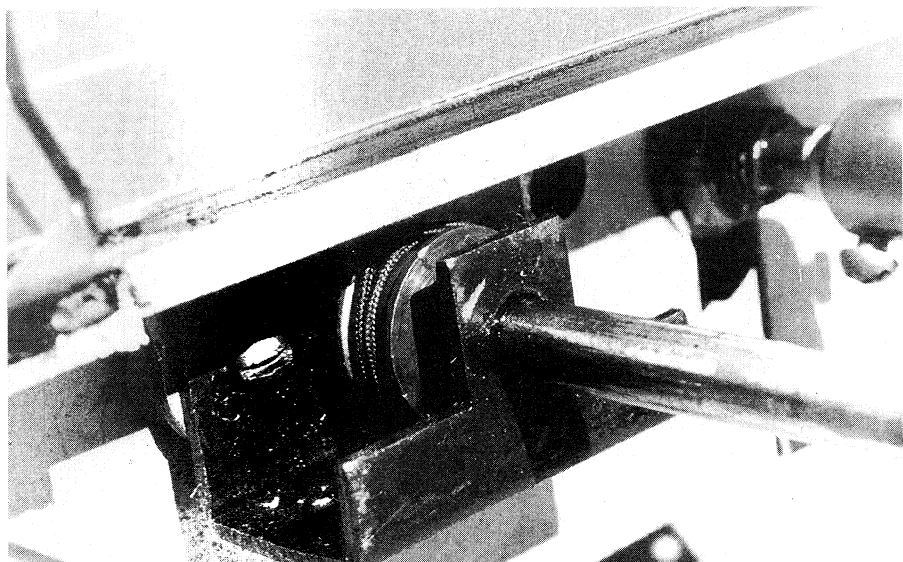
This is the bottom end of cord drive modification. The job was quite well done and is the logical thing to do if the original friction drive mechanism is badly worn or if parts are missing.
