Vintage Radio

Restoring a 1946 HMV Model 456A mantel radio

Built into an attractive up-market timber cabinet, the HMV 456A is a mid-price large mantel set from 1946. The circuit uses just four valves and covers the AM broadcast band only.

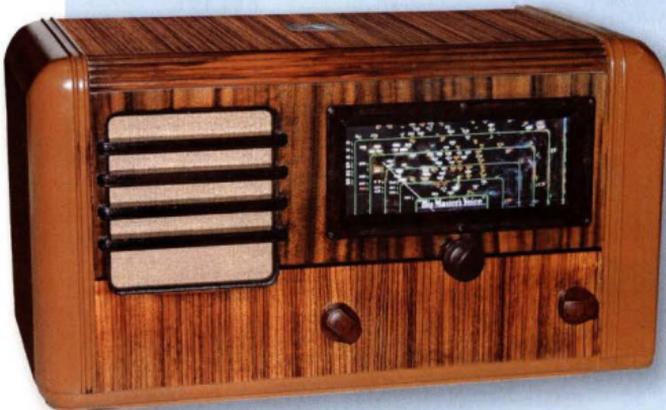
Above: the fully-restored HMV Model 456A. The cabinet in particular required a lot of work.

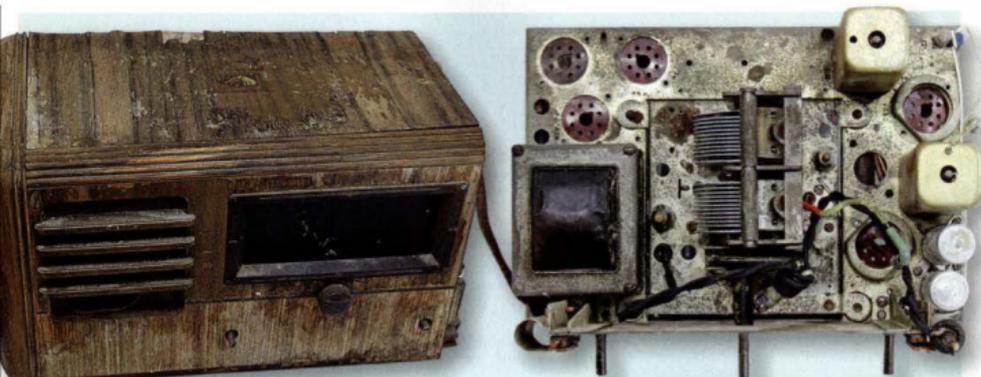
Unfortunately, this set had had a hard life. The dial glass was missing and timber cabinet was water damaged. The wood veneer was also cracked and had de-laminated in several places, while the righthand end panel of the cabinet was missing.

These photos of the cabinet and the chassis shows the very poor condition of the set prior to restoration. The cabinet had been badly water damaged, the righthand end panel was missing and two of the knobs were also missing.

The timber case was perhaps the most demanding part of the restoration because of its poor starting condition. The biggest job was making and fitting a new end piece. The remains of the original finish on the cabinet were then removed using paint stripper, after which it was sanded back and

the veneer restored. It was then given the paint and polyurethane treatment so that it looked almost new.

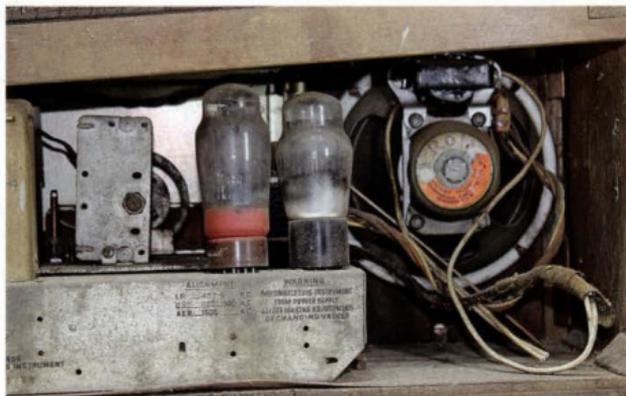
Also taken prior to restoration, this inside view shows the poor condition of the 2-core power lead (it had been joined at some stage in the set's past). The chassis and the valves were also dirty and the speaker cone had been punctured.

My next step was to replace the dodgy 2-core power lead with a modern 3-core lead, so that the chassis could be earthed.

A large hole in the original speaker grille cloth meant that this too had to be replaced. Whatever had penetrated this cloth had also punched a hole in the speaker cone which sits immediately behind it. This damage was repaired by cutting a patch from the cone of a non-functioning speaker and attaching it using PVA glue.

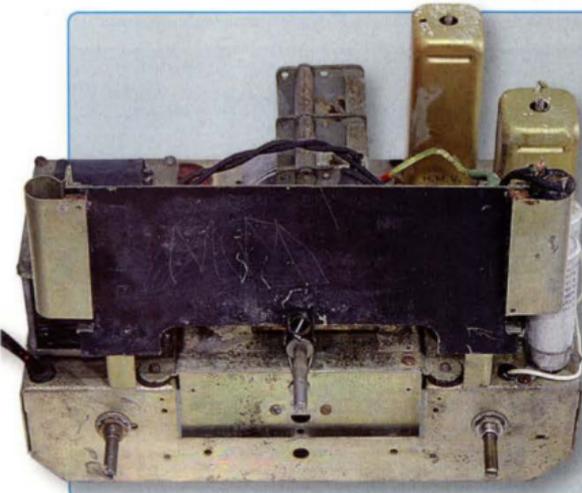
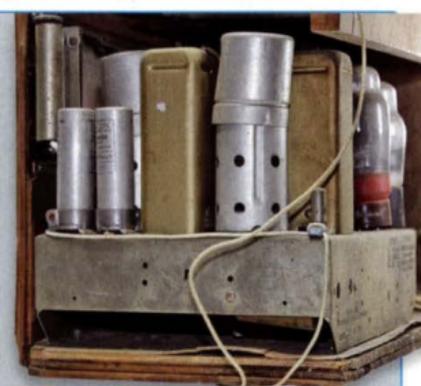
Another two views of the set prior to restoration. The dial glass was missing and the end panel was completely missing on the righthand side of the cabinet, which meant that a new piece had to be made and fitted.

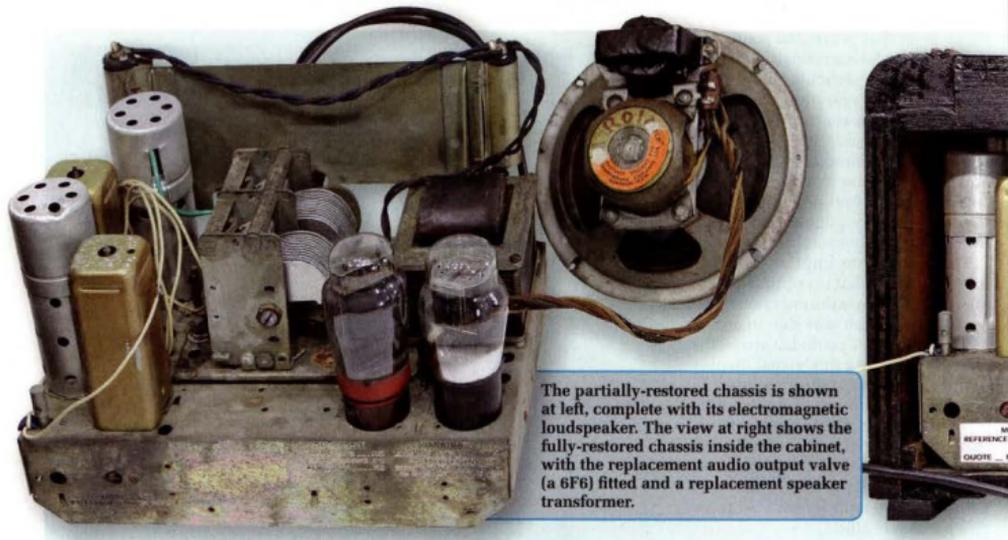
A few quick voltage checks revealed that there was no HT on the pentode's plate, indicating an open-circuit speaker transformer. This was subsequently confirmed by a resistance measurement and a replacement transformer restored operation.

The partially-restored chassis is shown at left, complete with its electromagnetic loudspeaker. The view at right shows the fully-restored chassis inside the cabinet, with the replacement audio output valve (a 6F6) fitted and a replacement speaker transformer.

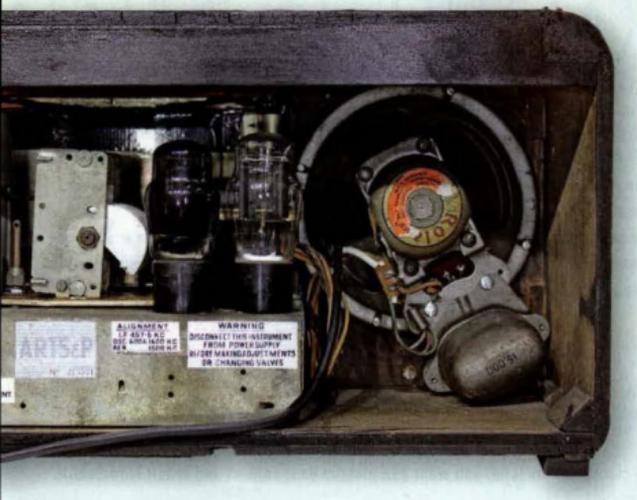
The power consumption rose to a reasonable 44W but my optimism was misplaced because the only noise that came from the set was due to arcing inside the EL33A pentode valve. This was attended by a fine visual display of purple plasma in the envelope.

A classic symptom of a gassy tube is oxidation of the silvery magnesium "getter" that's deposited inside the envelope to absorb residual gas. However, this EL33A was externally painted in red near its base, so there was no visible clue.

Arcing inside the EL33A pentode valve was accompanied by a fine visual display of purple plasma in the envelope, indicating that it had gone "gassy". The valve was replaced with a 6F6 which is a close equivalent.

And that was it – the radio then functioned reliably. I didn't have an EL33A output pentode in my valve drawer, so a 6F6 with comparable specifications was substituted. Unfortunately, the radio only worked for a few minutes with the replacement pentode in place before again going completely silent.
