Toshiba V8700

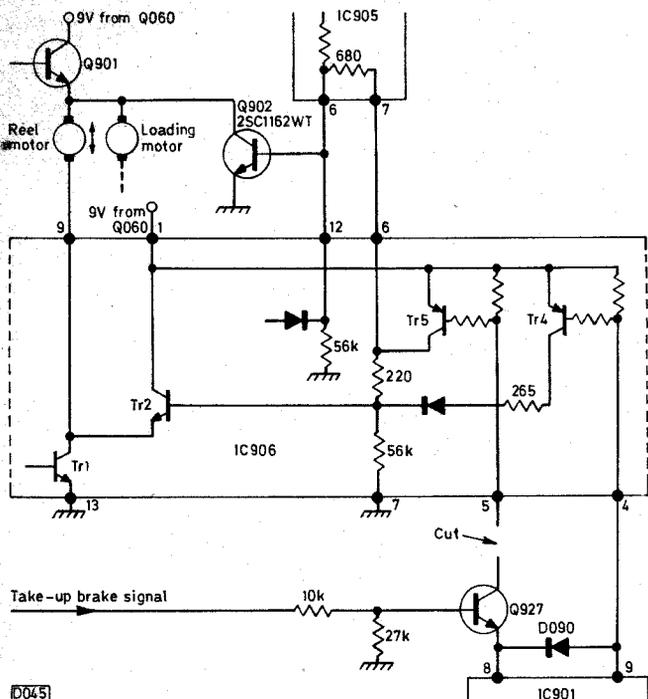
Little did I know when my friend Geoff sent me an Hitachi VT8500 that wouldn't eject what trouble and expense it would cause. The machine wouldn't unlace and it was found that Q902 in the loading motor drive circuit (see Fig. 1) was open-circuit. The curious thing was that it turned out to be a BD131. Other transistors had been removed and replaced as well – legs were sticking out at all angles. I hate to see this sort of thing. Why can't some people be bothered to tidy up? Three i.c.s had also been soldered and may or may not have been removed. The 9V supply for this part of the circuit comes from the series regulator transistor Q060: R081 (2.2 Ω) which is in series with this transistor was open-circuit. I replaced it with a resistor, a standard modification, but this didn't have any bearing on the main fault.

After replacing the defective components I left the machine in fast forward. After a while Q902 got very hot. So did IC906. This was strange as Q902 should be off for fast forward. I left the machine to cool down then put it into fast forward in order to make a few measurements. Result: there was 600mV that shouldn't be there at the base of Q902. It took some time to find the source of this voltage. Tracing back I found that it came via pins 6 and 7 of IC905 from pin 6 of IC906. Within IC906 the current was flowing via Tr4, a 265 Ω resistor, a diode and a 220 Ω resistor. Q901 and Tr1 are

Fig 1: Reel motor drive circuit, Hitachi VT8500. Q901/Tr1 drive the motor for fast forward; Tr2/Q902 drive the motor for rewind. Q901 and Q902 are also part of the loading motor drive circuit.

IC906 was replaced but the rogue 650mV persisted. Pin 4 of IC906 was disconnected and it went away. The microcomputer system-control i.c. (IC901) was next suspected and changed but we were still no nearer a solution. It was then realised that the modification had left the base-emitter junction of Q927 in circuit. Now the reverse breakdown voltage of such a junction is only 2-3V, so a leakage current path was present via D090, Q927 and the base circuit resistance. It was enough to turn Tr4 on.

When Q902 was changed to a sturdier TIP31 the threading problem was cured. So the machine went back to Geoff with the comment that it had already received attention. Geoff phoned the following day to complain that it wouldn't wind fast forward and enquired whether I'd checked this? Well yes, play, record, rewind – but perhaps not fast forward. He also said his customer was adamant that apart from head cleaning the machine had received no servicing attention during the three years he'd had it. This time one of the transistors in IC906 (TA4193) was open-circuit. So the i.c. was replaced and Geoff took the machine back to check it for himself as a final quality control. The remote control unit didn't work due to corroded batteries and he had some difficulty in setting it for timer recordings, but apparently the customer wasn't too concerned about the timer.

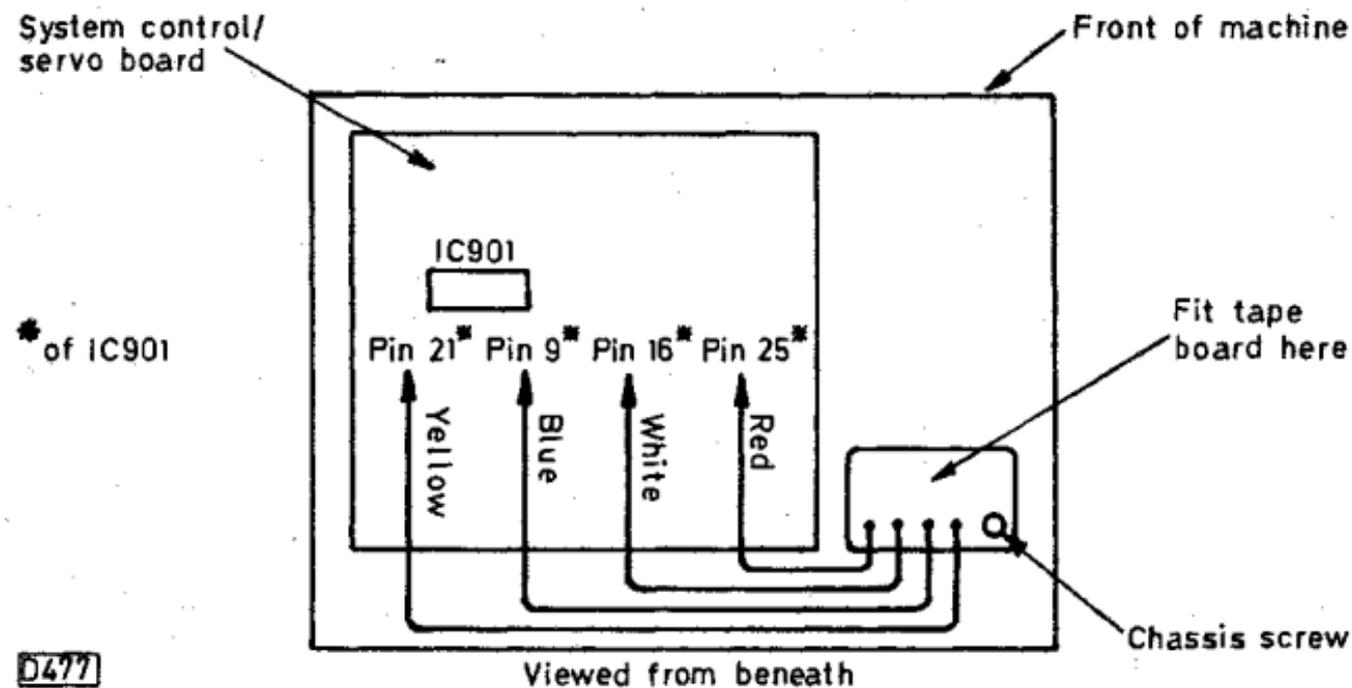
The brake modification applies to all models. The problem is tape damage after rewind, caused by the fact that the supply spool brake comes on fractionally before the take-up spool brake, or the latter slips slightly, when the machine stops after rewind. The result is a tape loop which gets trapped in the cassette flap when the cassette is removed. There are two modifications for this, a mechanical one and an electronic one. The former consists of filing

Fig. 3: Electronic modification to prevent rewind looping.

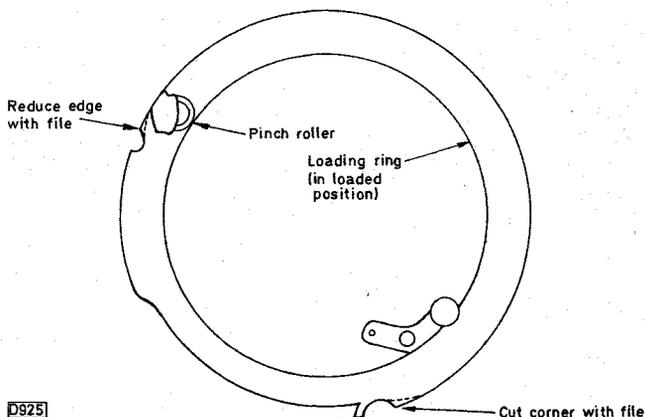
Fig. 1: Loading ring modification for the VTC5300/5400.

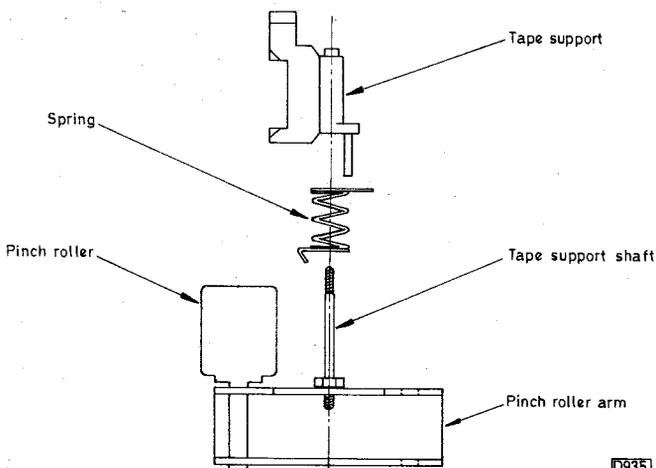
Fig. 1: The pinch wheel tape support assembly used in the Amstrad Model VCR4600.

We've found that a more certain modification can be carried out by fitting, in addition to the previously mentioned items, the pinch-wheel tape support as used in the VCR4600. The only problem here is that the nylon nut doesn't have a part number and is thus presumably not available. A steel nut can be used provided the thread is varnished after setting up. Replacing the pinch-roller arm doesn't appear to be necessary since in all the machines we've come across the arm has been drilled ready to accommodate this part. The relevant part numbers are as

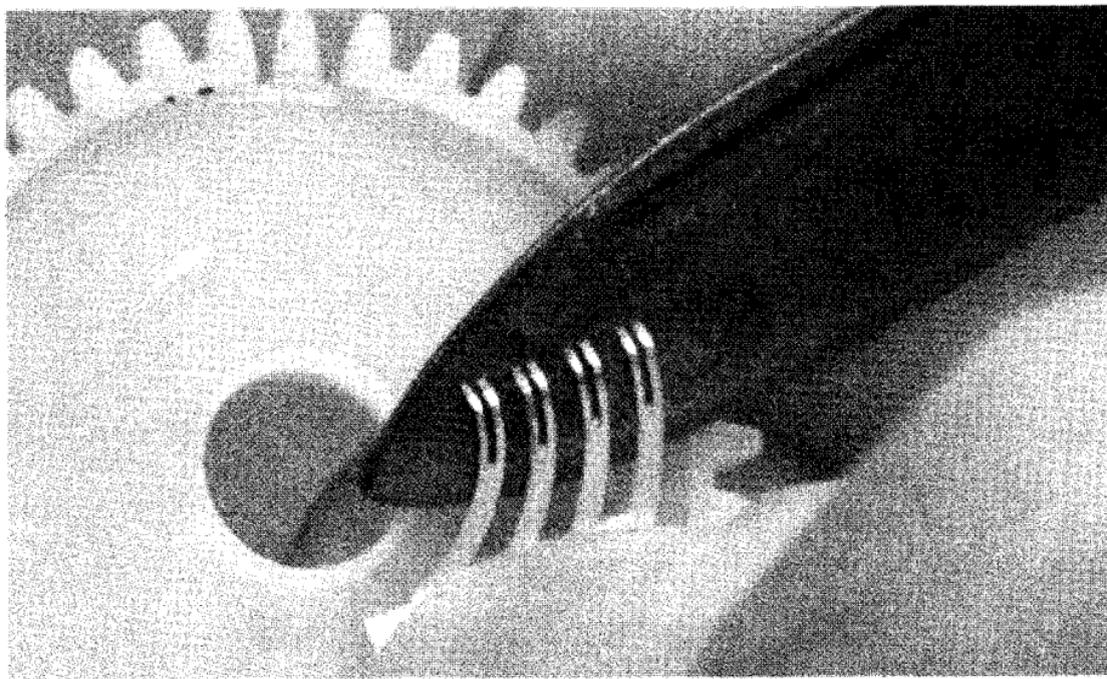
Fig. 2: Retensioning the wiper blades – take great care over this.
