The Vintage Serviceman...

Always a very popular feature of *Electronics Australia* and its precursors, the monthly Serviceman column has been published for more years than I care to remember. Today it concentrates mainly on TV and VCR topics, but in pre-television times there was just as keen an interest in radio servicing experiences. Recently, I was taken back in time with a series of diverse repair jobs that could well have been the subjects of a 'Serviceman Tells' column of a generation ago, and which I am sure will be of interest to vintage radio enthusiasts.

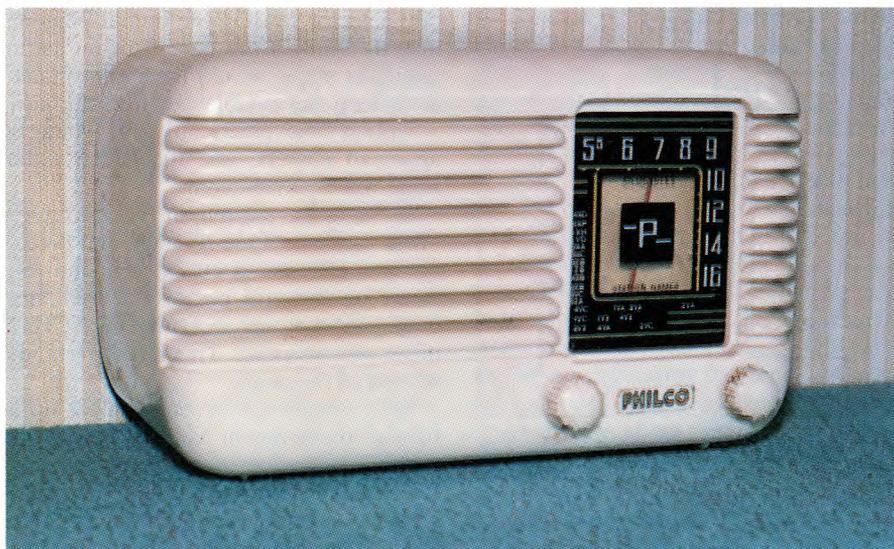
Fig.1: With only three Philips Noval valves plus rectifier, this little New Zealand made Philco receiver has a very basic circuit not unlike the 'Little General'. After 40 years of trouble-free service it developed a classic fault...

The final holiday 'surprise' was the small plastic-cased and New Zealand made Philco receiver shown in Fig.1. This had given 40 years of faithful service and I was assured that previously, it had never been serviced. The complaint was that it was 'very weak'.

This particular receiver is of the 'Little General' type, but with automatic gain control. The simple circuit, with the diode detector feeding the output pentode directly without the benefit of an audio amplifier stage, would have contributed to its long and trouble free life. But now reception was practically nil. Voltages appeared correct, and the EL41 audio stage was lively enough.

As far as I could tell, the EAF42 combined diode/pentode IF stage and detector was OK and a check with the test meter on the grid pin of the oscillator confirmed that *that* section of the ECH42 mixer was working. This left the hexode section of the mixer.

With visions of having to post up a further replacement valve, I was idly probing around with a screwdriver and touched the control grid pin of the mixer socket — creating a loud burst of noise. Clearly, the valve was not dead after all...

touched the coil end of this lead. There was no response! Taking care not to disturb anything, a check with test meter confirmed that there was no continuity between the coil and grid whatsoever!

Was the wire broken inside its insulation? A good tug on the lead showed the answer. It came away cleanly from the coil, without a trace of solder! A classic dry joint, it had taken all this time to reveal itself.

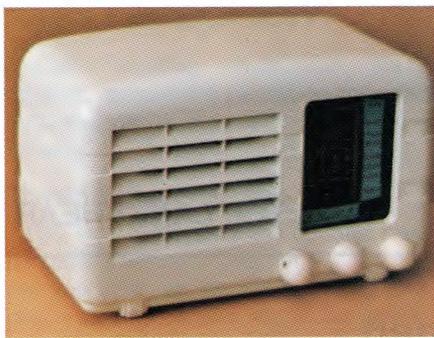
Fig.2: The Bell 'Colt', which provided some headaches out of all proportion to its modern size and circuit. Colts surely hold the World's record for longevity as a production model. First produced in 1951, it was made during the following 20 years, and continued as a transistorised set until 1980! Australian readers may recognise the cabinet as having been used for the Airzone 458 of 1946.

But the world does not stop for holidays, and when I finally arrived home, waiting for me was a Bell 'Colt', a little box of tricks that was to take far longer to fix than it should have and bring me back to earth with a jolt. A laconic note taped to the cabinet simply said 'NO GO'.

have changed value. Sure enough, the 150k anode load resistor for the audio stage measured more than two megohms. This was soon replaced and while I was about it, I tested the valves which all checked out as being quite healthy. With the power turned back on I confidently sat back, waiting for a response.

The audio amplifier was certainly working now, but there was still no reception. So much for my quick repair job! The problem appeared to be in the mixer or IF stage, but the voltages were correct. There were no open circuited windings and the oscillator was working.

It was then I noticed something that I had previously missed. The wax that seals the IF transformer tuning slugs had been disturbed. Each of the four cores had been attacked and damaged, apparently with a steel screwdriver. The correct tool for these particular cores is a hexagonal plastic alignment tool.

With the transformers repaired and replaced, IF realignment was straightforward, and there was some reception; but the stations were in the wrong places. By now I was prepared for anything, and sure enough, I found that the oscillator coil slug had been tweaked. Fortunately, the padder in these sets is fixed, eliminating one variable. Even so, it took quite a while to get the oscillator tracking correctly, especially as the tuning capacitor trimmers had also been 'adjusted'!

It seemed that mercifully, due to access to its slug being obscured by wiring, the aerial coil had escaped attention. However, although by now the set was operating well enough at the top half of the broadcast band, the sensitivity below about 1MHz was below normal. I rechecked the alignment, but the tracking was correct. Was there *still* something amiss?

That was the problem. A replacement aerial coil restored performance to normal. It would seem that somehow, somewhere, possibly in the factory, the wrong type of coil had been installed. Who knows, maybe the damage to the receiver was the result of attempts to remedy the poor performance. I never did find out.

Two of the slugs were still serviceable when reversed, but I had to replace one transformer whose former had been cracked. It is not uncommon to find that screwdriver adjusted trimmers have been screwed up tight, but to remove wax seals to get at ferrite slugs requires quite a lot of determination...

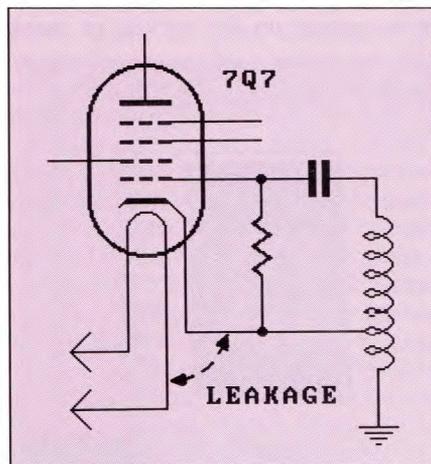
I had completely overhauled this receiver a few years ago, so I felt that the fault was unlikely to be a capacitor. By reason of its only occurring during warm-up, and the hum being 50Hz, it seemed very likely that the fault was heater-cathode leakage in a valve. In this receiver, RF bias is supplied by the AGC line and the cathodes of the valves are earthed. Usually, in such cases,

This simplified diagram of the oscillator section of the Courier receiver illustrates how heater to cathode leakage could create severe hum by modulating the RF oscillations via the coil tap. Had the cathode been directly earthed the leakage could well have gone unnoticed.

This receiver has a heptode 7Q7 converter valve, an uncommon type that is in fact electrically identical to the more familiar 6SA7 and similar to the miniature 6BE6. As these valves have no oscillator anode, the cathode would not necessarily be directly earthed, but connected to a tap on the oscillator coil. It seemed likely that this was the way the leakage hum could be modulating the oscillator signal.

There was not much more I could do but to identify the 7Q7, so that it could be swapped for a good one that I would send when I returned home. I do not like having to leave 'cures' for intermittent faults unproven. Too often the brilliant 'diagnosis' turns out to be wrong, but it seems from subsequent reports that in this case we were lucky.

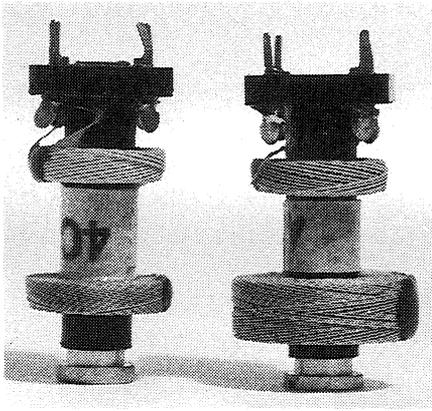
Fig.3: Matched aerial and RF amplifier coils. The upper tuned windings are of course identical, but the relative difference in size between the two lower untuned windings is clearly visible. The aerial coil is on the left. Swapping the two can seriously affect the performance of a receiver.

winding didn't look quite right — it seemed to be too big.

To simplify tracking with random external aerials, and to equalise gain over the tuning range, it has been common practice to fit both aerial and RF amplifier broadcast band coils with primary windings which are resonant at a frequency a little below 500kHz. However, as aerials provide additional capacitance, aerial coil primaries have a lower inductance than their companion RF coils. The difference can be clearly seen in Fig.4. Could it be that this receiver had the wrong type of coil? Surely not — but with this particular set, anything was becoming possible.
