Technics SLP8

This machine came into the workshop with the complaint that the tray operation was intermittent. It opened all right, so we inserted a disc. When the open/close button was pressed the tray shut partially then opened again. This happened several times before the tray finally shut. The TOC was read and all functions worked normally, including open/close.

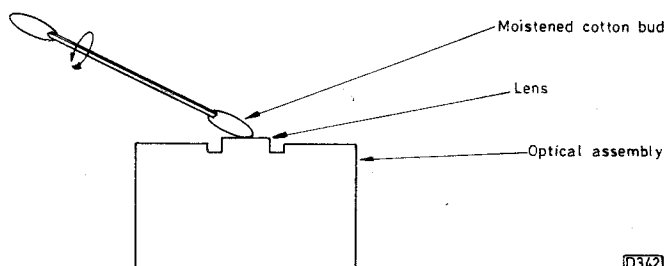
Fig. 1: Recommended method of cleaning a laser lens.

I've discussed cleaning the optical assembly with several engineers. Some use a fine soft brush while some use a soft cloth with some sort of cleaning liquid, all with varying degrees of success. It's difficult to clean anything without applying pressure, but too much pressure can damage the optical lens, rendering it useless. The safest method I know of is as follows.

First try to remove the disc clamp which can get in the way. Then slightly moisten one end of a cotton bud in alcohol and lightly roll the bud over the lens. When the lens is clean, use the other end of the cotton bud to dry it completely to avoid smears etc. I've found this to be a very effective method as it requires very little pressure. See Fig. 1

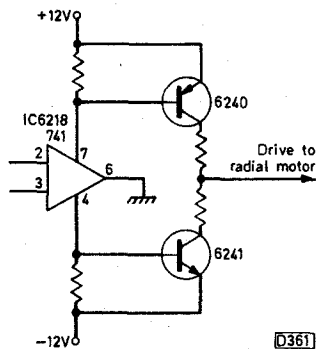
Fig. 1 (left): Radial motor drive circuit used in the B and O CDX player.

showing the ? figure. On examination we saw that the radial arm didn't swing to the centre of the disc to try to read the table of contents. The cause was loss of drive to the motor. The reason for this was evident when we looked at the servo PCB: there was a dry-joint on a through-the-board earthing link, a problem these units suffer from on the decoding board. When this particular link goes open-circuit the earth connection for the radial motor driver operational amplifier chip is lost. As you can see from the relevant bit of circuit (Fig. 1), the i.c.'s output pin is earthed, the two supply connections being used as the outputs to drive the push-pull output transistors. Remove the solder from the hole and insert a single strand of wire through it. Bend the wire over at each end and solder to the print on both sides. **I.B.**

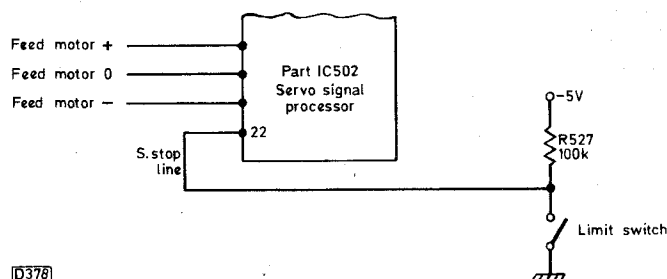
Fig. 1: Connections to pin 22 of the servo signal processor chip IC502 in the JVC Model XL-E300.

My attention was drawn to the VC4090S servo signal processor chip IC502 which provides the feed motor plus and minus signals. Comparative voltage checks were made with a similar, working machine (we all cheat sometimes!) after which I decided to replace the chip. This made no difference. I studied the circuit for a good twenty minutes before I noticed the s-stop line to pin 22 of the chip. This pin detects the position of the laser for TOC reading: if necessary, the laser is returned to the centre of the disc. A switch initiates this action. It

normally earths pin 22 (see Fig. 1). When the switch is open -5V is applied to pin 22 via R527. The problem was that R527 had never been fitted! The machine must have been new, because it could never have worked without R527. Fitting a 100kΩ resistor in this position cured the fault. M.L.
