Technics SLP8

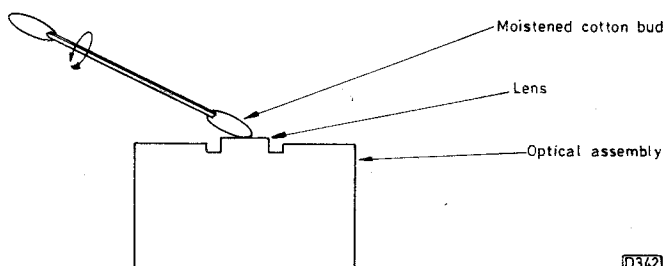
Fig. 1: Recommended method of cleaning a laser lens.

First try to remove the disc clamp which can get in the way. Then slightly moisten one end of a cotton bud in alcohol and lightly roll the bud over the lens. When the lens is clean, use the other end of the cotton bud to dry it completely to avoid smears etc. I've found this to be a very effective method as it requires very little pressure. See Fig. 1 **M.L.**

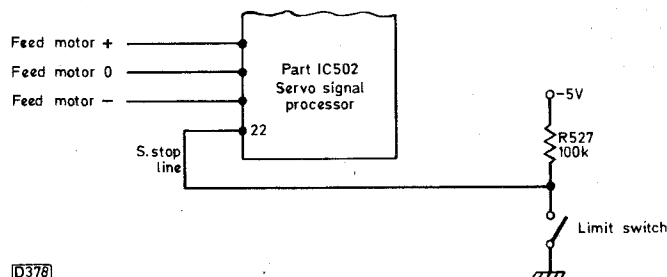
My attention was drawn to the VC4090S servo signal processor chip IC502 which provides the feed motor plus and minus signals. Comparative voltage checks were made with a similar, working machine (we all cheat sometimes!) after which I decided to replace the chip. This made no difference. I studied the circuit for a good twenty minutes before I noticed the s-stop line to pin 22 of the chip. This pin detects the position of the laser for TOC reading: if necessary, the laser is returned to the centre of the disc. A switch initiates this action. It

Fig. 1: Connections to pin 22 of the servo signal processor chip IC502 in the JVC Model XL-E300.

normally earths pin 22 (see Fig. 1). When the switch is open $-5V$ is applied to pin 22 via R527. The problem was that R527 had never been fitted! The machine must have been new, because it could never have worked without R527. Fitting a $100k\Omega$ resistor in this position cured the fault. M.L.
