# Vintage Radio

## This Little Nipper was a dog

### Restoring A 62-52

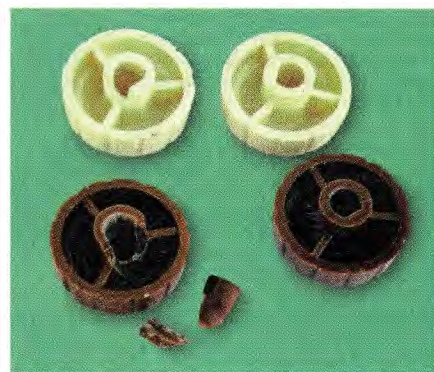
The original knobs fitted to the "Little Nipper" had a tendency to break in the centre.

Unfortunately, the correct knobs for these sets are rather hard to come by and I had none spare. In use, they often break in the centre but they can be repaired using Araldite or a similar epoxy adhesive. If any of the plastic that normally surrounds the shaft is left, a greased short length of shaft from an old control can be sat in the shaft groove. The trick is to make sure it is vertical (as it would have been originally) and before sitting the shaft in place, score the plastic on the underside of the knob to give the Araldite something to adhere to.

Most of the underside of the control can then be filled with Araldite and allowed to set. The shaft can then be removed after the Araldite has set, as the grease prevents it from adhering to the shaft. The repaired knob will work as good as new and will be stronger than before.

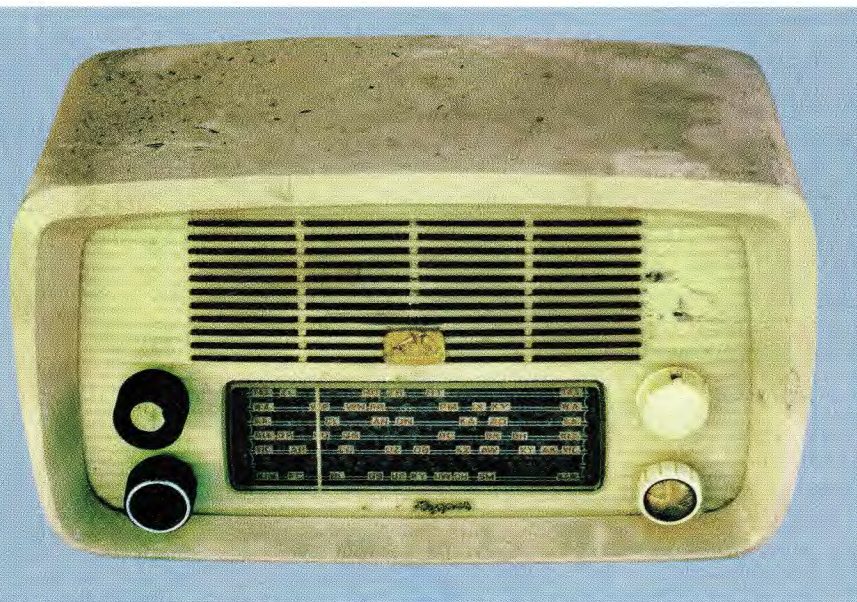
This view shows the Little Nipper receiver as it landed on my workbench. It was dirty and fitted with the wrong knobs - and that was just the outside.

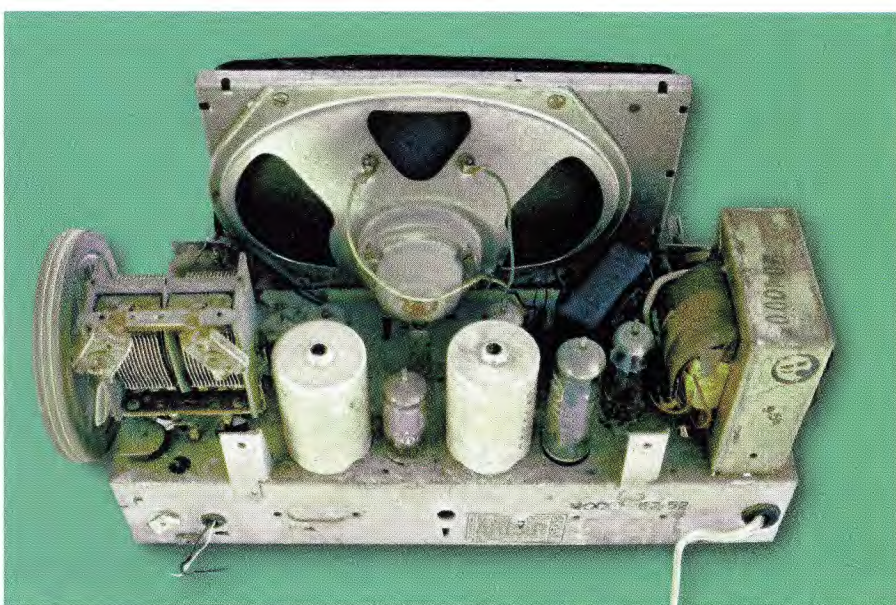
The layout on the top of the chassis is uncluttered, so access to individual parts is easy. It's just as well, because this set had more faults than you could imagine.

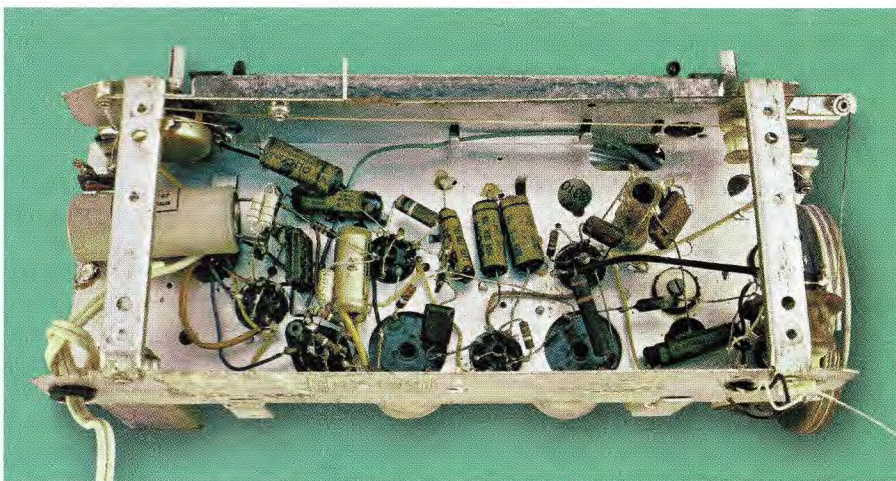
This is the under-chassis view before restoration. The 2-core mains flex was later replaced with a 3-core cord, so that the chassis could be earthed.

Before starting work on this set, I had attached an earthed lead to the chassis as a safety measure (eg, in case the power transformer developed a short to chassis). With the restoration work now completed, the final job was to fit a 3-core power lead, since there's no longer a risk of it getting marked on a dirty work bench.

A 3-metre 3-core extension lead can be used as the new lead. These extension leads can be obtained for around \$3-4. You simply cut off the socket and wire the lead into the set.

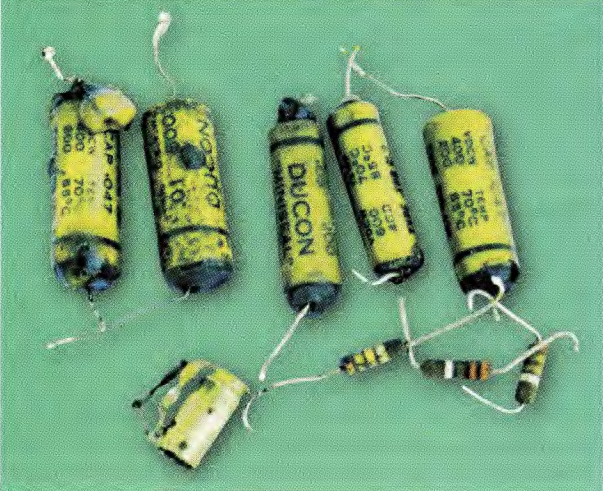
With all this completed, it was now time to test the audio coupling and AGC capacitors. The audio coupler (C18) from the plate of the 6AV6 to the grid of the 6M5 had no measurable leakage but someone had previously replaced it with one a tenth of the correct value. This was replaced, as were audio coupler C16 and the two AGC capacitors (C3 and C9), which were all leaky.

Moving on to the resistors, R7, R8, R9 and R13 had all gone high and were way out of tolerance. They were also replaced, so what was originally supposed to be a simple servicing job was becoming quite involved. And I still hadn't even turned it on with the

These are just some of the parts that were replaced in the set. It's a good idea to replace paper capacitors as a matter of course.

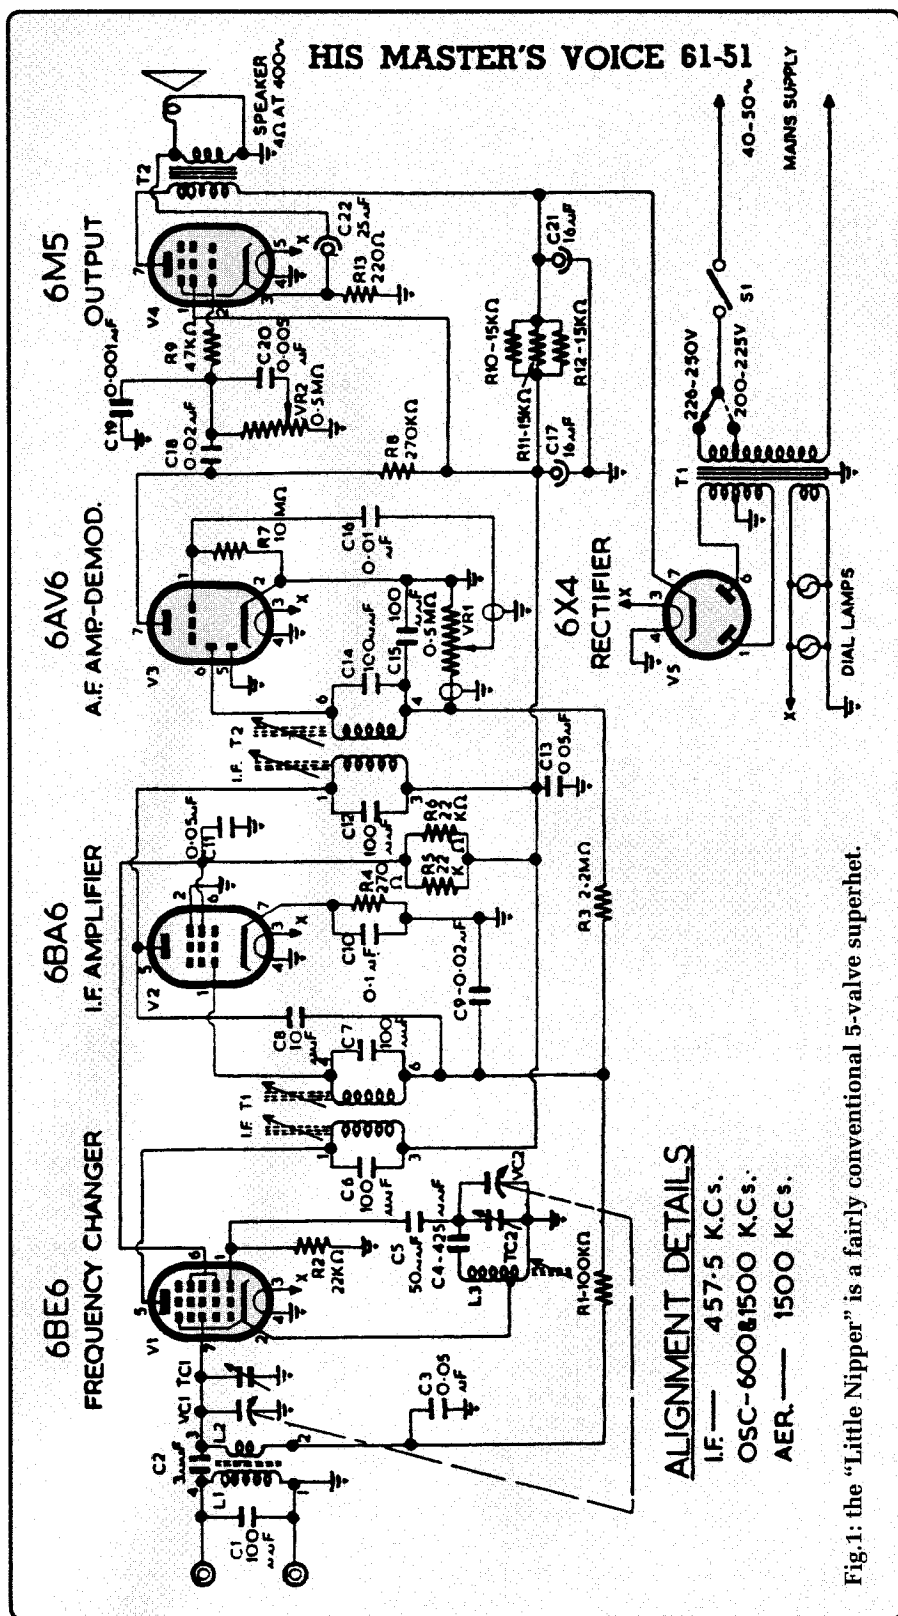
Fig.1: the "Little Nipper" is a fairly conventional 5-valve superhet.

Fig.1 shows the circuit details of the set. Note, however, that this is actually the circuit for a 61-51 but it's virtually identical to the 62-52.

to switch the set off and check the resistance of the HT line to earth – it measured just 80 $\Omega$  which, for all practical purposes, is nearly a dead short! I then checked electrolytic capacitor C21 on the output of the rectifier but it was OK, so I set about isolating everything at that point (with the rectifier still removed).

It didn't take long to discover the problem – when I lifted the speaker transformer clear of the chassis, the short disappeared. A quick check with a multimeter showed that it had a low-resistance short from its primary winding to the frame. So this was the "burnt out" transformer.

Note that in this circuit, C9 must be replaced with the same value, as it is part of a bridge neutralisation circuit in the intermediate frequency (IF) amplifier.

L3, C4 and TC2/VC2 are all frequency determining components, so this was their obvious place to start. TC2 and VC2 had been previously attended to, so I assumed they were OK. C4, however, consisted of two mica capacitors in parallel, one a much larger than the other. Perhaps the low value one was intermittently going open circuit, thus causing the oscillator to change frequency?

However, C5 was a different story when tested on the 500V range of the high voltage tester. This showed a leakage resistance of about one megohm, with the meter needle regularly flickering slightly. Eureka! - the rotten little beast tested OK on all but the high voltage tester, so you can understand why I consider this an essential item of test equipment.

The real cure lay in modifying the plate circuit of the 6AV6. This was made similar to other many older receivers by adding a 33k $\Omega$  resistor in series with the bottom end of R8 and installing a 1 $\mu$ F 350V electrolytic

capacitor from the junction of these two resistors to earth.
