Vintage Radio

The 1948 AWA model 517M mantel radio

Designed for the budget end of the market, the AWA model 517M is a conventional 4-valve radio that was produced just a few years after the end of WW2. Restoring this one proved to be quite a challenge.

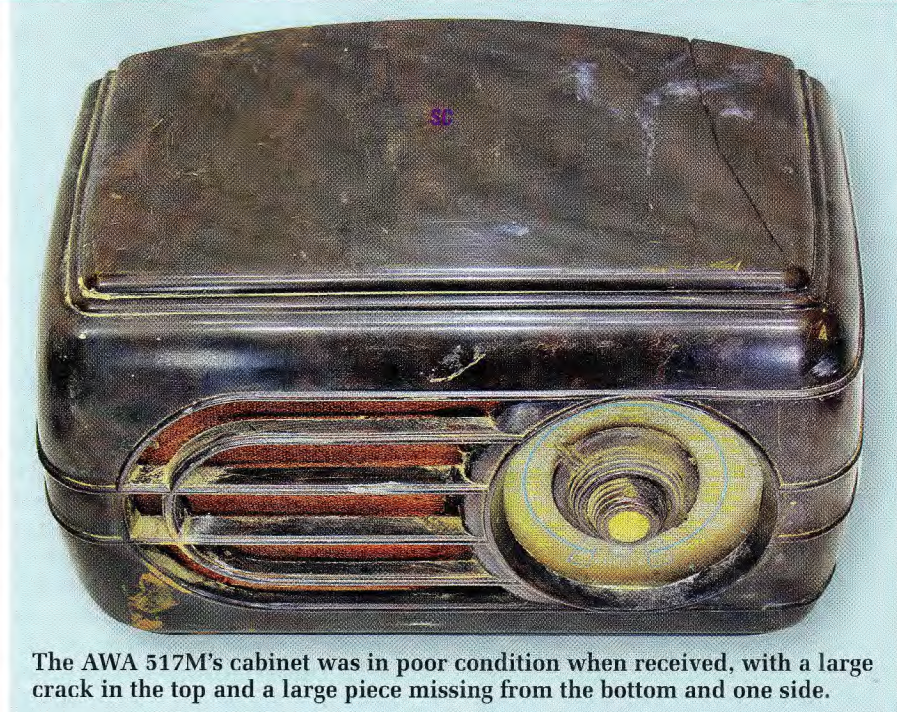
The radio featured here was acquired at an auction. It was sold as damaged and had a long crack in the top of the cabinet. In addition, a rather large chunk of the cabinet was missing. There were also smears of paint and

The AWA 517M's cabinet was in poor condition when received, with a large crack in the top and a large piece missing from the bottom and one side.

The crack in the top of the case had previously been glued but the bond had completely failed. It was re-glued, this time using PVA glue. PVA is not an intuitive choice for this type of repair but experience has shown that the bond is more enduring than for other glues. A possible explanation for this is that aqueous PVA penetrates the Bakelite filler (often sawdust) more completely and as a bonus, it leaves only a slight amount of external residue.

covered with grey car filler putty and sanded back to a smooth surface. I initially made the mistake of using wet and dry abrasive with water, as I had wrongly assumed that the grey putty would provide an impervious barrier. Unfortunately, water seeped into the crack and dissolved the PVA glue, causing the crack to open up again. As a result, I had to redo this repair.

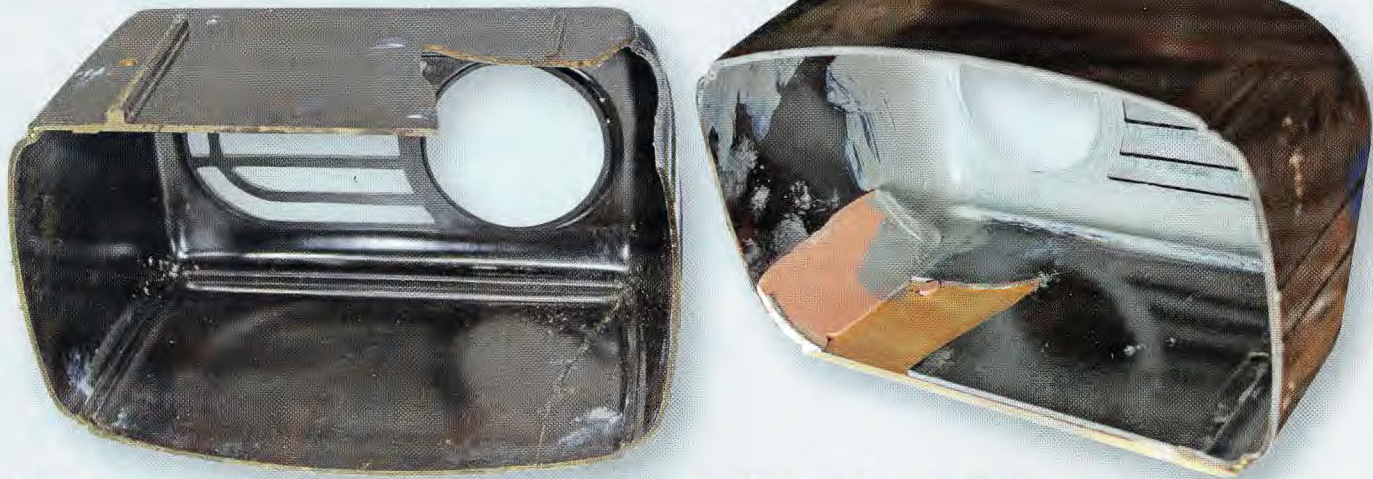
At left is another view of the damaged cabinet while the view at right shows the unit with repairs well under way. The bottom of the case was repaired by gluing a new base made from 3-ply under the existing base, while the hole in the side was filled using a section cut from a plastic cylinder. Car-filler “bog” was then used to fill the gaps.

In the end, the solution was to cut out a base of 3-ply that would look like an extra moulded layer under the radio. Contact glue was used to fix this new base in place, after which 2-part car-filler (bog) was used to fill the gaps between the ply and the original form.

Once the new base was in place, filling the hole left in the side of the case was straightforward. A section cut

from a plastic cylinder was taped to the inside of the gap and bog applied from the outside using a spatula. This bog was roughly crafted to the final shape but well proud of the wanted profile.

After allowing it to set for 20 minutes, a rasp was then used to further shape the profile, so that it was very close to what was wanted. It was then just a matter of using some spray putty

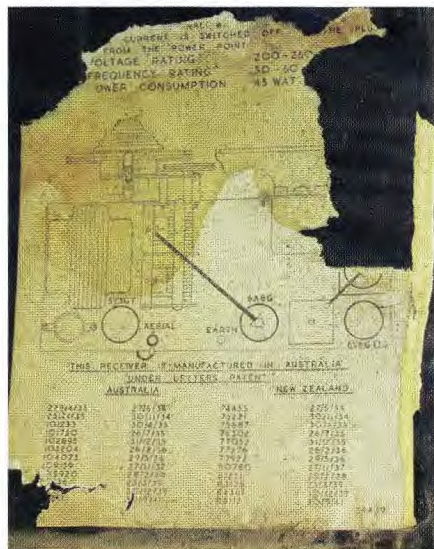
Another strange “modification” involved a connection between the 6A8's top grid and the antenna post. Fortunately, establishing the correct connection to the tuning capacitor was easy. It was just a matter of referring to the tattered layout diagram that had been glued to the inside of the case.

This tattered manufacturing label was attached to the inside of the cabinet. It clearly shows the connection between the 6A8's top grid and the tuning gang.

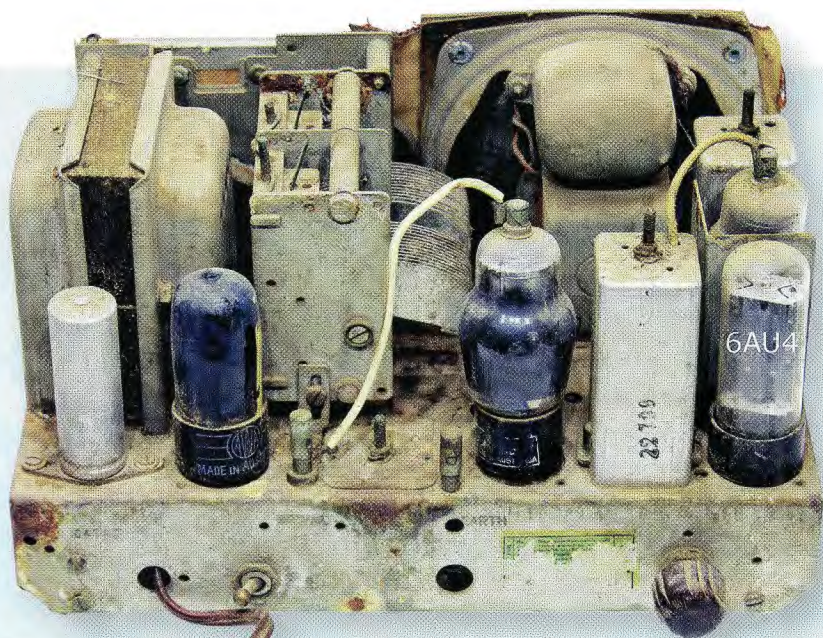
My first step was to remove the valves and here I got a surprise. Instead of a 6V6 output pentode, this radio had a 6AU4 installed. So was this an equivalent? The answer is a resounding “no”. It's not even close because the 6AU4 is a single plate, half-wave rectifier that was used in high-current applications in early TV sets. It had simply been plugged into the 6V6's socket to give the appearance of a full complement of valves!

This view shows the top of the chassis before restoration. A 6AU4 had been fitted in place of the 6V6 output valve but it is completely unsuitable for this role since it is a half-wave rectifier.

ly cleaned and any corrosion rubbed back with abrasive paper. The rusted sections were then covered with metallic silver paint. This sacrificed the original stencilled chassis lettering and the ARTS&P label. As a result, reproductions were computer-generated and printed onto acetate transparencies before being attached to the rear of the chassis.

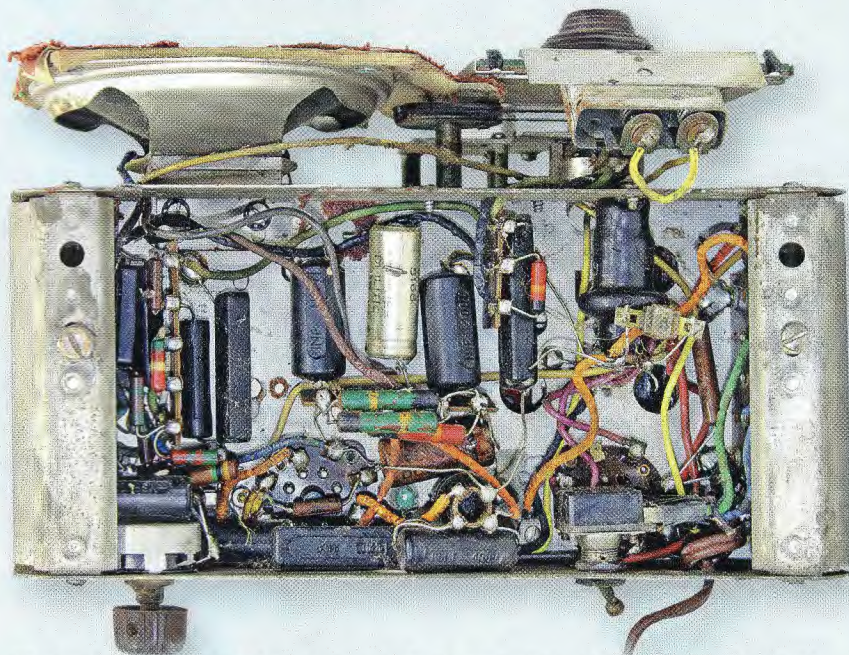
The underside of the chassis was in better condition than the top but still required work. Note the crude knot used to restrain the original twin-flex mains cord (now illegal).

The model 517M has a rear-mounted DPDT switch for the mains and this was used to switch both strands of the original twin-core mains flex. This is clearly superior to single-pole switching which could result in 240VAC mains Active being connected directly to the transformer (the conventions for connecting Active and Neutral to sockets were not introduced until the 1950s). This DPDT switch was retained when the original twin-core mains flex was replaced with a 3-core mains lead. This new lead was firmly clamped inside the chassis and allowed the chassis to be securely earthed, in the interests of safety.

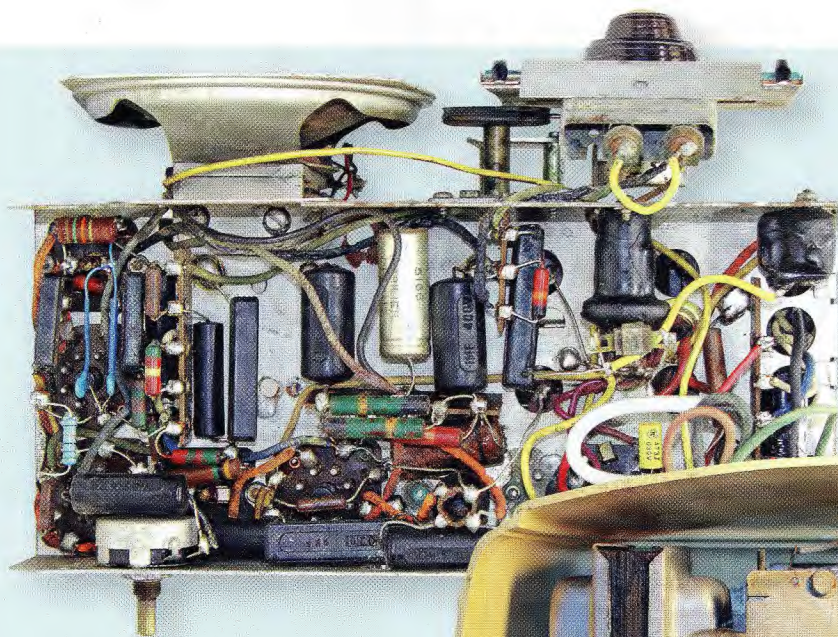
Left: an under-chassis view of the unit after restoration. Despite the set's age, only a few parts required replacement

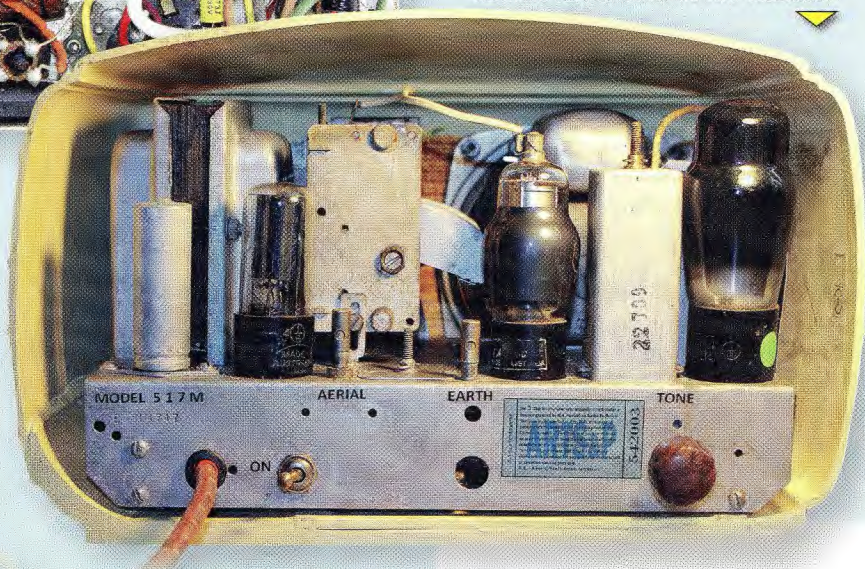
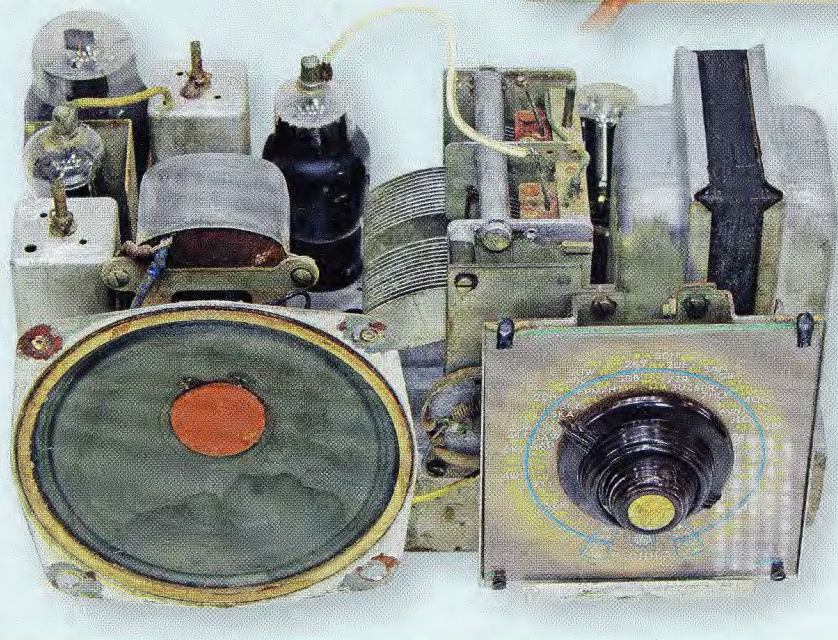
Below: the fully-restored chassis after it had been fitted into the repaired (and repainted) cabinet. The ARTS&P label was reproduced on a computer and printed onto an acetate transparency before being affixed to the rear of the chassis.

Below: a top-side view of the fully-restored chassis. An additional metal shield was later added adjacent to the 6G8 IF amplifier/detector valve to reduce the set's sensitivity to electromagnetic interference.

The set's sensitivity to EMI was annoying and the cause was poor shielding of the 6G8 IF amplifier valve. In fact, some valve radios completely fail to function without shielded IF stages.

Hence, a supplementary shield was fitted around the 6G8 and soldered to the side of the chassis. This proved to be quite successful, as the sound quality was much improved and the set now turned in quite a good performance.
