*The Lochinvar collision of 19/8/59 consolidated the 2nd Engineman's position on the locomotive. The Lochinvar collision was shortly followed by a collision between a 46 Class light engine and a 19 Class at Illawarra Junction.*

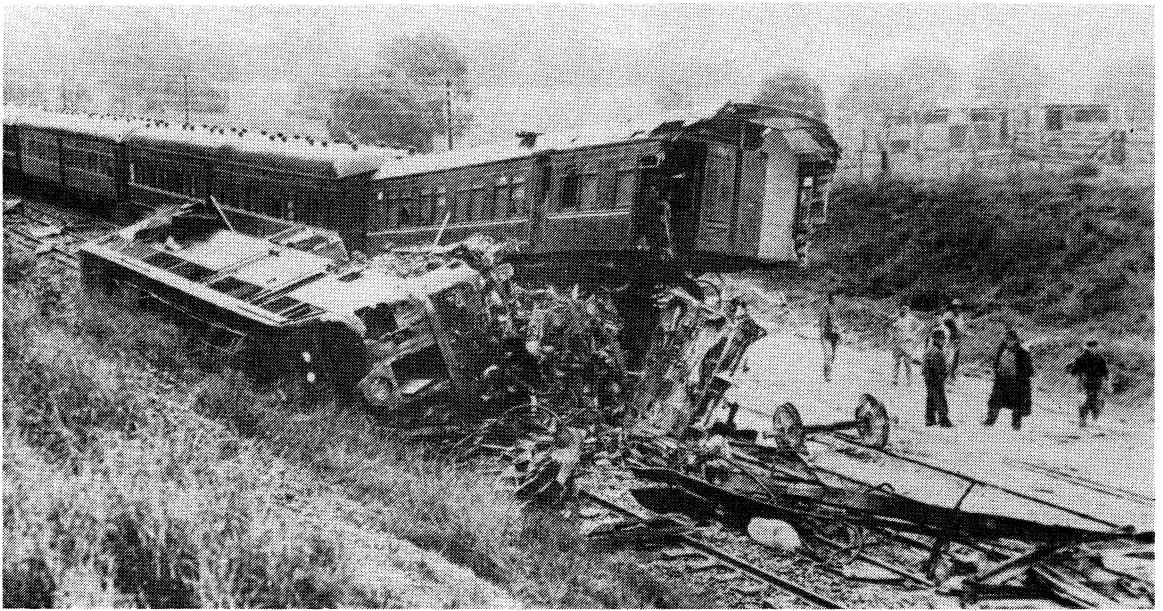
*These two accidents led to the Railway Administration directing that engine room inspections by the 2nd Engineman which were then a regular routine, should be terminated.*

*With the Robertson collision which was to follow a few years after, a complete review of the operation of the Vigilance Control occurred, in which the Vigilance Control button was rearranged to the position it is currently found in on locomotives.*
