# valve & vintage

This month Ben Nock G4BXD looks at a well known Eddystone receiver, and starts restoring an HRO NC-100.

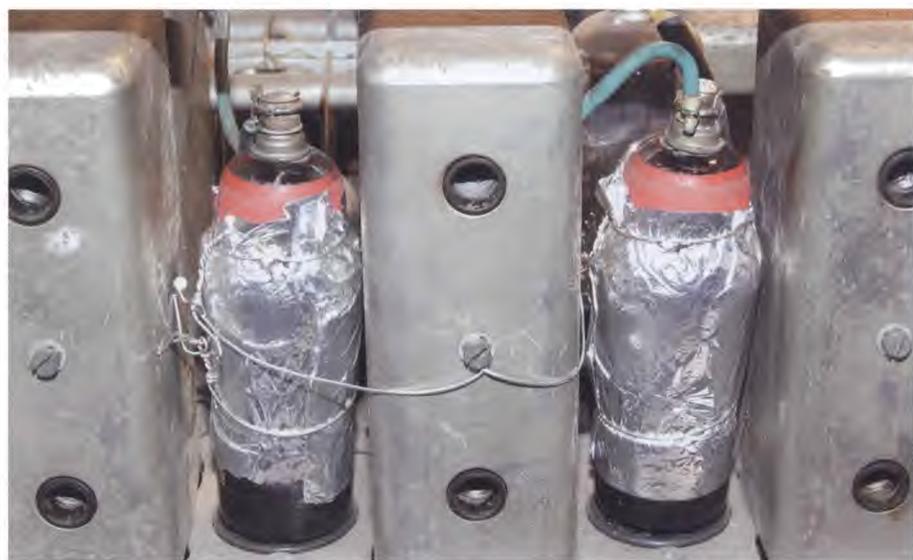
**Fig. 2:** The foil wrapped i.f. valves, now quietly doing their jobs!

near to the grid top cap of the 2nd i.f. amplifier valve, a strange change in the self-oscillating frequency occurred.

Further investigation led me to the conclusion it was not a capacitor fault directly but one of stray capacitance. The valves used in the i.f. stages are EF39 types, these have a red outer coating on the glass, which is in fact an earth screen. Wrapping the two valves in tin foil, **Fig. 2**, and securely grounding it to earth stopped the self-oscillation completely, the r.f. gain control works as it should and peace has been restored. New, old stock (NOS) valves would have had the same effect but I didn't have any in my stores.

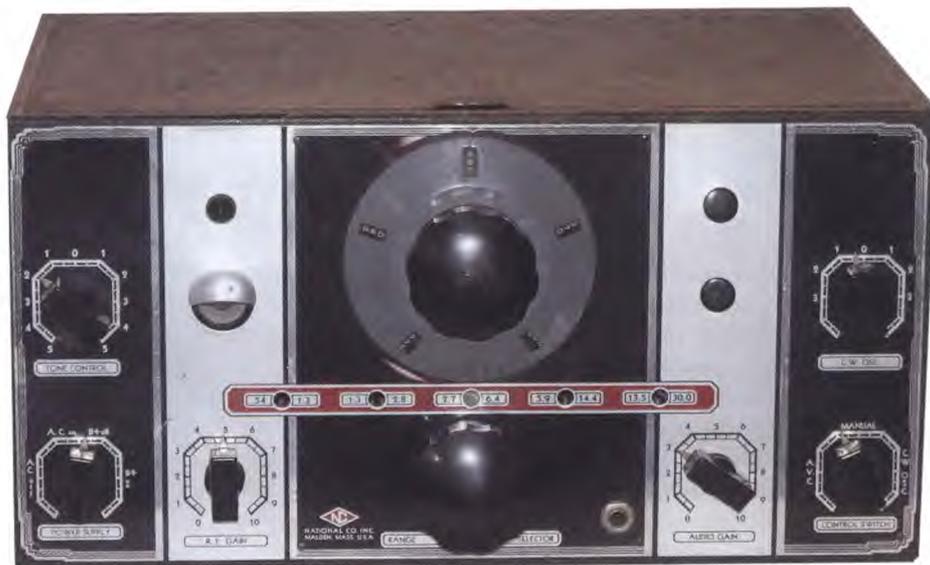
**Fig. 3:** The NC-100 receiver, with the very familiar tuning knob.

The receiver, **Fig. 3**, uses 12 valves in a single conversion superheterodyne design. The NC-100 is a general coverage receiver covering from 540kHz to 30MHz in five bands. There was another model, the NC-101X, which only covered the Amateur bands.

One stage of r.f. amplification and two stages of i.f. amplification

are used with low-loss insulation and high-Q coils. These were said to give the set ample sensitivity and selectivity while a 6E5 tuning indicator valve, with provision for signal strength measurement and provides an added convenience.

The NC-100 tuning ranges are in fact: 0.54 - 1.3MHz, 1.3 - 2.8MHz, 2.7 - 6.4MHz, 5.9 - 14.4MHz and 13.5 - 30MHz. While the NC-100 was available with or without a crystal filter the NC-101X was built and designed strictly for the Amateur bands and covered the 1.8, 3.5, 7.0, 14.0 and 28MHz amateur bands and had the crystal filter fitted as standard.

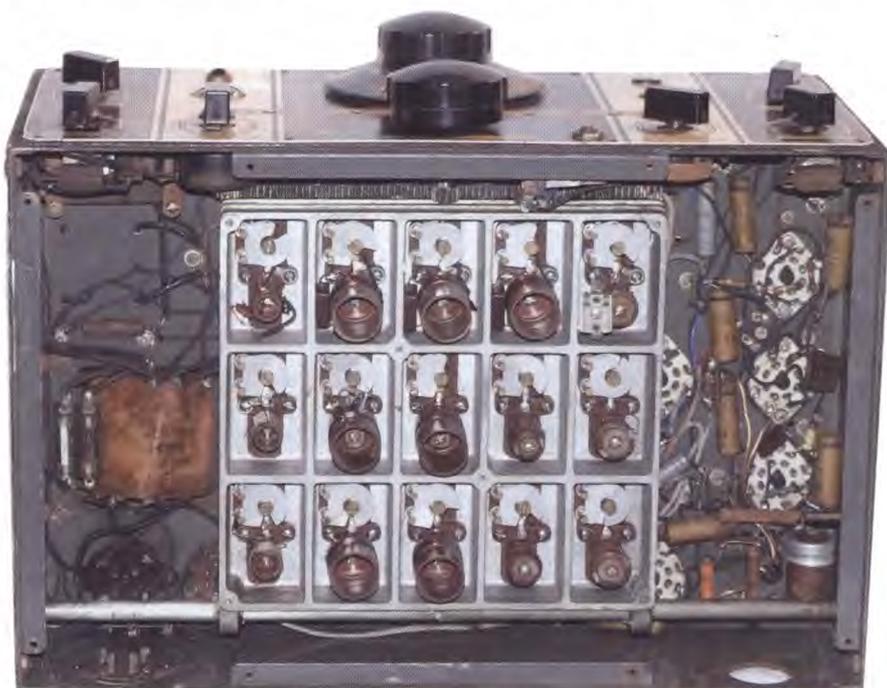
The method of band switching on this receiver uses a tray of coils, **Fig. 4**, which is mounted on a rail and moved using a rack and pinion gear system. The coils are in effect plug-in and as the tray is moved the coil pins engage in sockets fixed to the set's chassis. The tray holds five sets of three coils, for the r.f., mixer and oscillator circuits and the knob has a positive 'locked' feeling when they are correctly engaged. Additionally, the screen voltage to the receiver's r.f. and i.f. valves is also connected when the tray is in the correct position by an extra set of contacts.

**Fig. 4:** The NC-100's unusual coil switching arrangement.

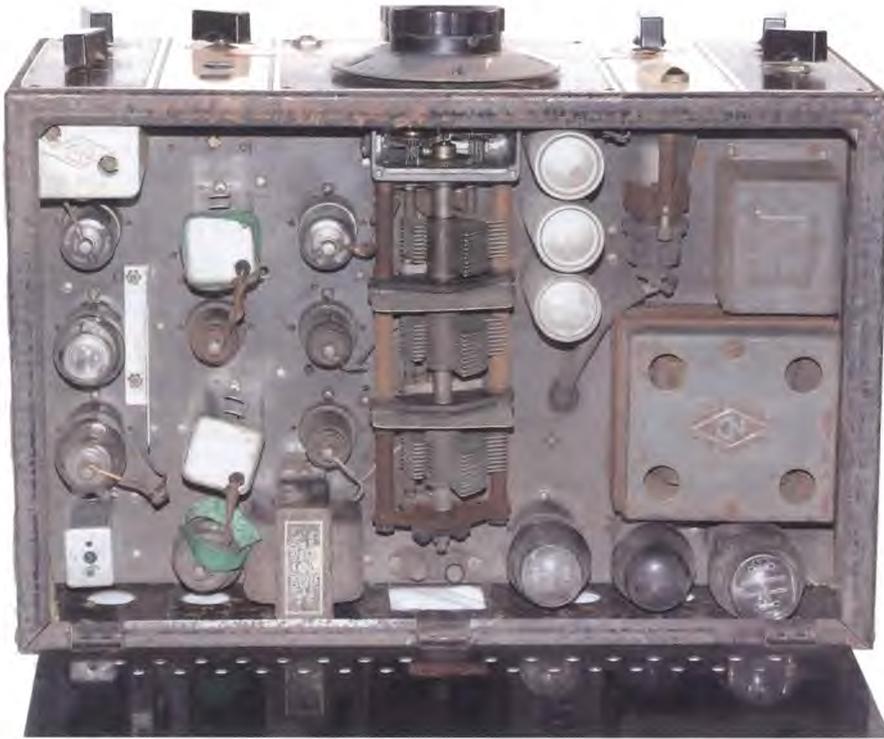
When I received the set it was apparent that quite a few modifications had already been done to the set, see **Fig. 5**. The i.f. transformers (i.f.t.s) had been changed, from the nicely canned NC stamped ones to some rather inferior Maxi-Q types. The audio driver

Fig. 5: The internal view of the NC-100 as the set arrived on Ben's bench.

transformer had been replaced and an electrical examination revealed the mains transformer was dead as were all the on/off toggle switches used in the set. Obviously it was going to be a demanding restoration project!

At the time of writing this column I've managed to complete quite a lot of work on the set. I purchased a new set of valves for the receiver, amazingly, even in these dire economic times, I was able to buy the valves from the USA, and pay postage, more cheaply than I could find them in the UK! I have changed all the old capacitors as a matter of course and after a couple of web-based collector group postings, I managed to purchase a set of i.f. transformers and the crystal filter unit from an HRO someone was breaking up.

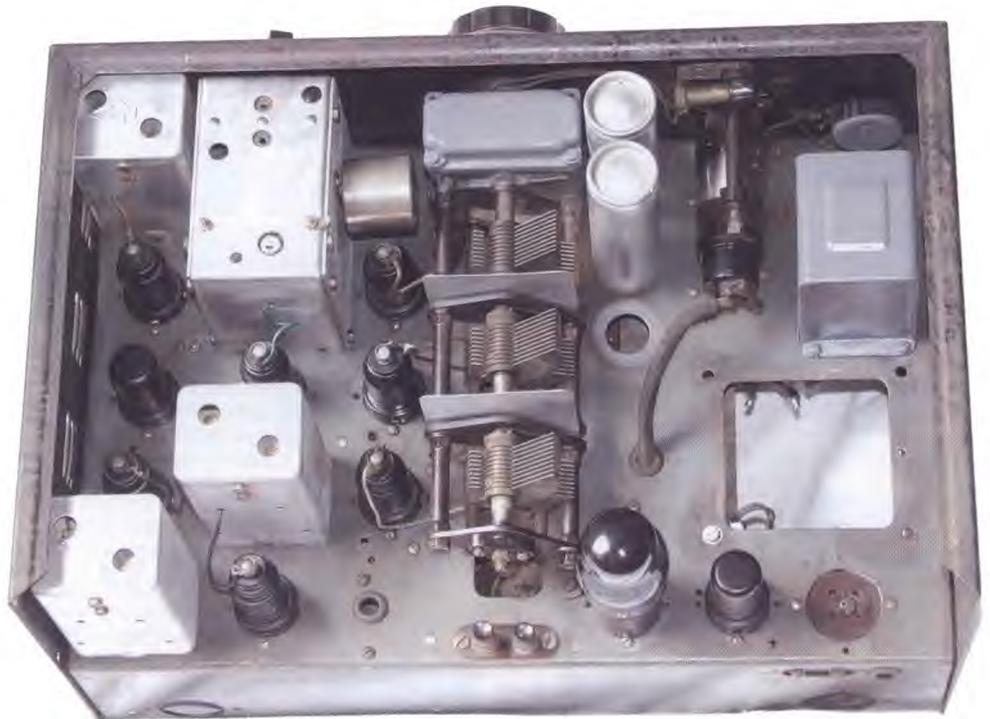
Fig. 6: Part way through internal restoration, although Ben thinks there's still much more to be done!

From photographs in the NC-100 manual its i.f.t.s appeared to be the same as used in the HRO. These I have fitted, Fig. 6, and the set is working very well. There was a slight problem with the crystal filter unit though. In the HRO the actual crystal sits on top of the filter box. In the NC-100 there's not enough headroom and the photo in the manual shows the crystal mounted on the side of the box. So, I had to drill and mount a holder to the side wall and after a

little persuasion the crystal is now in place.

The audio side of the set is a 6C5 detector, which drives a pair of 6F6 valves in push-pull via a coupling transformer. This transformer had already been changed previously and tests to it made me feel it was also faulty. As finding a suitable

replacement was unlikely, I decided to replace one of the 6F6 output valves with another 6C5 wired as an audio pre-amplifier and simply use the remaining 6F6 as a single ended output stage. This proved an excellent solution and the audio output and the gain is more than adequate.

I have still to find a replacement mains transformer, find out why the automatic gain control (a.g.c.) is not functioning and change a further two special on/off toggle switches. I then need to give the set a full alignment and touch-up the paint job but all in all I am very pleased with the results. So far, it should prove to be a worthwhile job.
