VINTAGE RADIO

Capacitors cause lots of problems

Vintage radios, like all radios, have a considerable number of capacitors in their circuitry. Many of these capacitors are a potential source of trouble, especially the paper and electrolytic types. Here's what to look for.

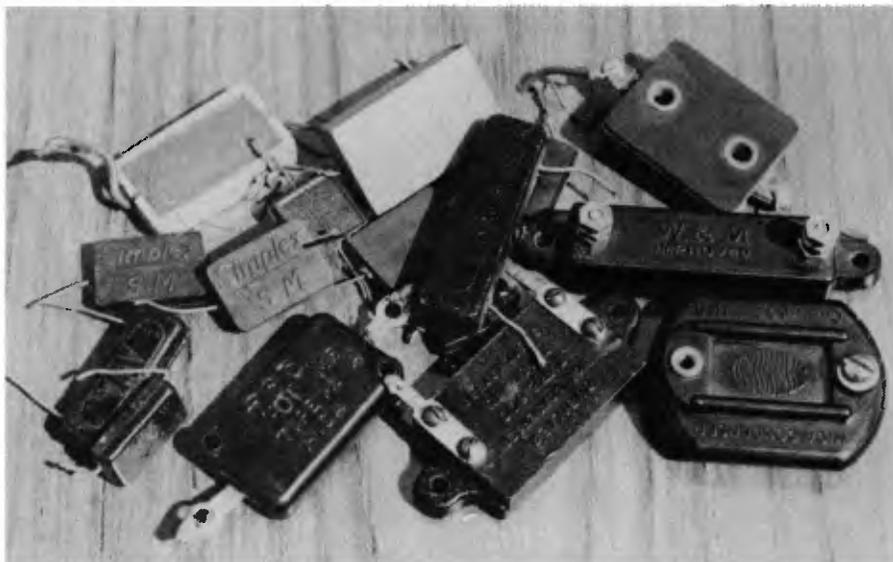
A selection of old mica capacitors. These capacitors are very reliable and seldom require replacement with more modern types.

Early radio capacitors were constructed out of layers of either brass or copper shim which were separated by thin slivers of mica. Mica capacitors were quite enduring and many of those that have survived from the 1920s are still quite useable today.

Mica capacitors are frequently encountered in valve radios of all ages and they rarely give trouble. Only once have I found it necessary to replace a mica capacitor.

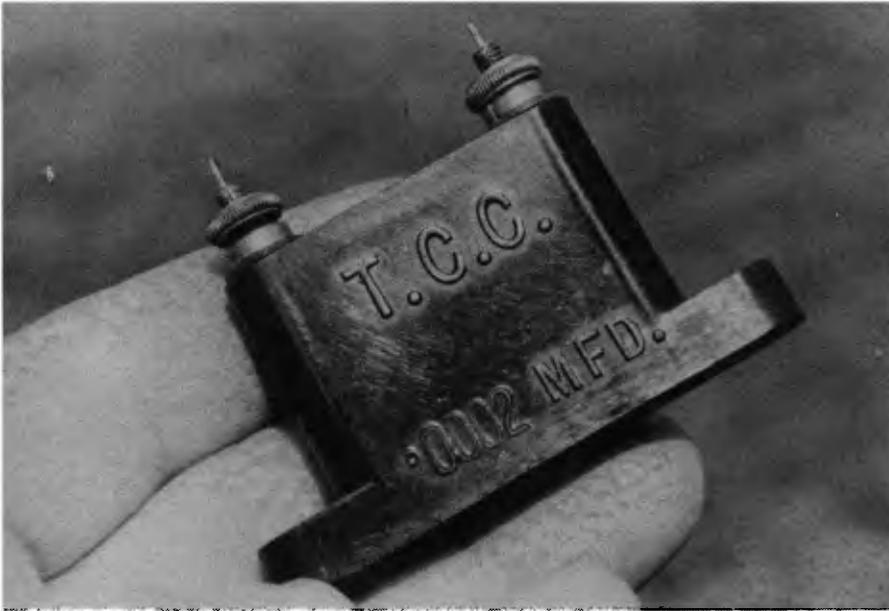
Many early mica capacitors featured mounting lugs and thumbscrew terminals. This particular unit is rated at $.0002\mu\text{F}$.

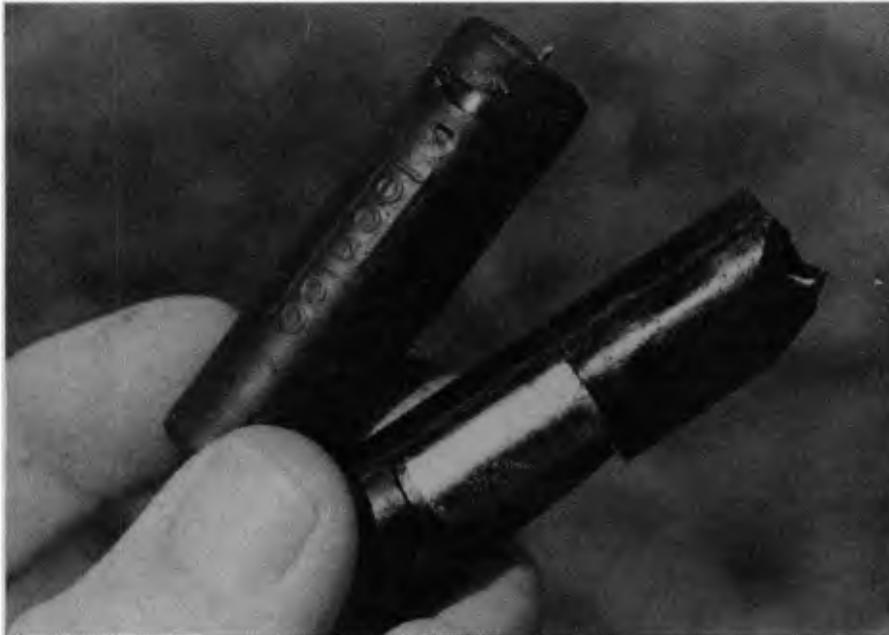
A couple of typical paper capacitors — cracked, troublesome and quite unreliable.

The reason for this decline in performance is simple: the capacitor absorbs moisture over the years, thus allowing electrical leakage between the two plates. Paper capacitors are one of the most suspect components one can find in an old valve radio, with some brands being more suspect than others.

Many paper capacitors simply can no longer take this high voltage strain. Those old black AWA paper capacitors, in particular, are most troublesome and frequently split open at the ends. On odd occasions, they may even blow themselves apart.

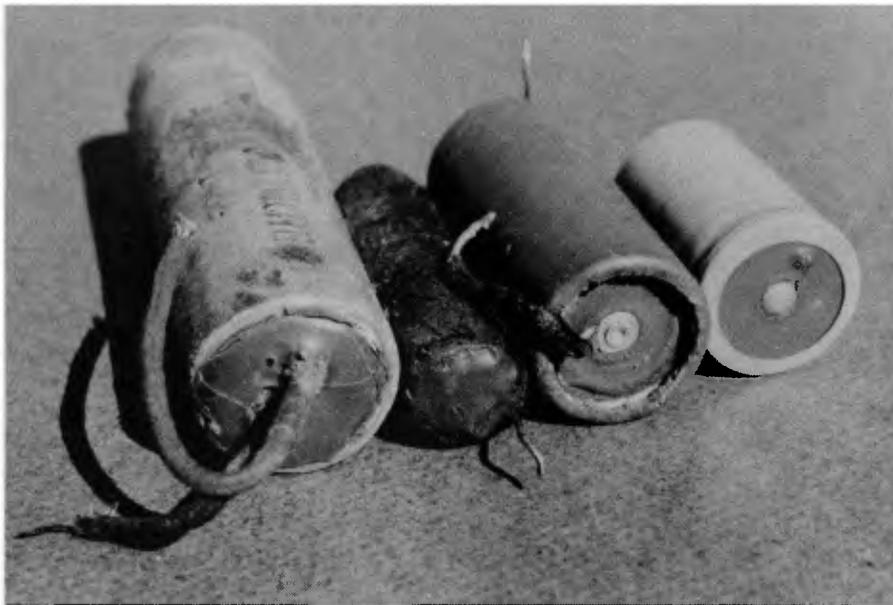
Old electrolytic capacitors are a common source of serious trouble in vintage radios. The replacement of all electrolytics during restoration can save a lot of hassles later on.

Electrolytics are also troublesome components in old valve radios and their replacement is frequently required. Electrolytics usually contain a liquid or paste which often leaks away, leaving the capacitor dry and useless. Leaking electrolytics are a sure sign of trouble and should always be replaced.

When checked with an ohmmeter, most old electrolytics show a considerable amount of leakage. However, this situation often improves when the capacitor is put back into service. Applying a potential across an old electrolytic capacitor helps to "reform" the oxide dielectric.

Faulty electrolytics can cause a pronounced 100Hz mains hum in the loudspeaker. And if an electrolytic develops an internal short circuit, it will result in the rectifier anodes glowing red hot. Capacitors with these ailments must be replaced.

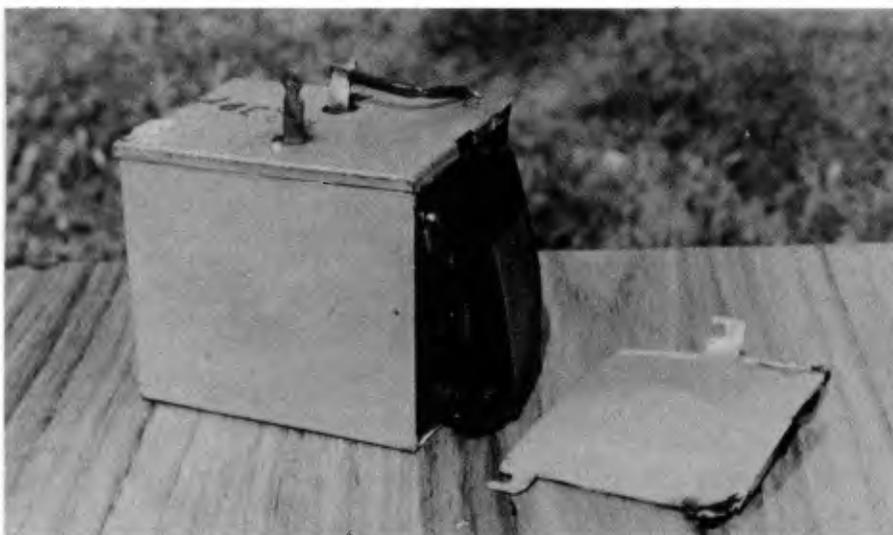
This old 4 μ F paper capacitor has seen better days, with internal problems forcing the end off the can.

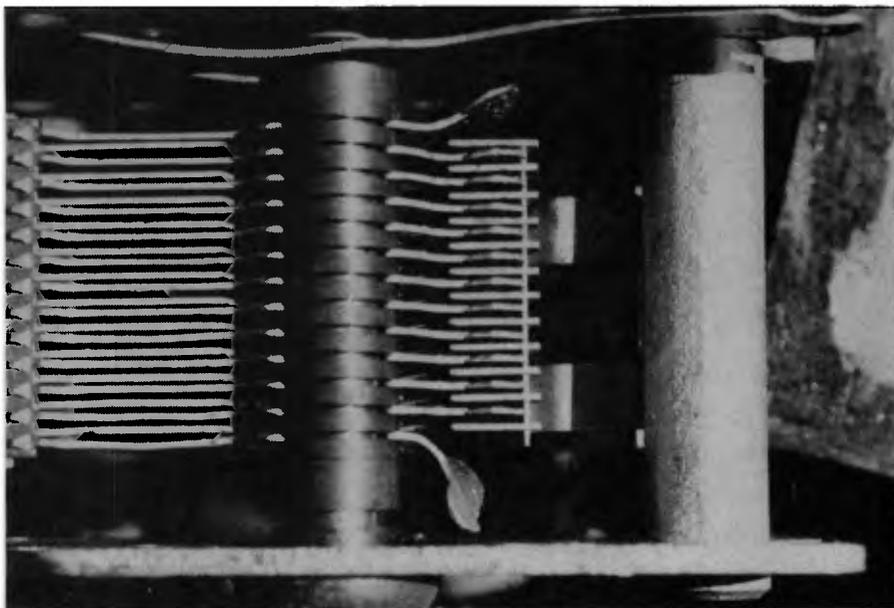
Many tuning capacitors have the outside plates bent outwards (though not usually as much as shown here) to compensate for capacitance discrepancies between the gangs. Don't bend them back otherwise you won't get accurate tracking across the dial.

Another point regarding the tuning capacitor: don't straighten the outside moveable plates if they appear to have been bent away in different places. This has been deliberately done so that the two (or three) gangs will track accurately over the full range of the dial — so don't interfere with them.

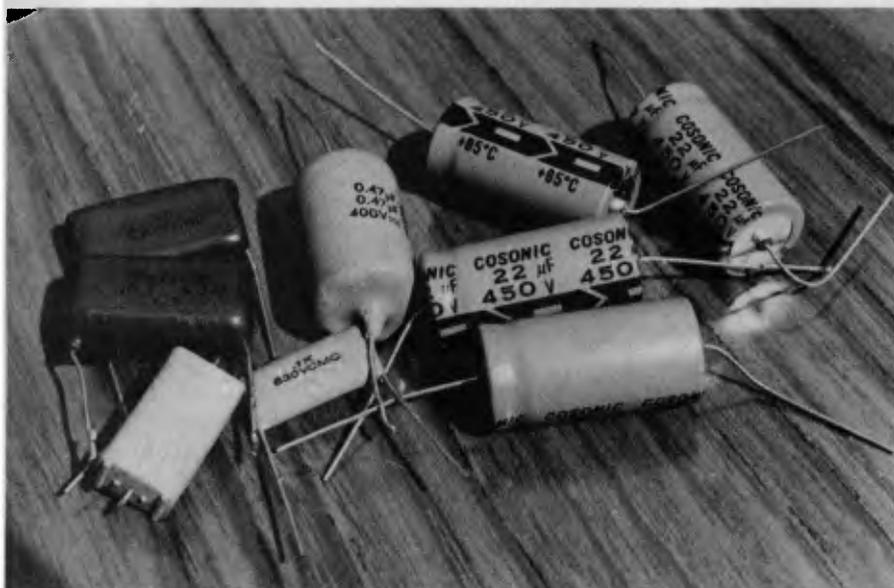
Many of the capacitors used in valve radios are high voltage types. Always make sure that replacement capacitors have an adequate voltage rating.

Modern replacements will usually either be rated at 100, 160 or 630 volts, although other voltage ratings are available. Even low voltage capacitors can be used quite extensively in a vintage radio.

While a valve radio is basically a high voltage instrument, not all the capacitors are subject to high voltages. This means that 100 volt greencaps are quite suitable for use in many circuit locations. Generally speaking, most 200 volt paper capacitors can be replaced with a greencap.

If a set is in going order, it is a simple matter to check out the voltage on each capacitor and mark those that really do need a high voltage replacement. 630 volt capacitors are considerably more expensive than 100 volt ones, so they should only be used where needed.
