VINTAGE RADIO

Cleaning up the chassis

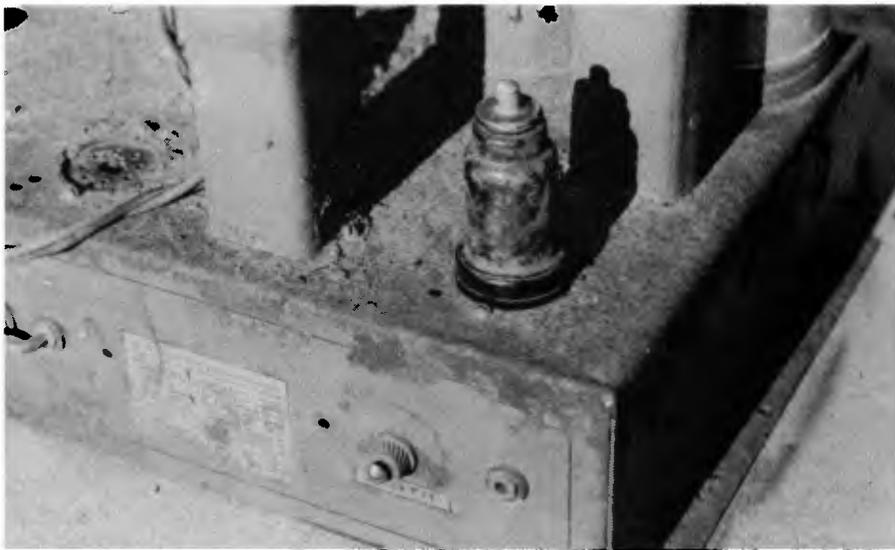
A badly rusted chassis requires anti-rust treatment before repainting. Failure to prepare the chassis properly prior to painting will result in the rust quickly breaking through the new paintwork.

Preparing a radio chassis for painting is no different to any other painting job. The rust must be removed and the corroded area treated with a rust inhibiting paint

such as "Kill Rust". Kill Rust metal primer under a couple of coats of Silvafrost or enamel paint must help to contain the rust. Hopefully, such a treatment would be permanent and no further rust problems should arise.

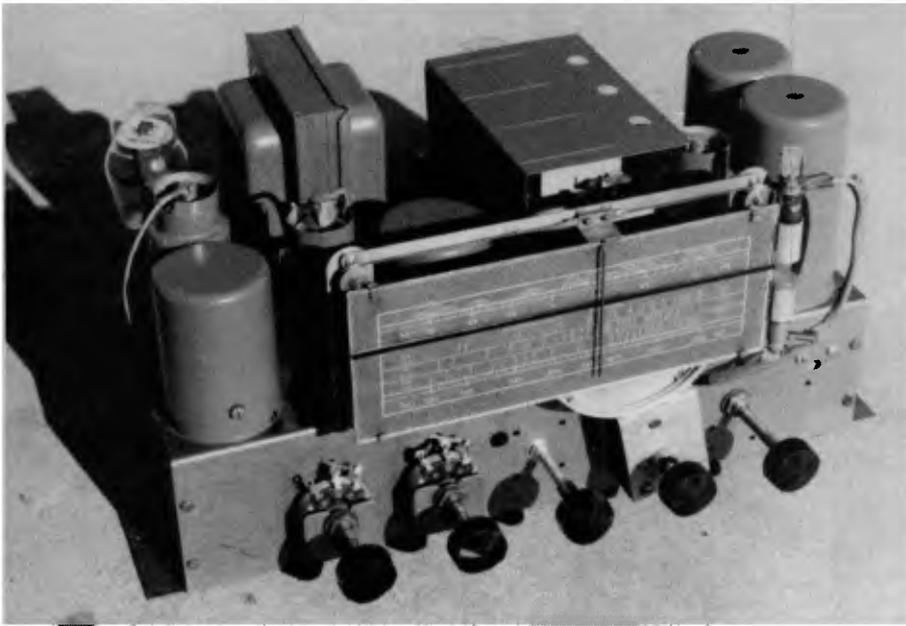
A fully restored 1936 dual-wave Radiola. This particular chassis clean up only involved repainting the coil cans and other top accessories. The chassis itself was cleaned up with an automotive "cut and polish" compound.

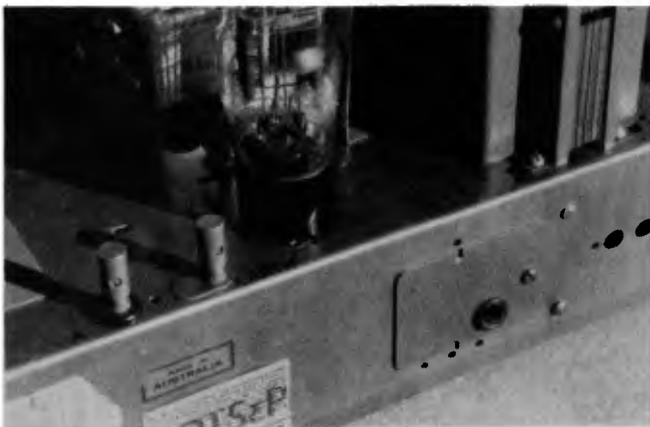
The advantage of a good clean and polish is that all the original inscriptions, transfers, etc are retained. However, not many chassis are as well preserved as this one after half a century.

The advantage of not painting the main chassis is that all the manufacturer's stencilled inscriptions remain intact; eg, aerial and earth terminals, valve types etc.

It is always advisable when not painting the chassis to clean it thoroughly with hot soapy water and a cloth, being careful not to slosh water everywhere. When dry, a rub over with automotive polish will bring back the shine to the old paint surface. It will also quickly remove various marks and stains that the hot soapy water treatment failed to dislodge.

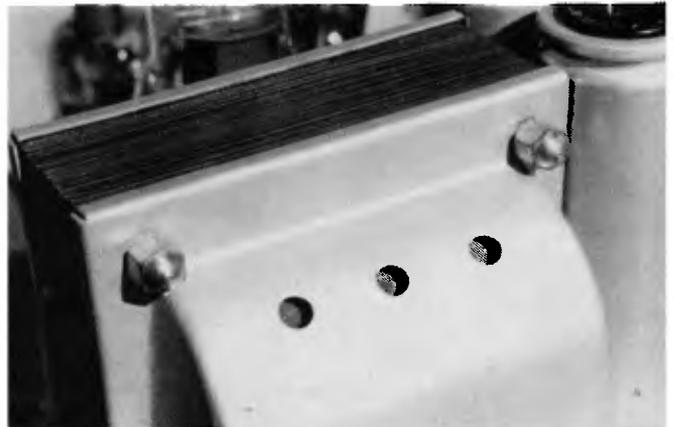
Although this power transformer was left bolted to the chassis, it was painted with the nuts removed and the laminations highlighted in black to improve its appearance.

Not all chassis need repainting and the 5-valve Radiola is still original as far as its main chassis is concerned. However, the power transformer and coil cans have been repainted because these components were beginning to look tatty.

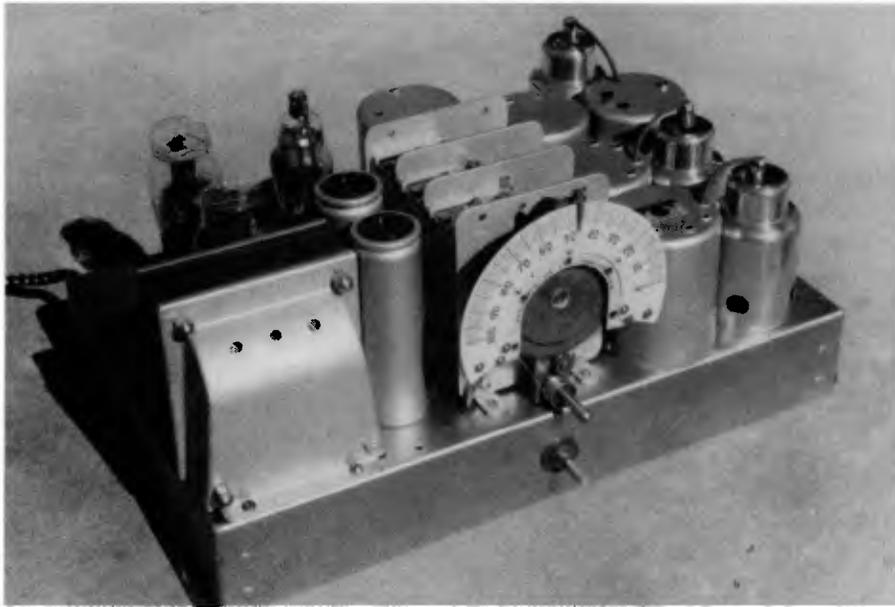
This 6-valve chassis was manufactured by Eclipse Radio and would be about a 1934 model. Its colour scheme is gold, silver and polished aluminium. It really is too good to put back into its cabinet.

The tuning capacitor on the 6-valve Eclipse radio chassis (as shown in one of the accompanying photographs) proved to be interesting and warrants further discussion.

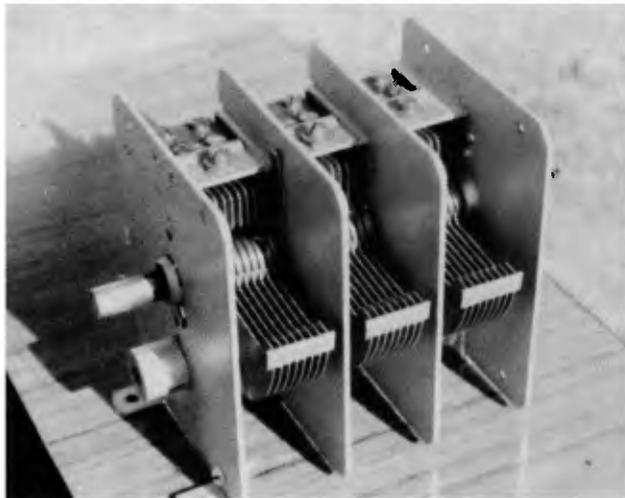
The tuning gang of the Eclipse was removed to make it easier to paint and to provide easier access to the chassis. It also made it possible to re-align the three sections of the gang using a digital capacitance meter.

While cleaning the tuning capacitor, I was alarmed to see that some of the moveable plates were badly positioned. Some were almost touching, while others had quite large gaps.

This prompted me to check out the capacitance with my digital multimeter. My suspicions were justified and in some positions there was approximately 8pF difference between the three gangs.

I sought to remedy the situation and spent about three quarters of an hour re-adjusting the capacitor plates.

The improvement was considerable to say the least and the final result was a tuner that had no worse than 1pF variation at any setting. Such an adjustment could have a significant effect on the overall performance of the receiver. In future, more tuning capacitors will be removed from their chassis and it will not be for ease of cleaning and painting alone.

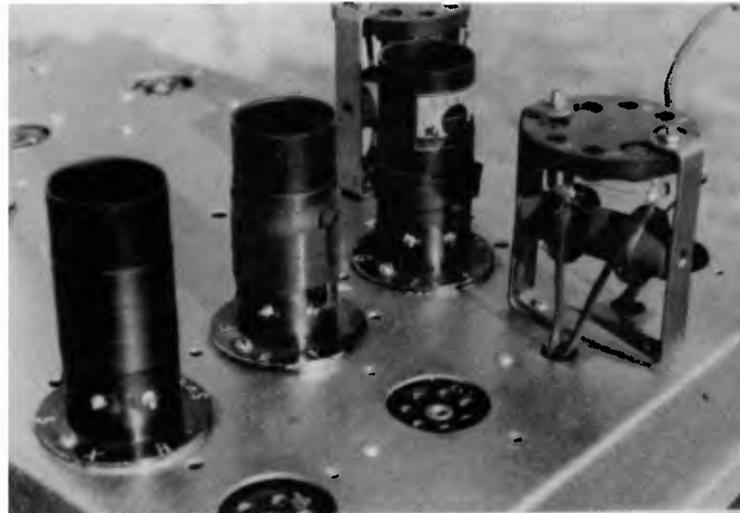
Removing the electrostatic shields allows the coils and IF transformers to be inspected and cleaned. They look better with the cans on, don't they?

thorough chassis job was revealed when the coil cans, etc were removed from a 5-valve Radiola. With this receiver, the sealing wax that moisture-proofs the coils and the IF transformers had dried and cracked with age, leaving numerous gaps of several millimetres in width.

Removing the cans not only reveals such problems but also allows an inspection to be made of the fine wiring which is normally out of sight while the coil cans are in place.

wax sealant into the cracked moisture proofing must also help to produce a more reliable restoration.

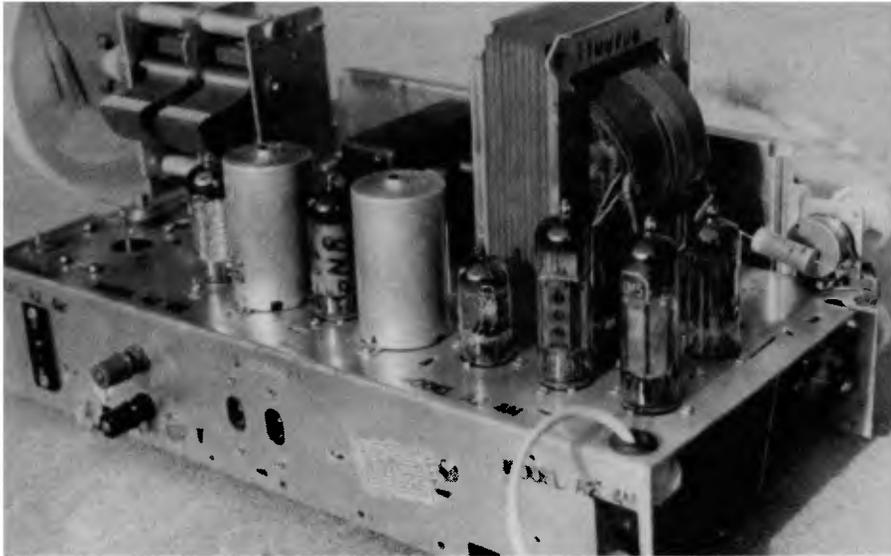
This HMV radiogram used a plated chassis. An automotive cut and polish compound cleans metal components quite well and leaves a protective coating.

The car polish technique really rejuvenates the old paint work and helps to tidy up the general appearance of the chassis. The cut and polish treatment also works on a plated chassis that has become dull and powdery but not yet gone rusty. The polish will bring up the surface to a reasonable lustre. It also leaves a protective coating to help prevent further corrosion.

The two finishing techniques for chassis were either paint or plating. Generally speaking, painted chassis were common in pre-war radios while the plated steel type was more common after the war. The plating was usually cadmium but plated chassis appear to be more rust-prone than those that were painted. Perhaps it depends on how the sets have been stored over the years.

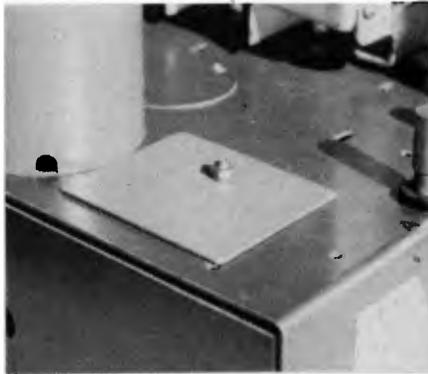
This coverplate looks better than the two odd shaped holes that someone had hacked into the chassis. It also excludes dust and mice.

One problem with the old Radiola chassis was that it had been modified. The aerial coil had failed (possibly due to corrosion) at some time in the past and it had been replaced with a smaller more modern coil. This coil had been installed underneath the chassis whereas the original one was on top.

Unfortunately the repair left two odd shaped holes showing where the original coil and can had fitted. There was no problem with the effectiveness of the repair, it was just that the gaping holes looked a bit rough and that there was obviously

The problem was simply overcome by fitting a cover plate over the unsightly area. The plate was painted the same colour as the other mounted components and doesn't look that much out of place. It keeps out dust, mice and other vermin and hides untidy parts of the chassis from view.
