VINTAGE RADIO

Restoring an AWA Radiolette receiver

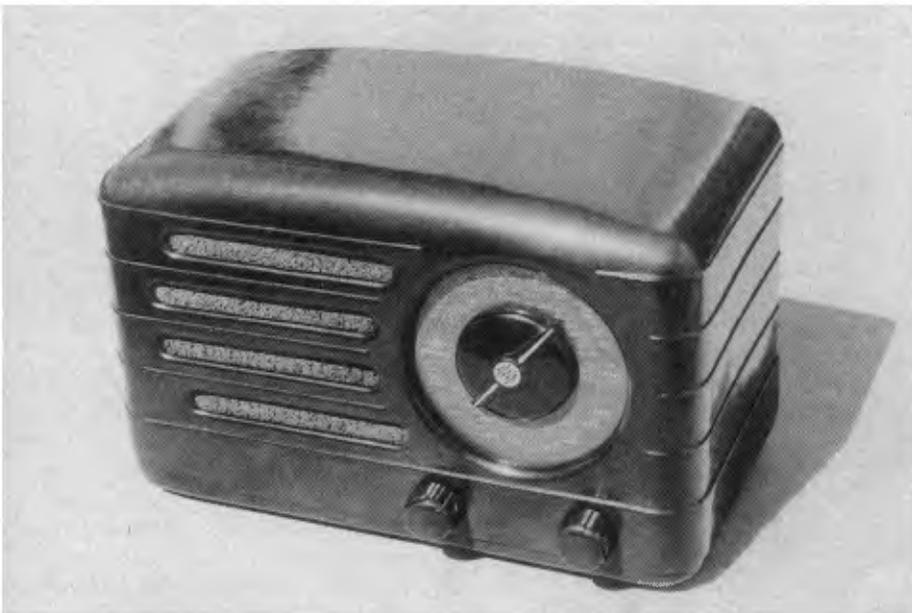
Radiolettes were still being produced in the early post-war years. This 4-valve model has octal valves and is of late 1940s vintage.

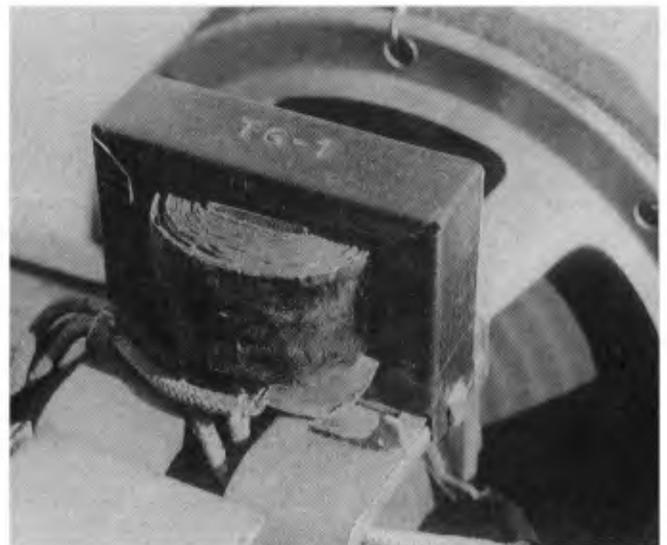
The loudspeaker was the first major component to fail the test. While the field coil checked out OK, the output transformer primary winding was open circuit. This is not an uncommon fault with valve radios and the output transformer should always be a suspect component until proven otherwise.

The little AWA's output transformer was in need of replacement (primary open circuit). Fortunately a spare transformer was discovered lying in my junkbox.

Fortunately, luck was on my side for a change as a search through my spare output transformers revealed a similar unit in working order. It was quickly fitted to the loudspeaker mounting and wired up accordingly. That was one problem taken care of.

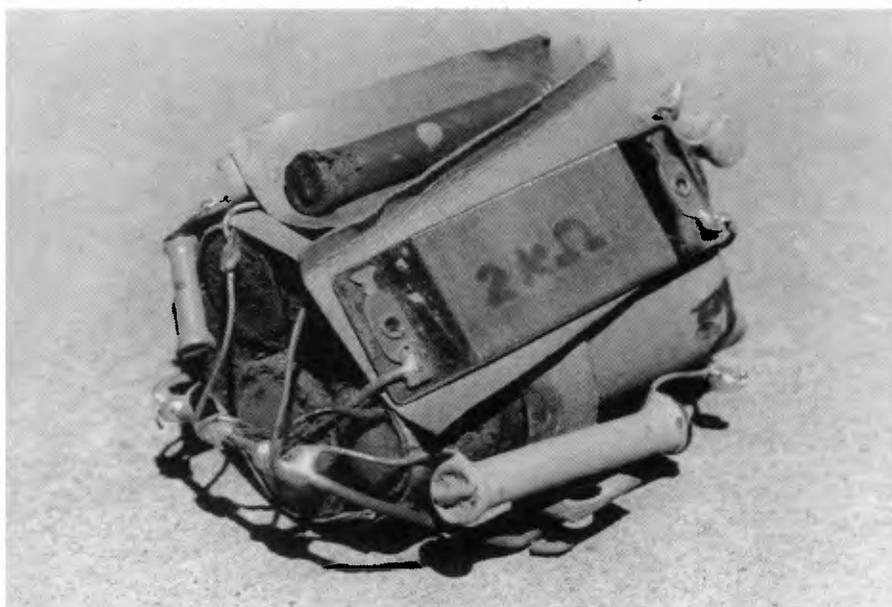
These early Radiolettes vary considerably in their under chassis construction. Some have little component boards with numerous capacitors and resistors attached, while others have a big bundle of parts which are taped together and attached to one endplate of the chassis. Neither arrangement is particularly easy to work on.

My little Radiolette was of the bundle type and if readers care to check with the appropriate photograph, the word "bundle" is about the only word one can use to describe this type of construction technique. Obviously, the printed circuit board hadn't been invented in the 1930s.

There were two 25V cathode bypass electrolytics in the bundle which needed to be replaced. One carried a value of 25 μ F, the other 5 μ F. Both were totally inoperative and judging by the cracks in the ends of them, they had dried out many years ago.

The infamous bundle: this mass (mess) of components consists of paper and electrolytic capacitors, carbon and wirewound resistors, and insulating pieces of cardboard. The bundle need not be removed from the receiver and is best left hanging on its many connecting wires while individual components are replaced.

Replacing components in the bundle must be done carefully in order to maintain the existing circuit. Capacitors should be removed one at a time and appropriate replacements fitted in their place. With a receiver of this age it is advisable to replace all of the paper capacitors, whether they be in the bundle or elsewhere.

were small modern types, the bundle looked a bit gutless when the change over was completed. That's one good point about replacing old capacitors with new units – the modern varieties take up much less room.
