VINTAGE RADIO

Paper capacitors cause lots of trouble

Paper capacitors cause lots of problems in old valve radio receivers. Often, the best approach is to simply replace the lot with modern equivalents.

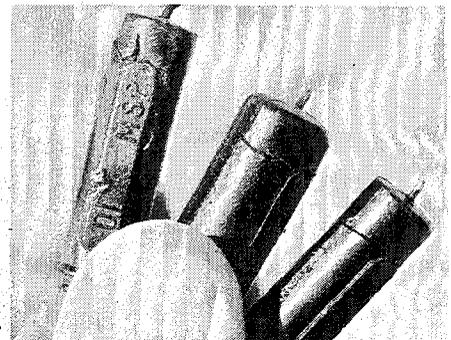
These black moulded paper capacitors were used in AWA receivers from the mid 1930s to the mid 1950s. They were and still are a common source of trouble and are usually found with their ends either split, bulging or completely separated. Replacement is the only solution.

But the black moulded MSP types used in AWA sets are not candidates for this trick. This material is extremely brittle and is almost impossible to work with. There is little option but to replace these.

About the only thing in favour of these black moulded capacitors is that they are well-labelled and their capacitance value is easily identified. Today, some 40-50 years after they were made, they are no longer capable of doing the job and must all be replaced. No doubt, many other brands of paper capacitors are just as bad but, when they are encased in a

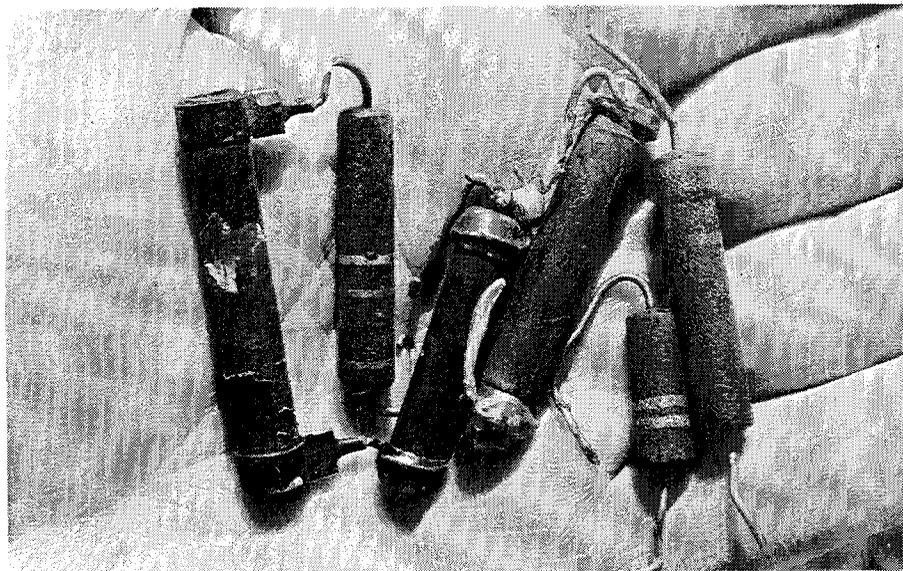
A handful of burnt-out resistors. While a resistor can break down under normal working conditions, an overload caused by a faulty capacitor is usually the cause. Replacing the resistor is pointless unless the real culprit (the leaky capacitor) is also replaced.

If a faulty screen bypass capacitor is allowing current to flow from the screen to chassis, then the resistor that feeds the screen grid must bear the overload. Often it can't, becomes open circuit, and the receiver stops working. In such a case, it is pointless replacing the burnt-out resistor without also replacing the faulty capacitor that caused the overload in the first place.
