VINTAGE RADIO

Realism Realized – the Precedent console receiver

A great deal of patience is sometimes needed if one is to restore an old radio to its former glory. My 1932 Precedent console was just one such set.

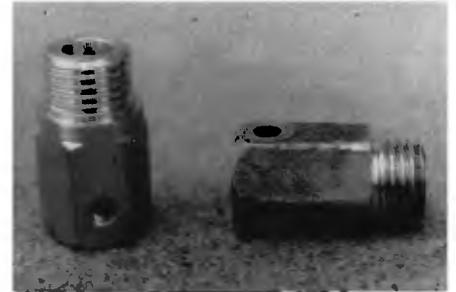
This home-made bearing (left) solved a troublesome dial problem. It was turned up on a metal-cutting lathe in the author’s workshop.

Another problem was the friction drive dial mechanism. Although the drive had plenty of friction, the bearing that the control shaft turned in was very worn and allowed the control shaft to lift. This movement was sufficient to let the friction drive parts come out of engagement and lock up the works.

Having a metal cutting lathe in my workshop helps to solve many worn dial problems and this occasion was no exception. A new bearing was turned up in hexagon brass (see photograph) and the dial drive now functions as it was meant to. Without the lathe, worn dial parts could present some really nasty problems that would be difficult to overcome.

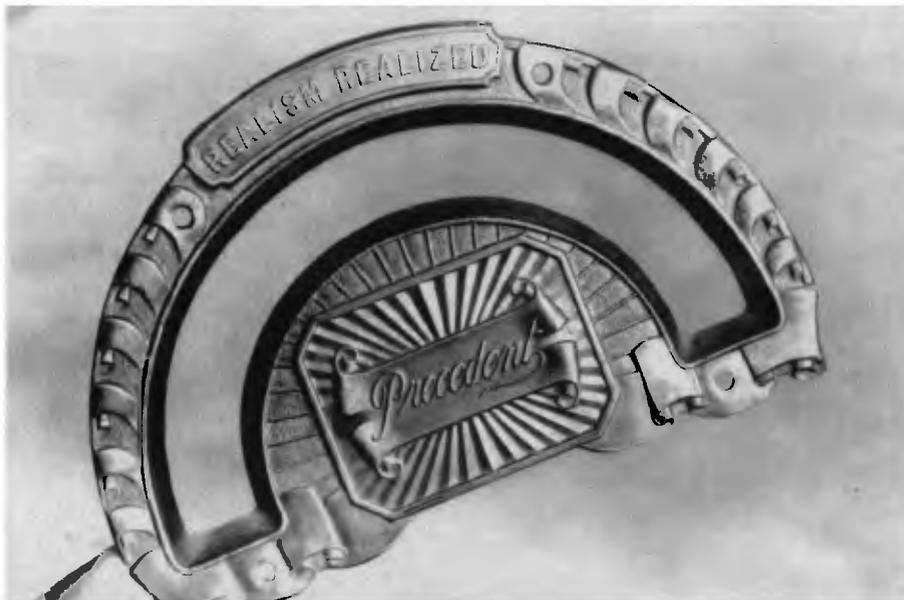
The Precedent’s dial escutcheon bears the motto “Realism Realized”. It is a typical half-moon dial from the early 1930s.

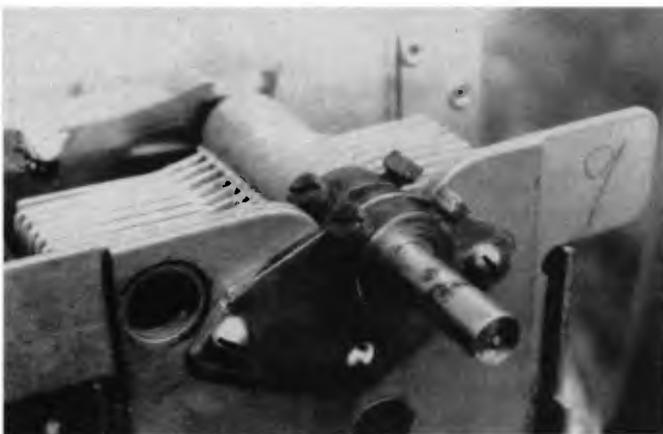
The tuning capacitor is a plain bearing type with two collars & set screws to control end float. Plain bearing tuners often require cleaning & lubrication if they are to work smoothly.

Another capacitor that needed attention was the tuning capacitor, an old 3-gang type with plain bearings. It was in really good condition for its age and only required cleaning and lubricating. The thrust bearings were also adjusted to prevent end float and to prevent the plates from touching each other.

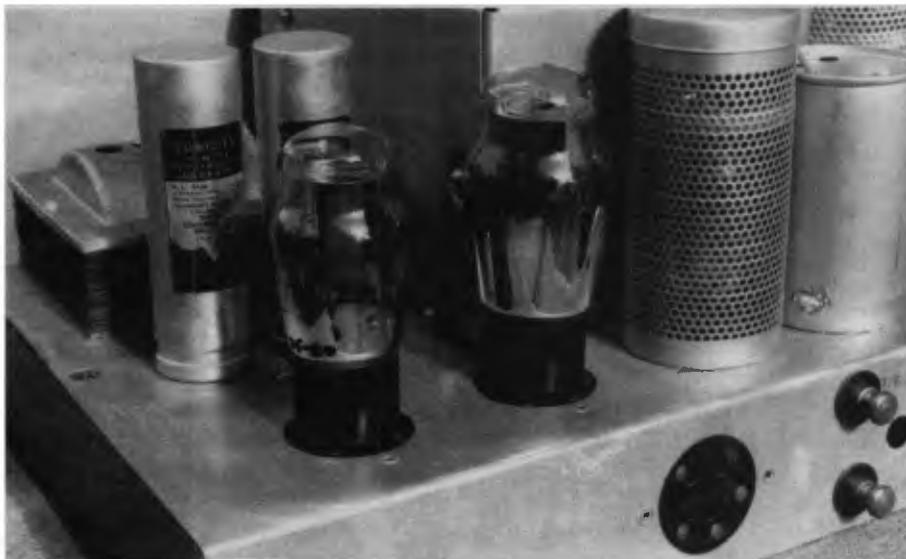
This view shows the 80 rectifier valve (left) & the 47 output valve. The chassis cleaned up quite well for a 60-year old receiver. The two terminals at bottom right are for a gramophone pick-up.

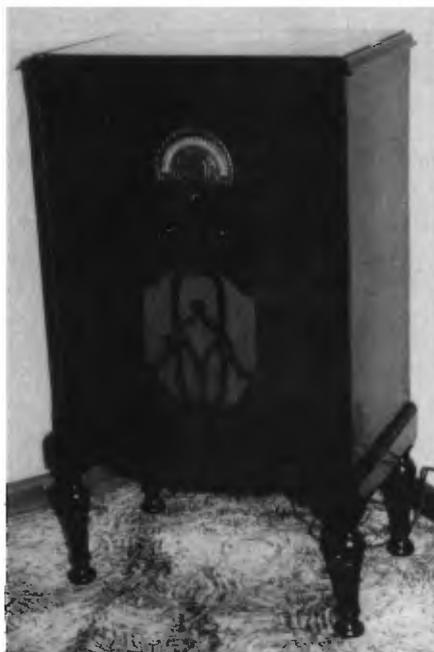
This view shows the finished receiver in its refurbished cabinet. It's quite a stylish outfit if you happen to like old console radios.
