VINTAGE RADIO

Watch out for incorrect valve substitutions in old receivers

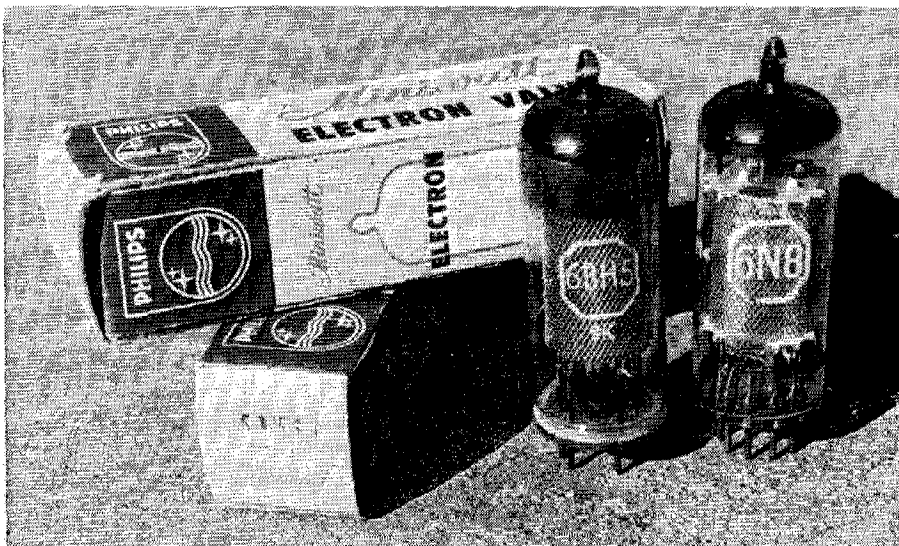
These are the two valves mentioned in the text: the 6BH5 & the 6N8. While both valves can be used as intermediate frequency (IF) amplifiers, they require slightly different socket connections. In the case of the Philips set, someone's failure to make the necessary modifications resulted in a distorted output.

If one checks the base pin connections of these two valves, everything works out reasonably well until pins 7, 8 and 9. Pin 9 on a 6N8 connects to the suppressor grid and, in this case, it wasn't earthed. There is no connection at pin 9 on a 6BH5.

In a 6BH5 valve, the suppressor grid is earthed internally via the cathode, whereas in the 6N8, the suppressor connects to pin 9 and must be earthed externally from the socket connection if the valve is to function properly.

Therefore, using a 6N8 as a substitute for a 6BH5 was simply asking for trouble because it was operating without the suppressor grid.

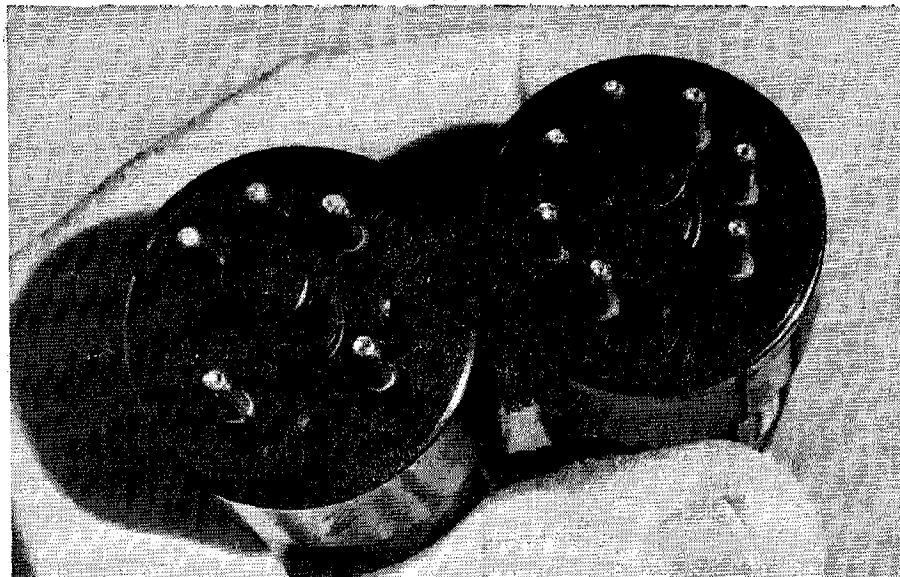
Many valves use only some of their base connections. For example, the 5Y3 (left) has just 5 pins, while the 6V6 (right) has 6 or 7 pins. Receiver manufacturers often used vacant socket terminals as convenient mounting points for other components & so a substitute valve may require considerable socket rewiring.

base pins and, in the case of some octal based valves, not all of the pins are fitted. For example, 6V6 valves often have 6 or 7 pins while 5Y3s have only 5 pins. The missing pins are not fitted for the simple reason there are no connections to them anyway and it makes economical sense not to have them.

However, it is frequently the case that the socket connections corresponding to the missing pins have components soldered to them. Radio manufacturers often used these socket terminals as connection points to join other components and, in some

This situation can cause problems when substituting another valve if what was once a non-connection becomes a valve pin connection. Naturally, any components soldered to that particular socket terminal must be removed and mounted somewhere else.

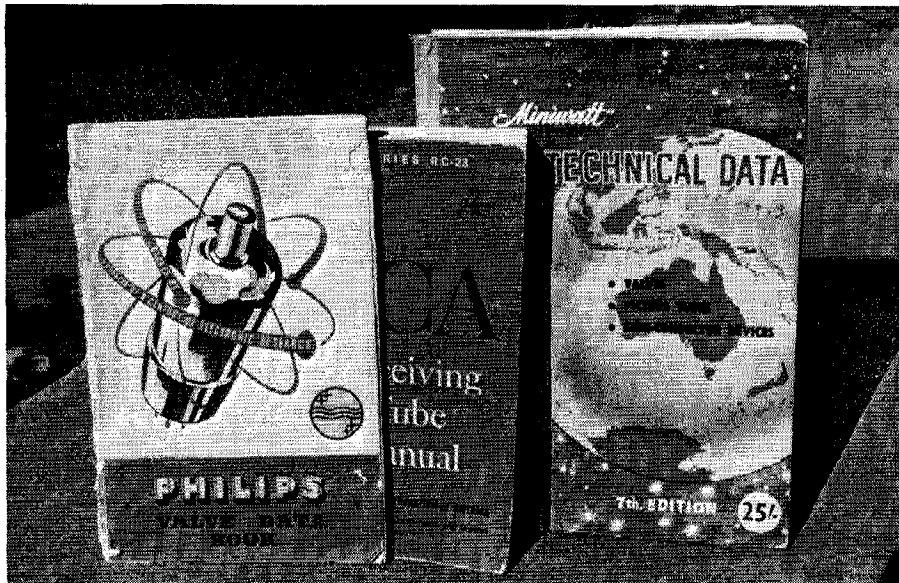
Valve data manuals are invaluable when it comes to substituting valves. These manuals contain details of various valve types & show their socket connections.

Obviously, any radio repair involving valve substitutions is quite difficult if one does not have a comprehensive valve characteristics manual. A valve manual provides all the necessary base pin information and is a much needed guide when it comes to substituting valve types.

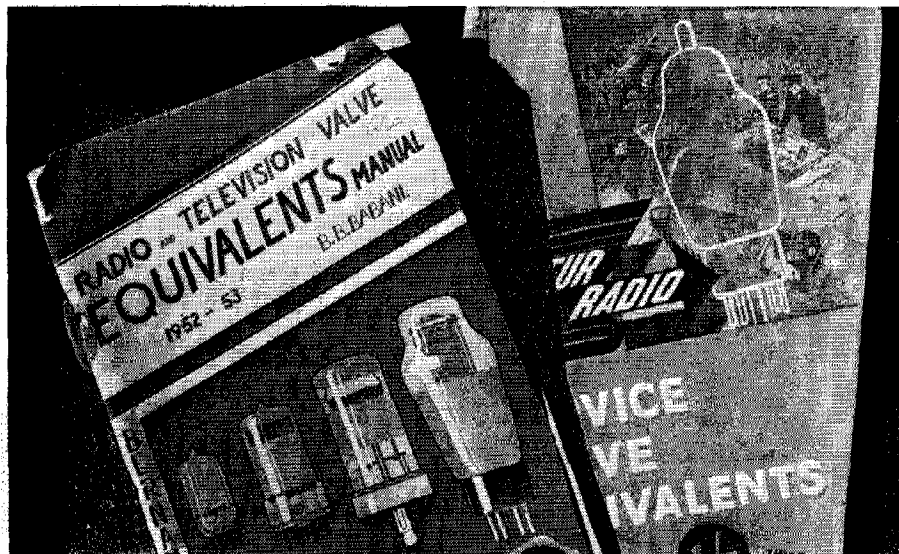
Equivalent manuals are also handy guides when looking for substitute valves. An equivalent valve is one that will fit into the socket & work without modifications to the circuit. A substitute valve, on the other hand, may require extensive socket rewiring or even the fitting of another type of socket.
