VINTAGE RADIO

Fault finding – there's always something different

Vintage radio receivers can develop some very unusual faults. Here's what it took to bring two old receivers back to life again.

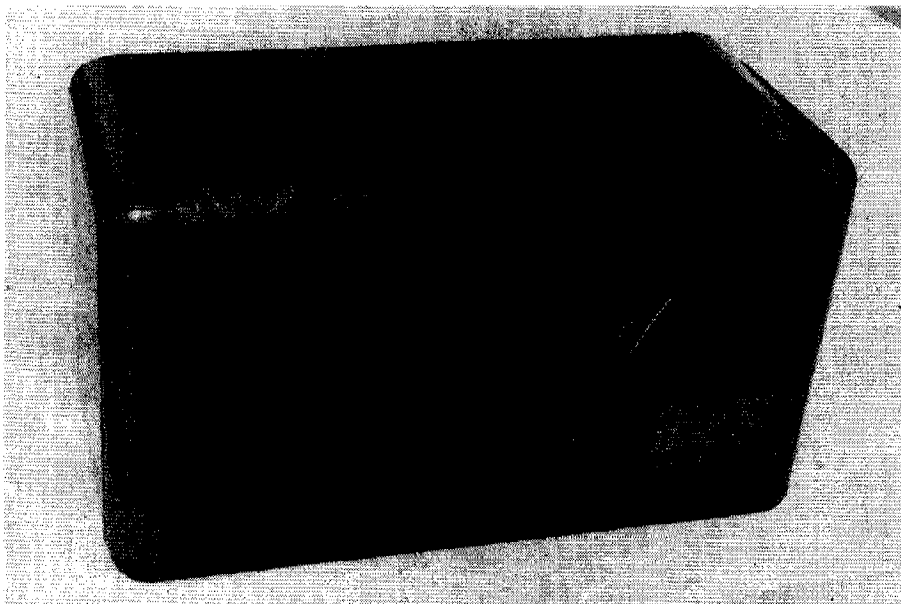
The HMV receiver was an early post-war 5-valve table model in a timber cabinet. Some misplaced wiring, a short circuit in some shielded wire & a missing capacitor caused quite a few headaches.

Not having a circuit diagram, I did the next best thing. I borrowed a similar model HMV from a friend and used it to trace the muddled connections. A bit of a swap around at the volume control and all was well in that department. The shortwave reception was restored by adding a capacitor that had been previously removed and not replaced. After realignment, the receiver then worked normally.

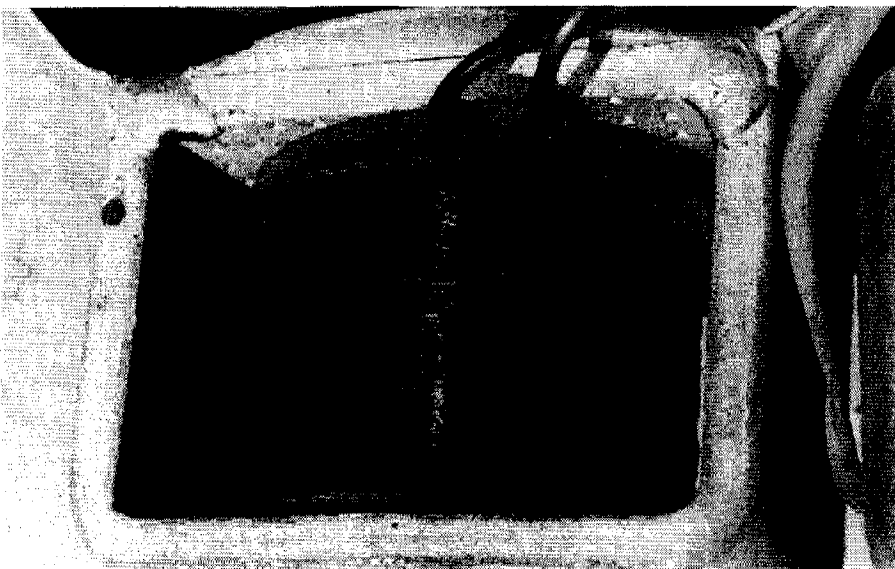
The Radiola's field coil suffered permanent damage due to the flow of excessive high tension current. Note that the enamel insulation has been burnt off the wire. The paper wrapping on the outside was charred to a crisp.

The most likely scenario regarding the set's demise is as follows. A shorted high tension component (possibly a paper capacitor or an electrolytic) caused a considerable increase in high tension current. As the receiver used an electrodynamic loudspeaker, the increased high tension current had no option but to flow through the field coil, which caused considerable overheating.

In fact, the field coil became so hot it burnt the enamel insulation off the wire and charred the paper wrapping around the coil to a crisp. Only a few fragments of blackened paper remained.

The overcooked field coil was replaced with a 20W resistor of similar resistance. This substitution produced a little hum in the speaker but it was not objectionable by any means. While a resistor and choke would have given better results, there is little room to mount such things underneath the chassis.
