# VINTAGE RADIO

## A pair of Astor valve radios

**Occasionally, I get to repair vintage radios for other people and that's what this month's column is all about. It concerns a couple of interesting old Astors.**

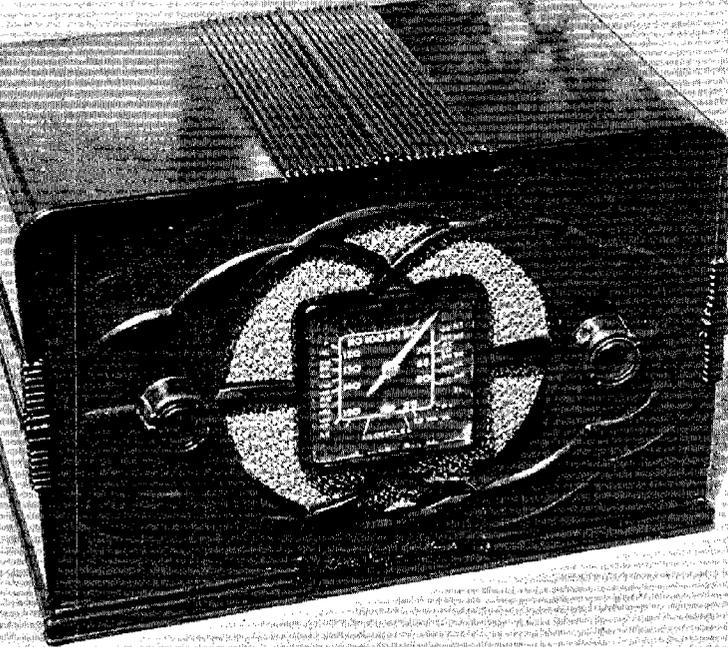
**A 1940 BP model Astor "Mickey Mouse". Although a very collectible item, it is a fairly awkward receiver to work on and has no really outstanding features apart from being very compact. No, the knobs are not the originals!**

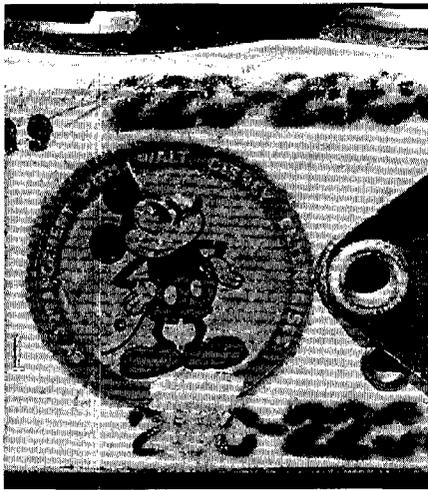
If it wasn't for the "Mickey Mouse" aspect of these radios they would be just another old radio. Astor used the Disney name without permission and later dropped the "Mouse" bit. The Astor "Mickey" was a very popular post-war receiver.

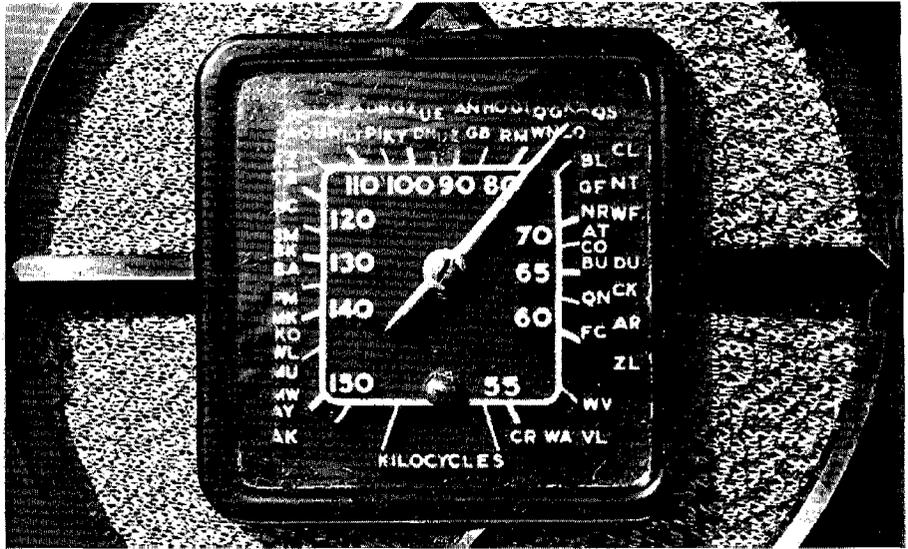
This close-up shows the dial and speaker opening. Having the dial in the centre of the loudspeaker makes a new grille cloth rather difficult to fit. Note the hole in the dial (at 12 o'clock) where the dial lamp has "burnt" through the celluloid.

is appropriate. And finally, fitting a new speaker grille cloth is fairly tricky due to the fact that the dial is in the centre of the speaker opening.

grille cloth was replaced with a piece of original material obtained from an old console cabinet. There were a couple of good corners in this piece of cloth and having the right fabric in a collectible receiver such as a "Mickey Mouse" really sets it apart.

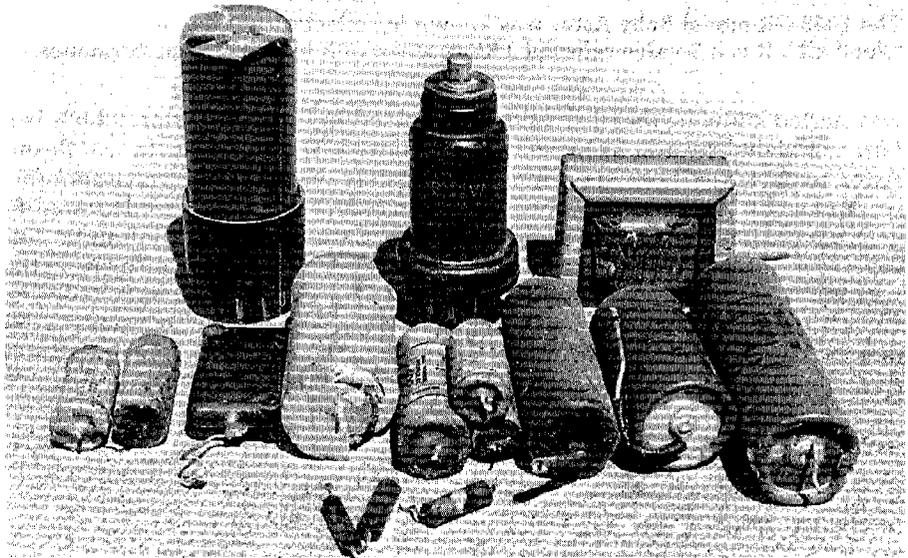
The Astor "Mickey" required several component replacements before it worked satisfactorily. Some of the old resistors had tripled in value.

A closer inspection revealed that the output transformer was open circuit and that someone had previously disconnected the electrodynamic loudspeaker and then mixed up the leads when reconnecting it. The original 6Q7 detector/first audio valve had also been replaced with a 6SQ7 which is just about the same valve except that it is a single-ended type and lacks a top cap connection.

After doing everything that needed doing, it was tryout time. The set burst into life and there was that feeling of relief knowing that all the checking, replacing, and repairing had finally produced a positive result. But that feeling of relief was short-lived because, 30 seconds later, the sound had faded to nothing.

emission test. This test does not check a valve for all working functions and other faults can be overlooked. A replacement 6A8 sorted out this particular problem but it took a while to locate.

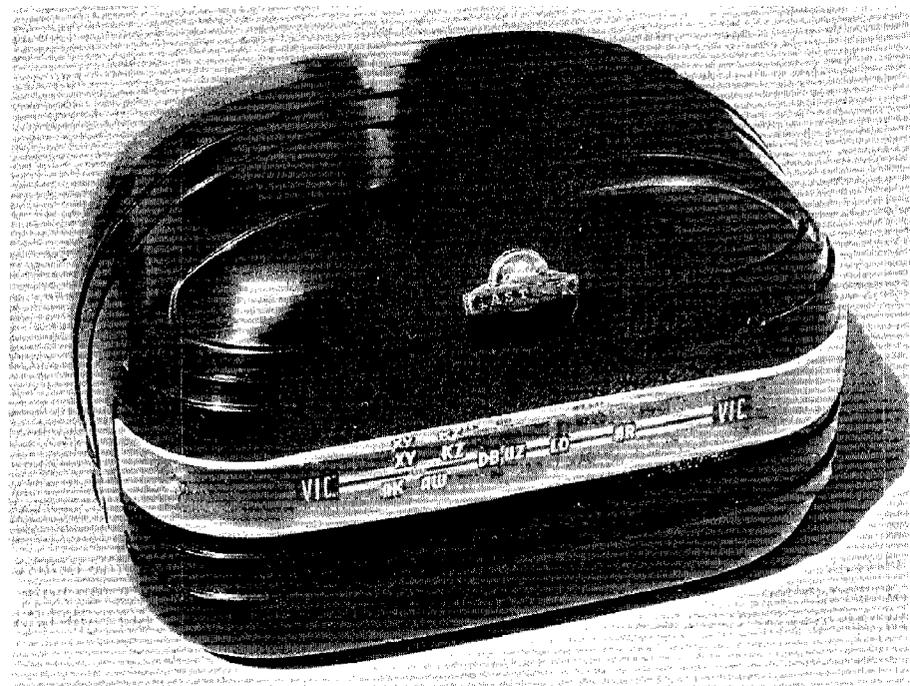
**The 1948 GR model Baby Astor was known to collectors as the Astor "Football". It is a 3-valve reflexed TRF receiver of fairly limited performance.**

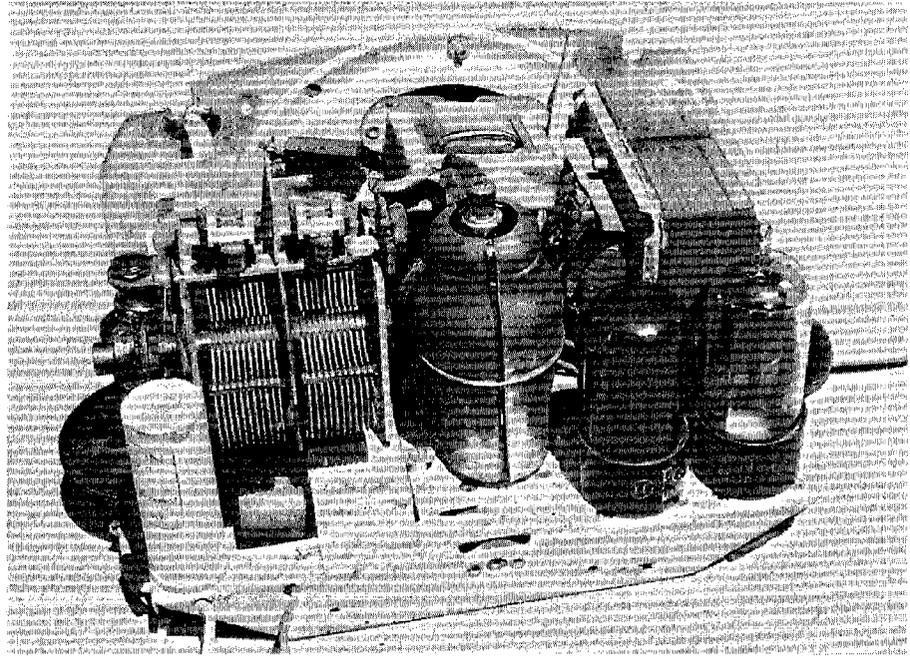
**This photo shows the rear view of Baby Astor chassis. The three valves are: 6G8G, 6V6GT and 5Y3 rectifier.**

On removing the chassis from the cabinet it was surprising to see that it was not a superhet but a simple 3-valve TRF (tuned radio frequency) receiver. The valves used are: 6G8G, 6V6GT and a 5Y3 rectifier.

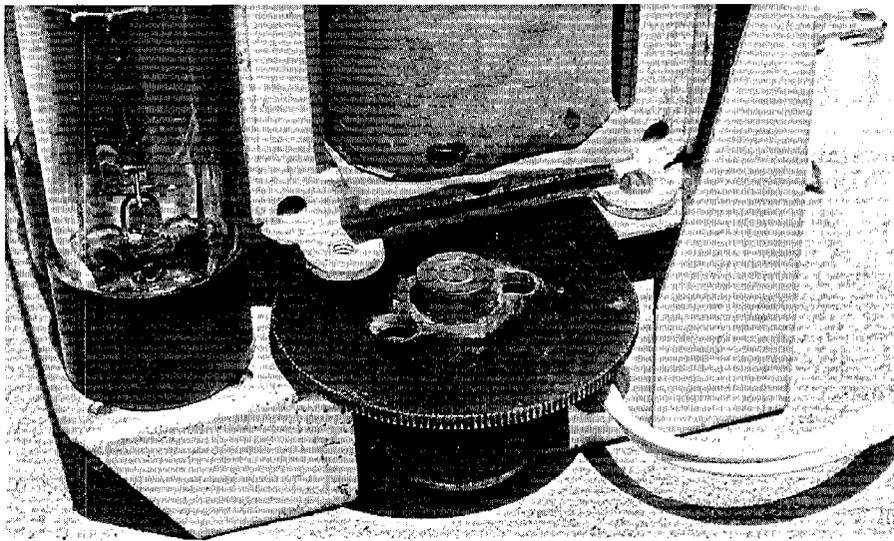
The Baby Astor's control knobs are chassis mounted and the edges of the knobs protrude through the sides of the cabinet.

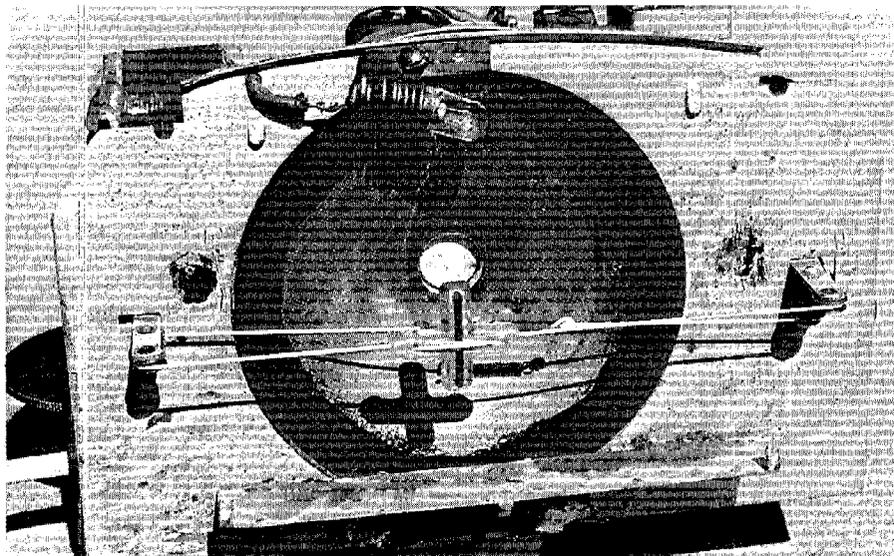
There is a small bracket at the front of the chassis near the bottom of the loudspeaker. Mouse activity had been intense in this area and the bracket has obviously been a popular spot for the relieving of bladders. Unfortunately, the overflow had seeped down onto the edge of the speaker cone and had rotted out some of the cone.

"Silastic" silicone rubber was used to reinforce the outer rim of the speaker cone. It mightn't look too neat but it certainly makes an effective and long-lasting repair. The dial cord was difficult to re-string.

The speaker was repaired using Silastic silicone rubber compound. In fact, the whole outer rim of the cone was reinforced as the edge had become very thin and fragile.

These speaker repairs proved entirely satisfactory and the receiver could not have sounded better had a new speaker been fitted. It is amazing the cone reconstructions that can be done with a bit of perseverance. The silicon rubber treatment may not look very dainty but it is usually effective and long lasting.

The dial cord nearly always needs attention and this particular one was a bit tedious to string. It is one of those with a hole through the tuner control shaft and as the cord unreels on one side of the hole, it winds up on the other. The right number of turns needs to be on the shaft and it must also be wound in the right direction before success is possible.
