VINTAGE RADIO

The combined A-B battery eliminator

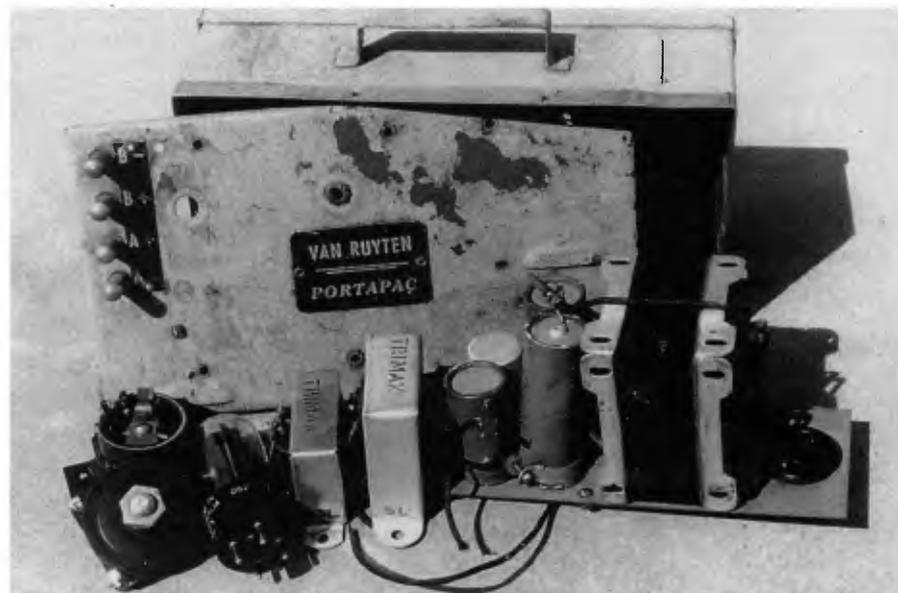
The old Van Ruyten battery eliminator is shown here stripped, ready for repairs. Like most vintage radio equipment it was in a fairly sorry state.

There were a number of other items that needed attention and the old Van Ruyten was completely stripped so as to make the necessary repairs. These repairs included: replacement of the filter capacitors and the 5Y3GT rectifier valve, a new power cord, repainting of the steel cabinet and, as mentioned above, alterations to the high tension circuit to permit the "B" voltage to be varied.

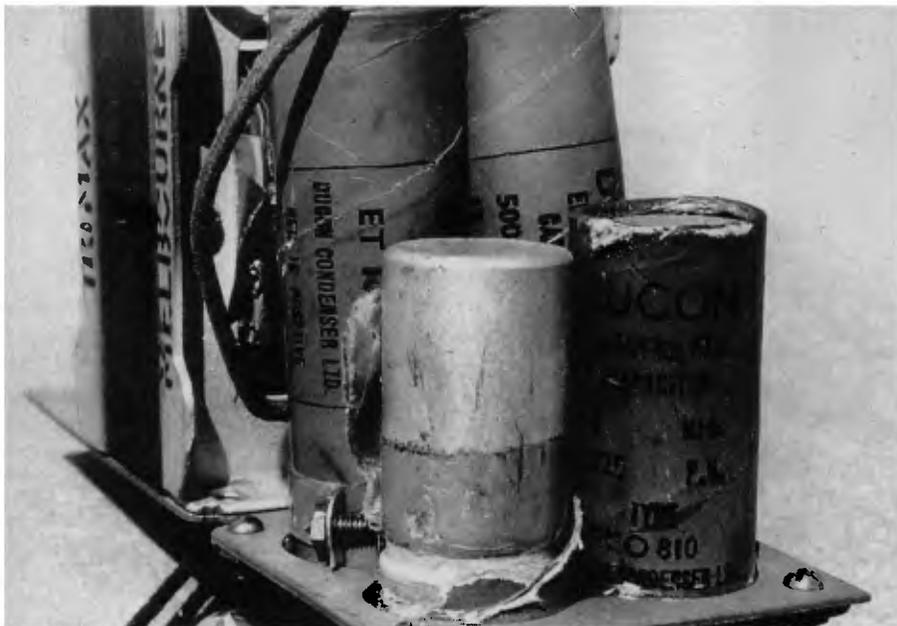
These old electrolytic capacitors were next to useless. Three had virtually no capacitance while the fourth had an internal short.

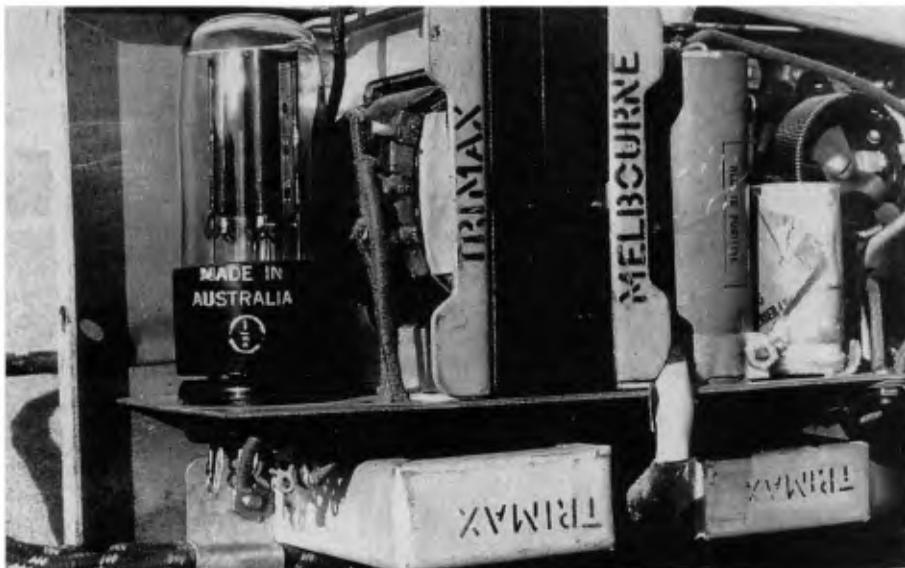
This view shows the power transformer, the 5Y3GT HT rectifier and the two Trimax brand filter chokes (beneath the chassis).

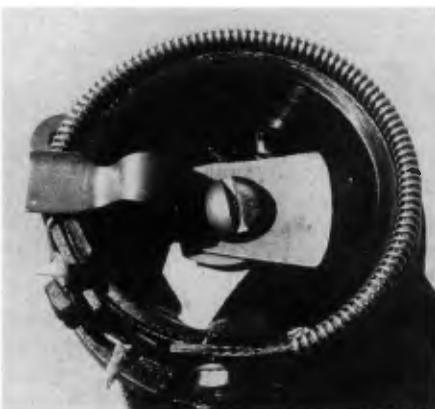
Because the low tension supply is unregulated, the supply voltage varies with the load. This wirewound rheostat is used to adjust the "A" voltage to suit the receiver.

Now this old battery eliminator, like most other power supplies of that era, is unregulated in both the "A" and "B" circuits. To counter this problem a 6-ohm rheostat is incorporated into the "A" circuit to help compensate for various loads that may be applied. This allows the correct voltage to be delivered to suit a particular current demand and there is enough adjustment to allow use at 1.4V and 2.0V, although the latter situation is very marginal.

The adjustment procedure for setting the "A" supply is as follows: (1) with the eliminator hooked up to the receiver, connect a voltmeter to the "A" battery terminals of the set; (2) back off the rheostat as far as it will go before switching on; and (3) slowly advance the rheostat until the desired voltage is shown on the voltmeter. And that's it!

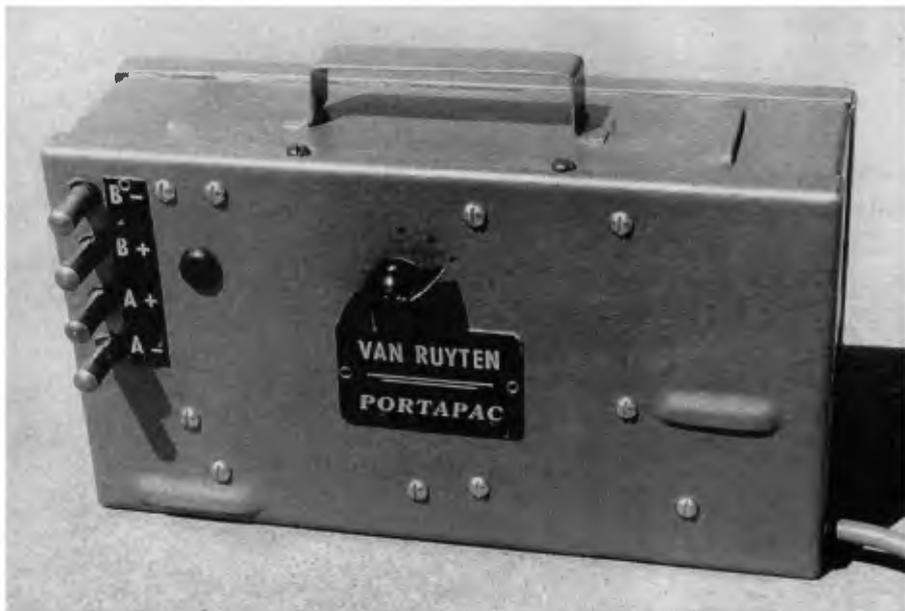
The finished battery eliminator, or "Portapac" as it was called, includes a rotary switch on the front panel. This switch serves to fill the hole originally used for the power cord and allows the "B" voltage to be varied in three steps. The rubber grommet near the output terminals allows screwdriver adjustment of the "A" voltage rheostat.

The modification to the "B" circuit involved adding a multi-pole 3-position switch so that two pairs of resistors could be switched into the plate circuits of the high tension rectifier.

The resistors used here were 10k Ω and 27k Ω and they reduced the "B" voltage to approximately 60V at 4mA and 45V at 2mA. The unloaded voltage without the resistors is 150V.

Another reason for incorporating the variable "B" voltage switch was to fill a hole in the control panel. Originally the power cord exited through this hole but a previous repairer has cut a new power cord hole (and a fairly ragged one at that) in a far better position on the side of the cabinet.
