# VINTAGE RADIO

## Clean audio for old Henry

**It has now been 12 years since I first became interested in collecting and restoring vintage radio receivers. Over that period, I have found it necessary to rework some of my earlier restorations, for the simple reason that they were not done correctly in the first place.**

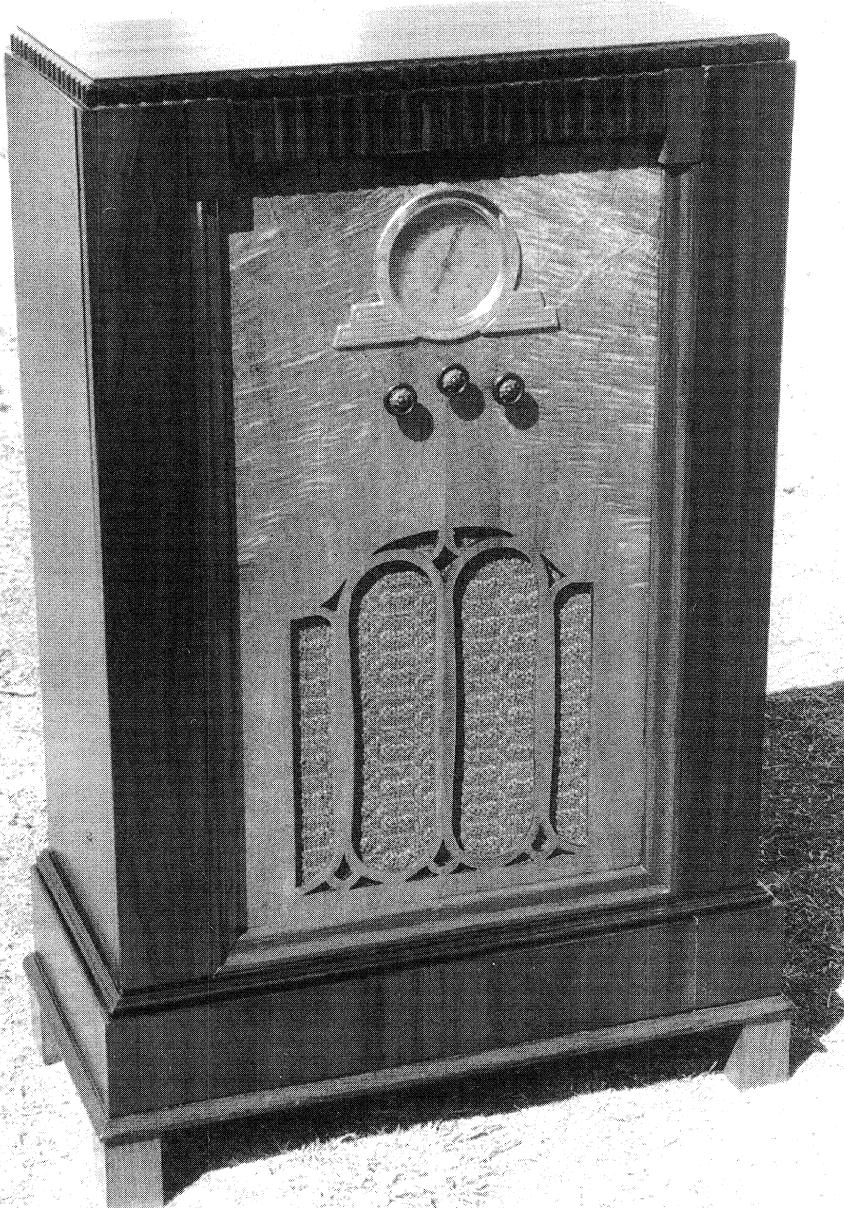
Henry is an early 1930s 7-valve superhet receiver of rather large proportions and is typical of the era. The challenge was to cure his audio distortion problems, which have been present since restoration many years ago.

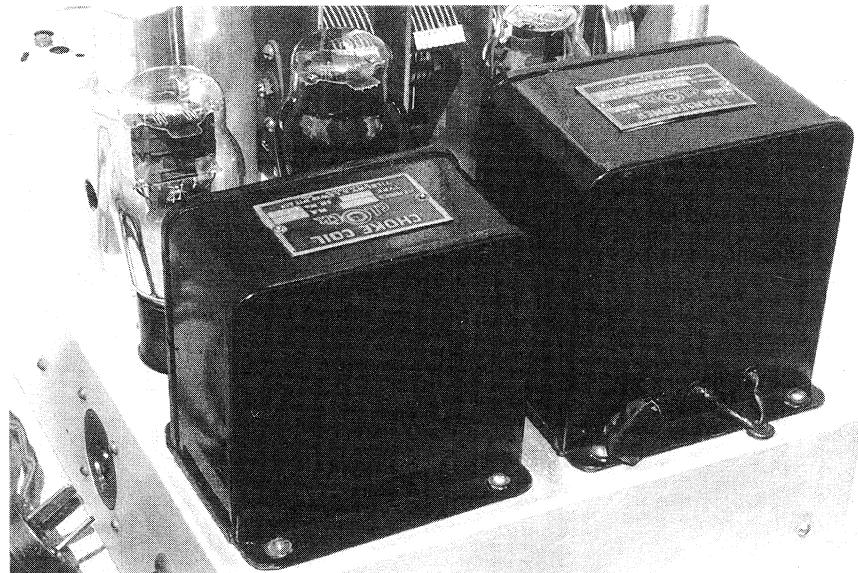
The high tension choke (left) and high tension power transformer (right) are mounted on the top of the chassis.

The high tension transformer is on top. It has two secondary windings: (1) a centre-tapped high voltage winding for the type 80 rectifier plates; and (2) a low voltage winding for the rectifier filaments.

There is also a huge 30H, 85mA high tension choke mounted above the chassis next to the HT power transformer. These two units weigh quite a few kilograms and concentrate a lot of weight at one end of the chassis.

Similar bare connections (in the form of terminals) are to be found on the high tension choke. These connections are easily reached (even when the chassis is in its cabinet) and they have a DC potential in excess of 300V.

tentially fatal nasty is on the high tension power transformer. A bare unused 240V primary connection protrudes from the transformer cover. It seemed prudent to tape over this hazard. Mains voltages, by reason of their low source impedance are by far the most dangerous.

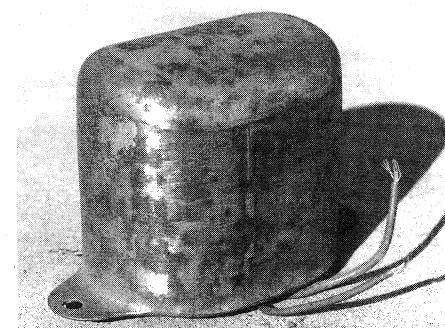
A parallel output stage requires an output transformer with half the primary impedance of that used for a single output valve. In the case of parallel 59s, an output transformer with a  $3\text{k}\Omega$  primary is required but that is not what was installed when the set was restored. The transformer used would have been more in keeping with a battery receiver, as it had a  $10\text{k}\Omega$  primary.

A  $2.5\text{k}\Omega$  "Isocore" output transformer was used to replace the earlier  $10\text{k}\Omega$  unit. This was necessary because the primary impedance required for parallel connected output valves is half that of a single stage.

tors and the output transformer would all have to be replaced. The replacement transformer was a  $2.5\text{k}\Omega$  "Isocore" type in a pressed steel can. While it looks a few years too modern for the set's age, it was the only transformer that came near the required  $3\text{k}\Omega$  primary. Being an Isocore type, with floating, "hot" laminations, it should be relatively troublefree.

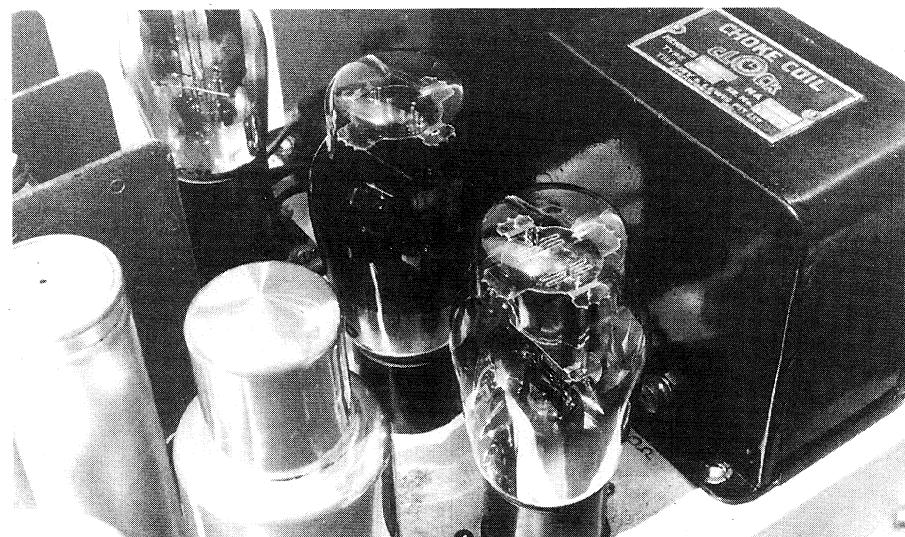
Henry has an unusual output stage which consists of two type 59 output pentodes in parallel, rather than push-pull. The two valves are wired grid to grid, plate to plate, etc. This arrangement provides twice the output power but is not as good as push-pull which has a number of advantages, including lower distortion.

On top of that, one of 59s had an open heater. Readers unfamiliar with this output pentode may be surprised to learn that the valve has two heaters and will still work reasonably well when one is open. However, as there was a distortion problem to correct, a replacement valve was required.

This close-up view of the chassis shows the two 59 output pentodes which are wired in parallel. The old 59 was in production for only a short time and was superseded by the 2A5.

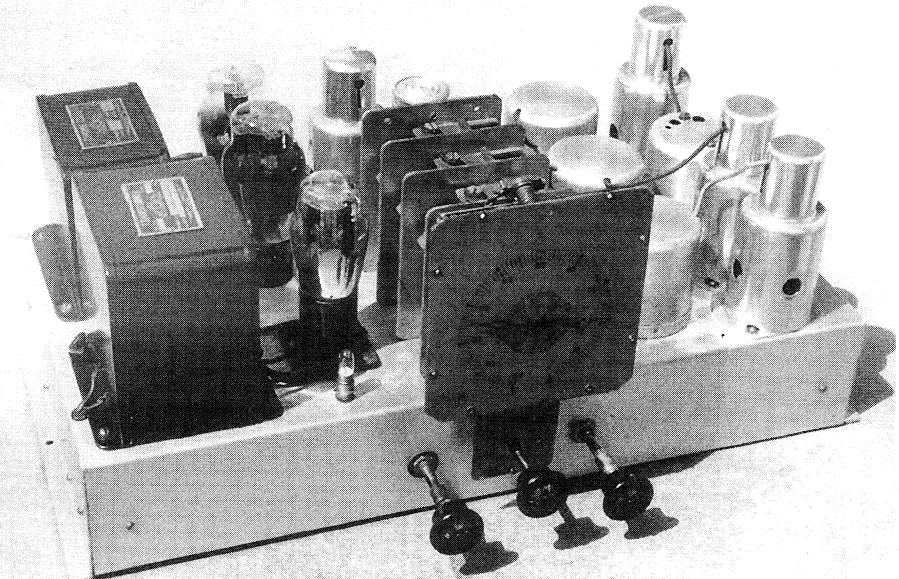
Old Henry was built using very large 1930s-style components and boasts no less than seven valves, including two 59 output pentodes wired in parallel.

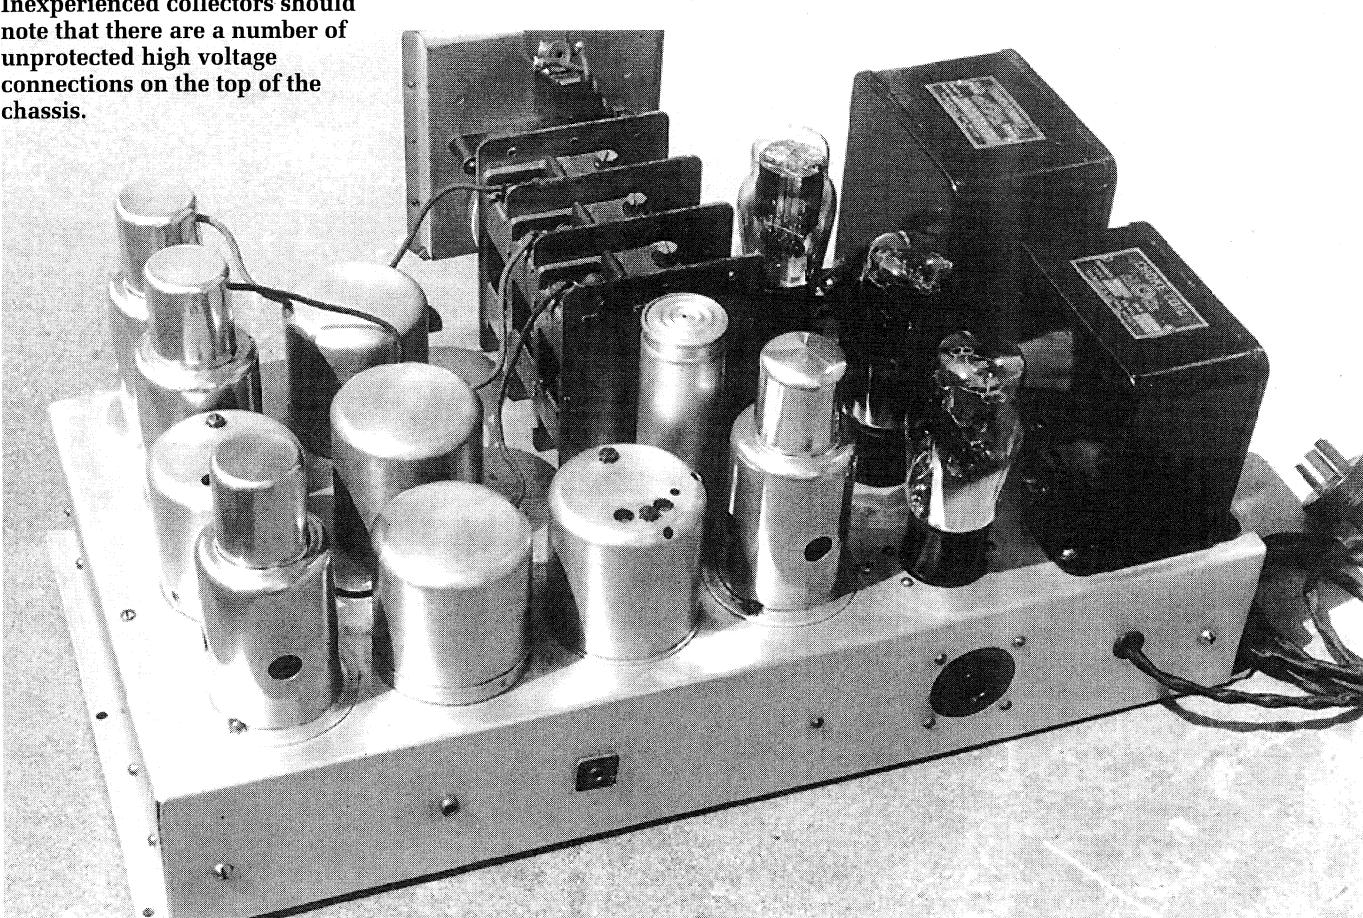
**The receiver is impressive because of its size alone.**  
Inexperienced collectors should note that there are a number of unprotected high voltage connections on the top of the chassis.

Perhaps the worst aspect of Henry is the unprotected – and potentially lethal – high voltage connections above the chassis, where one would least expect to find them. Inexperienced collectors/repairers should take note of the following.

The rectifier socket is mounted above the chassis. Its bare external connections are within easy reach of any careless fingers that may venture close enough to touch those high plate voltages.

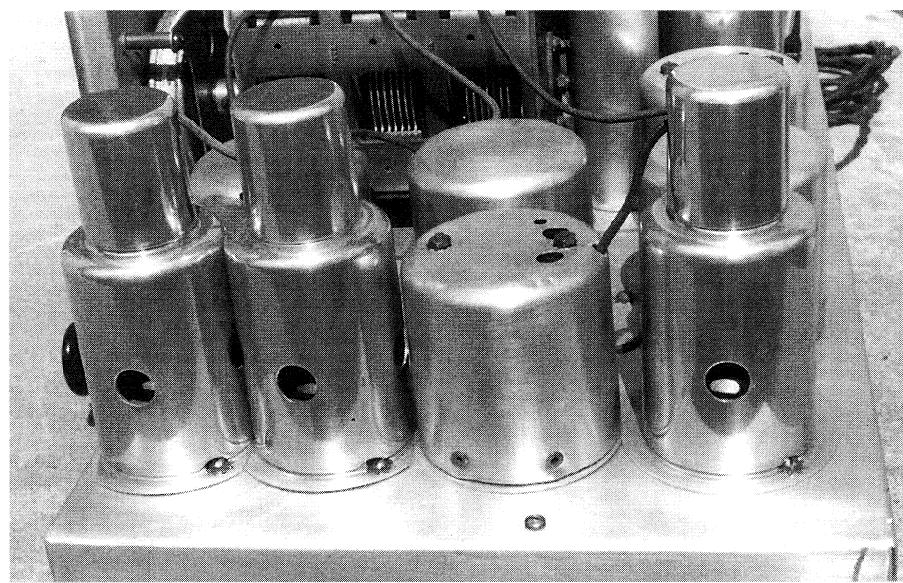
The front end valve line-up is: 58 RF amplifier, 57 autodyne oscillator/mixer and 58 IF amplifier. The gain of the two 58s is controlled by AGC. There is no AGC applied to the frequency converter as the autodyne circuit was unsuitable for AGC. The IF is 175kHz.

The front end or RF part of the receiver. The valves inside the shield cans are: 58 RF amplifier, 57 autodyne mixer and 58 IF amplifier.

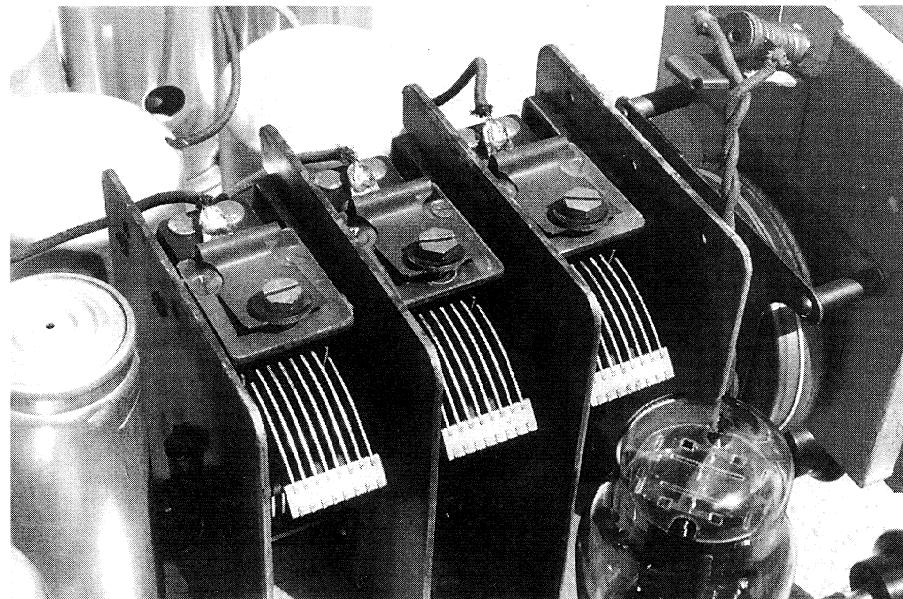
This large 3-gang tuning capacitor is typical of many early 1930s receivers. Miniaturisation had not been thought of then.
