VINTAGE RADIO

Vintage Hifi Stereo AM Radio

I recently had the pleasure of restoring a Pioneer SM-B161 AM (circa 1964) stereo receiver. What is immediately different about this receiver compared to the run of the mill sets of the era in that it has two complete independent AM receivers in the one case. It had two slide-rule AM dials and two tuning knobs.

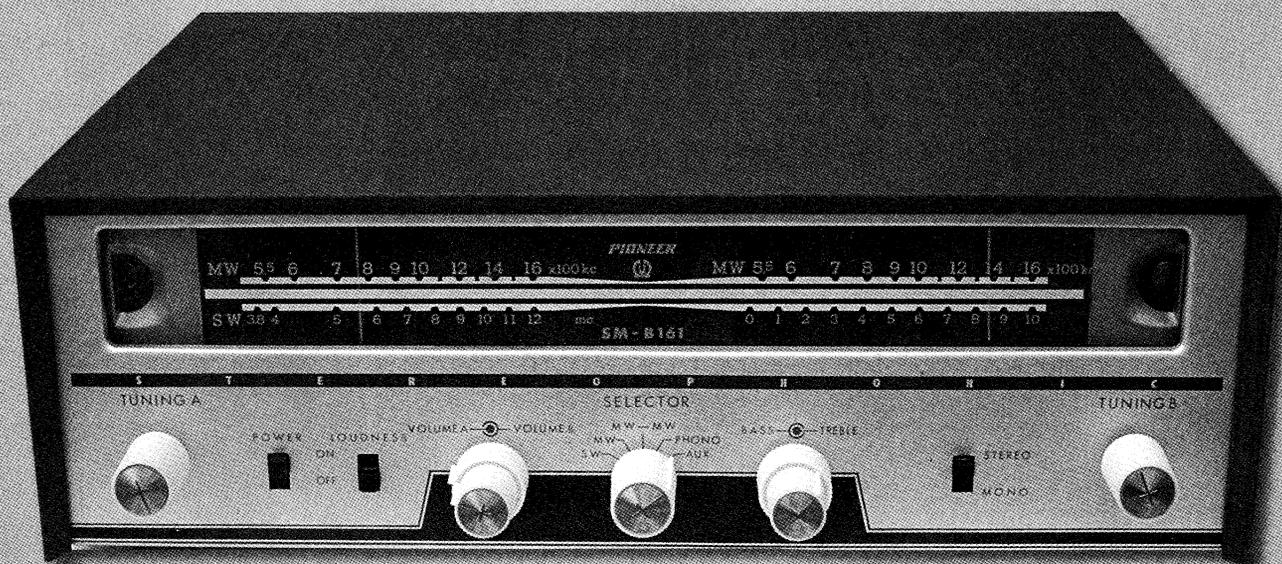
BELOW: two dial scales, two tuning knobs and two magic eyes made this Pioneer stereo AM receiver a knob-twiddler's delight at the time of its production in about 1964. The bass and treble controls used concentric knobs, as did the volume control. There was no balance control.

One of the photos in this article shows the front panel layout which has the two dial scales. One is purely the AM broadcast band while the other is the broadcast band plus a shortwave band from 3.8 to 12MHz.

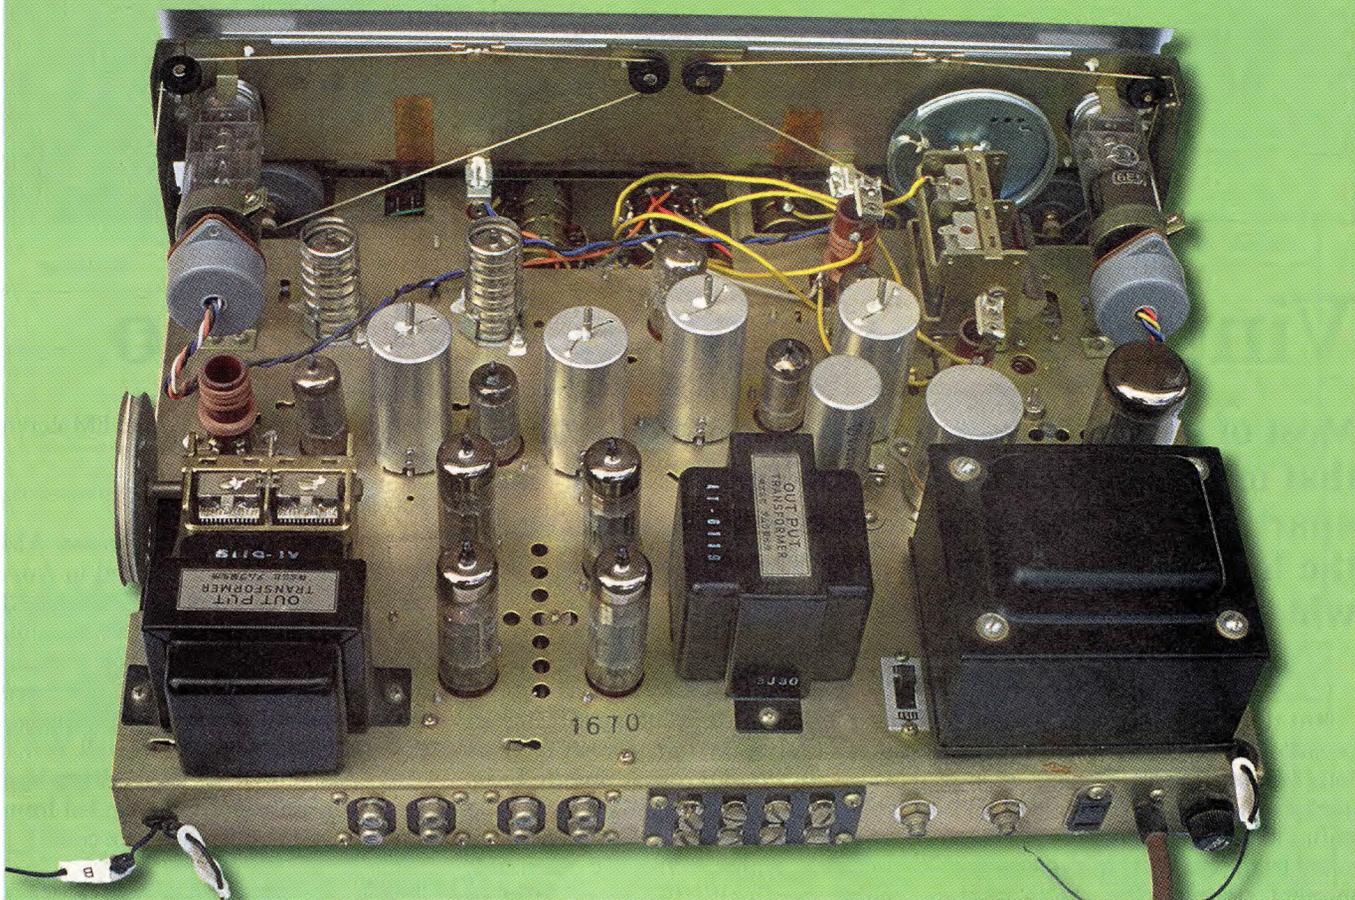
The top of the chassis was neat and well laid out. Note the two tuning gangs, one at the front and one at the rear, near one of the output transformers. The two magic eye tubes are mounted horizontally at each end of the front panel.

The top of chassis view shows a set which is easy to access with major components well labelled. While the photo may not show it well, the valve types and similar pieces of informa-

tion are stamped onto the chassis. This would have been most useful if any of the valves were missing.

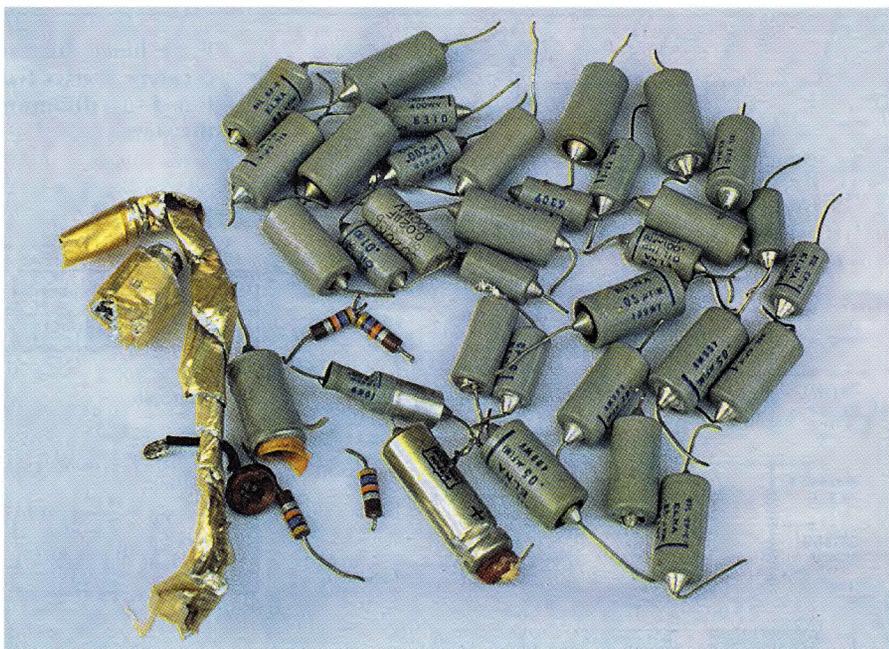
This photograph shows the great handful of components which had to be replaced. As can be seen, most of the electrolytics were faulty.

found that wax had been dripping out of one of the audio output transformers. This suggested that it had overheated for some reason or another. I then checked the capacitors around the particular twin 6BM8 output stage and found that the cathode bypass electrolytic capacitor had emptied its insides out. This almost certainly means that the valves had been drawing a lot of current. The grid capacitors were then found to be quite leaky so that was likely to be the reason for

the high current through the 6BM8s and the cathode resistor.

It was also obvious at this stage that a few other capacitors had spilled their insides around the underside of the chassis, as can be seen in one of the photos. The set was designed for 115V or 230V AC operation and there were three ordinary paper capacitors of 400V rating from mains to earth – depending on which way the mains supply was connected.

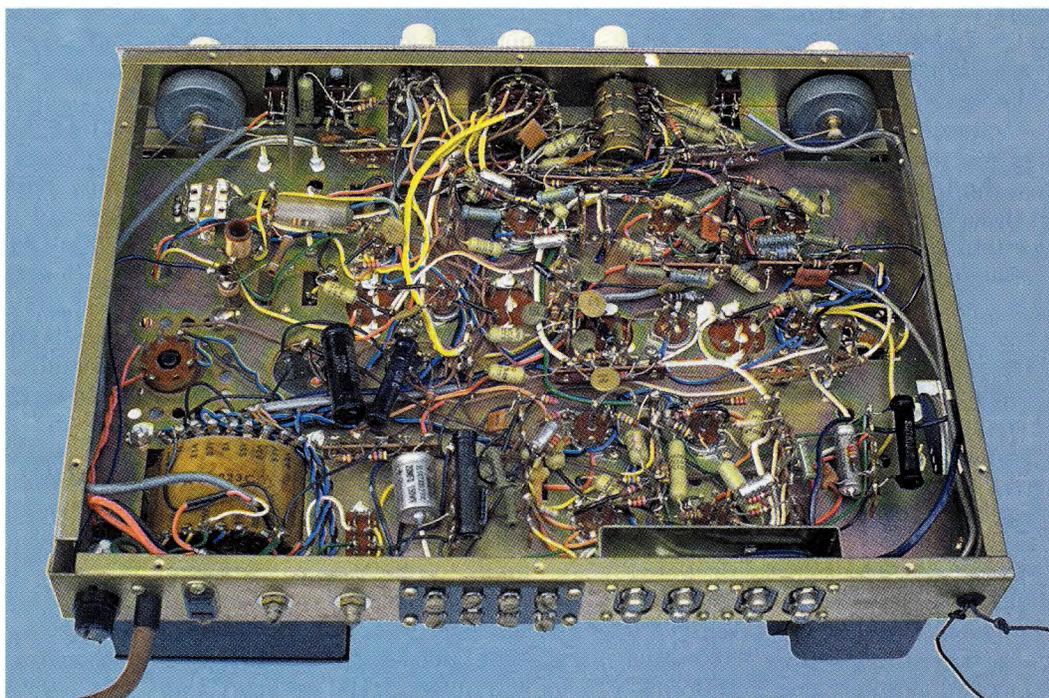
The under-chassis view shows the crowded point-to-point wiring of the era. Access is good though and replacing parts is straightforward provided you do just one at a time.

The top and bottom covers of the receiver come off easily, allowing ready access to the componentry. It is a complex piece of equipment with 14 valves, including the rectifier and the two magic-eye tuning devices. From the under-chassis view it can be seen that there are a lot of passive components. I had to replace around 30 leaky electrolytic capacitors and a few out of tolerance resistors. Care is needed in replacing the components. I replaced them one at a time so as to not get any in the wrong spots.

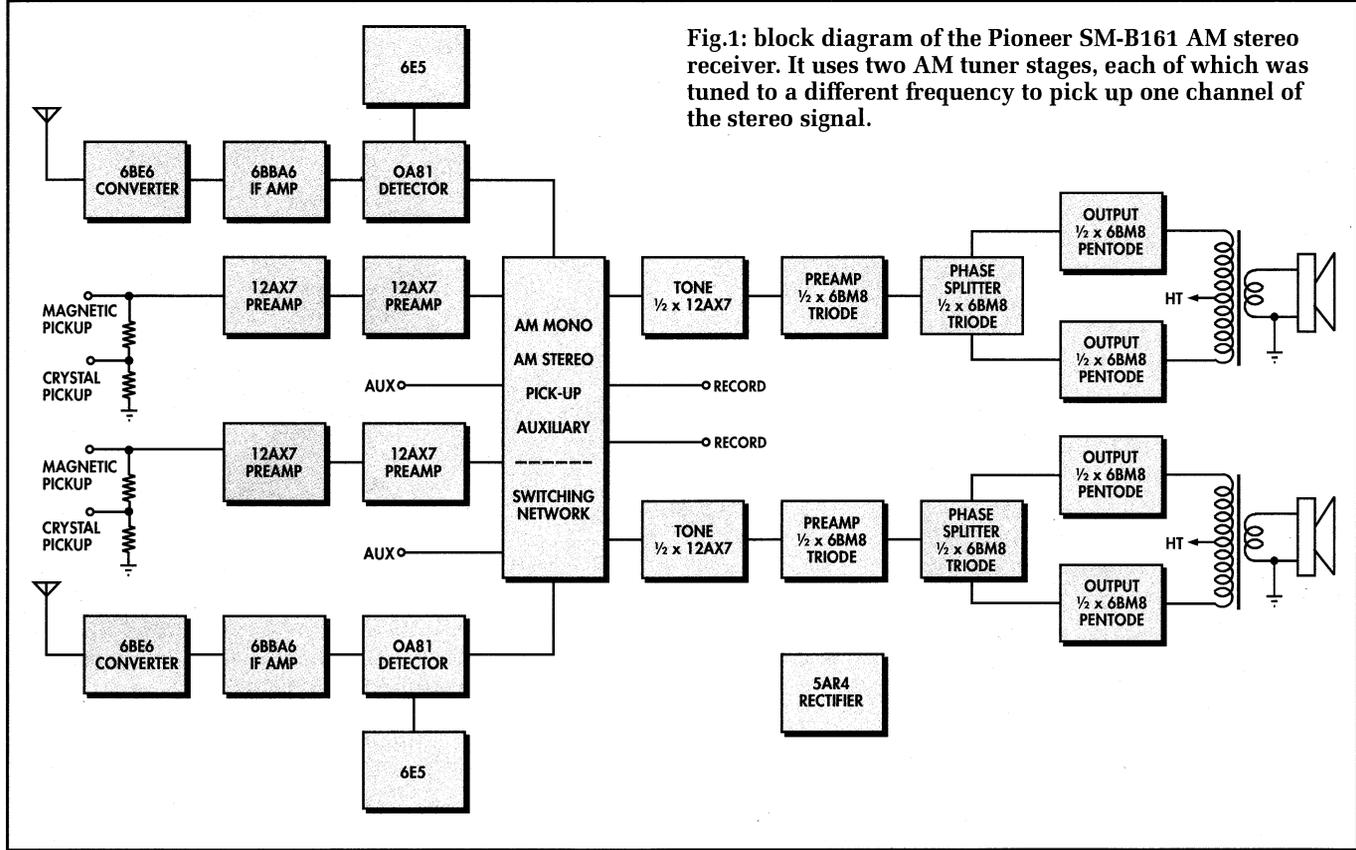
Fig.1: block diagram of the Pioneer SM-B161 AM stereo receiver. It uses two AM tuner stages, each of which was tuned to a different frequency to pick up one channel of the stereo signal.

The output of each receiver then goes into a large switch which combines, separates or selects the receiver, record pick ups or auxiliary inputs; this is a large and busy switch. From this switch, the signals are either separated or combined go to the respective tone control network and audio amplifiers and thence to the speakers.

Fig.1 is a block diagram showing how the receivers and amplifiers are interconnected.
