VINTAGE RADIO

HMV's Nippergram: a classic 1950s portable radiogram

Portable radiograms became popular during the 1950s and early 1960s and are now very much collector's items. One classic from that era was HMV's Nippergram.

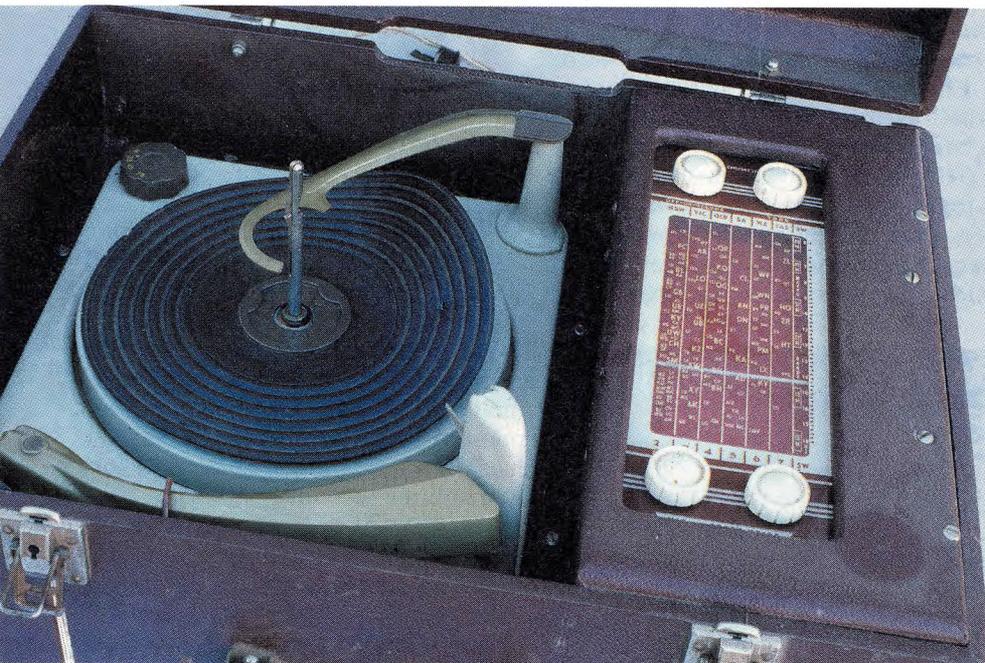
This is the view inside the cabinet of the old Nippergram prior to restoration (note the buckled turntable platter). A previous serviceman had installed the turntable the wrong way around.

With all of these things undone, all of the innards were lifted clear of the cabinet. Now all sections could be worked on. But would you believe it? – the last person to work on the unit had put the changer in the wrong way. Had he installed it correctly, access to the receiver would have been quite straightforward. Did someone say something about Murphy's Law?

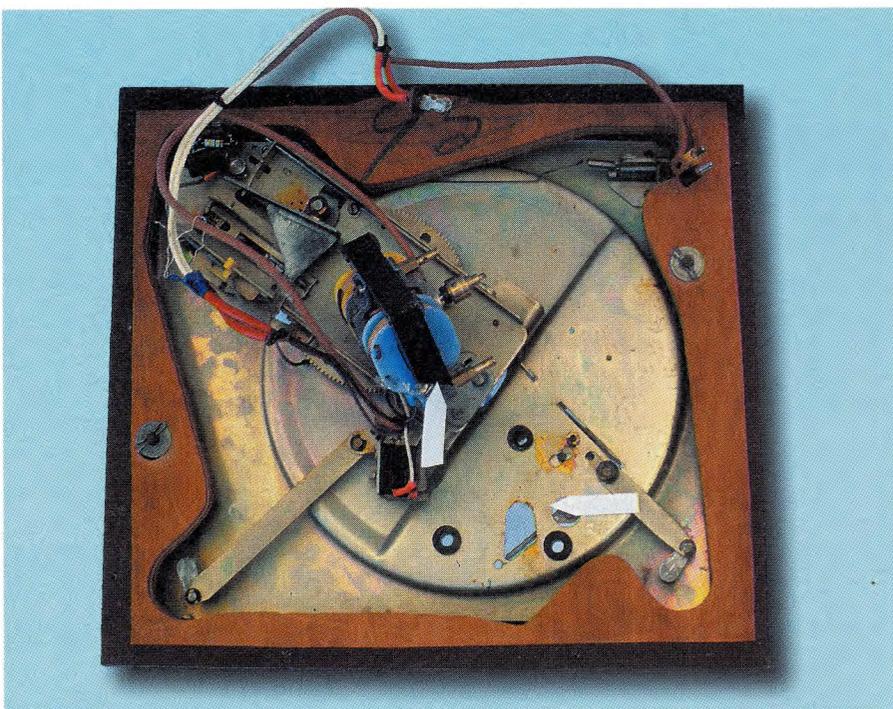
The rubber mounts for the motor had perished and had to be replaced. The mounting position is indicated by the white arrow at bottom right, while the second arrow indicates the motor itself after removal.

One problem I found was that the idler was not contacting the stepped drive pulley correctly. It didn't take long to find out why – the rubber resilient mounts on the motor had perished and the motor assembly was sagging and pulling the pulley out of position.

The mounts look rather like rubber grommets but the centre hole is much smaller. I wondered for a while what could be used in their place before remembering that I had bought some tuning-gang rubber mounts (grommets) some time ago. They turned out to be almost perfect and only needed a small plastic sleeve to fill the gap

between the motor mount spigot and the inside edge of the grommet. A photograph shows the motor removed so that this could be done.

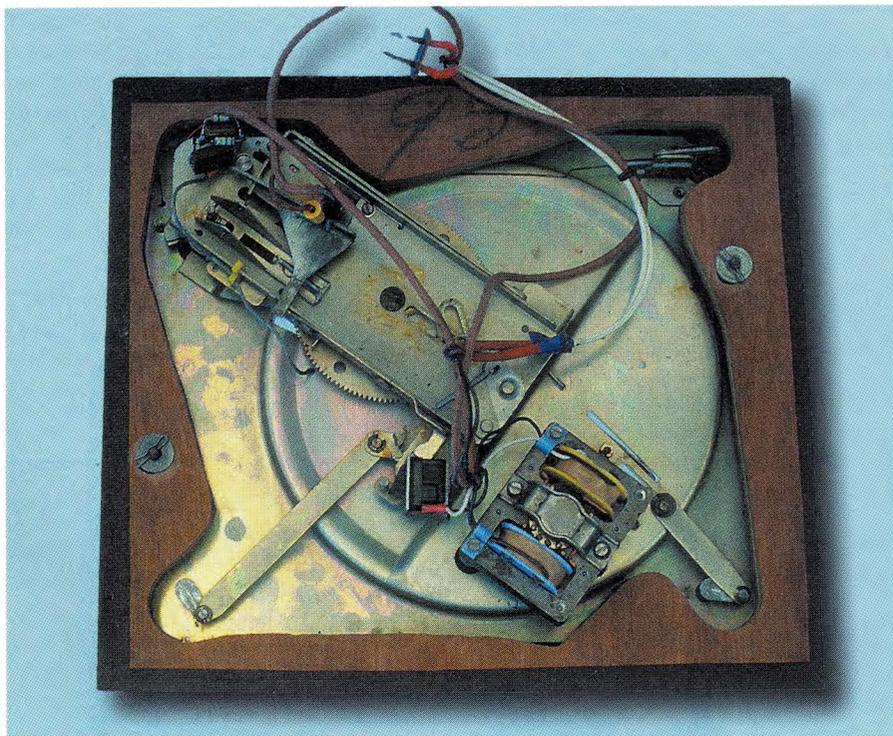
In this photo, the motor has been bolted back into position, following the replacement of its rubber mounts. A fair amount of time was spent cleaning the underside of the turntable and oiling the moving parts.

While the motor was out, the bearings were oiled. With some units, it's possible to oil them through a small hole in the side of the bearing case. The bearings are phosphor bronze and usually have a felt pad around them to contain the oil. I undid the screws holding the bearing in the motor and this gave sufficient access for oiling. There were covers over the bearing assembly but it was possible to flood the bearings and the felt pads through gaps in the assembly.

The idler pulley bearing was also oiled and the motor was then re-assembled and fitted back in place. The stepped pulley on the motor is used to set the turntable speed, via a stepping mechanism attached to the record speed control. This was greased and oiled after being cleaned. However, the idler pulley still wasn't sitting in the middle of each section of the pulley as selected by the speed control.

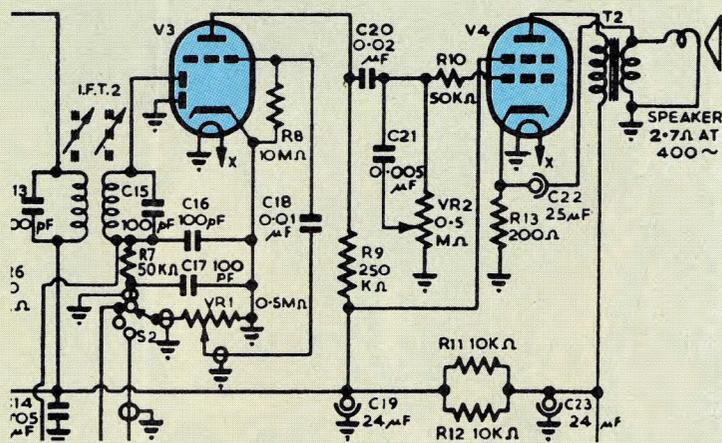
Fig.1: the HMV Nippergram uses voice-coil negative feedback in the audio output stage. An incorrect connection resulted in positive feedback and a howling noise from the loudspeaker.

What was causing the howling? This set, like many others, uses voice coil negative feedback. This is accomplished by connecting the cathode bypass electrolytic capacitor (C22) to the unearthed end of the voice coil, as shown in Fig.1.

The transformer that had been in the set and the nondescript replacement I used were not colour coded in the same way, so I had only a 50% chance of getting the feedback right. I got it wrong and so had positive instead of negative feedback, hence the howl.

Overcoming this problem was easy – just swap the two voice coil wires out of the transformer, so that the one that was earthed became the unearthed lead and vice-versa.

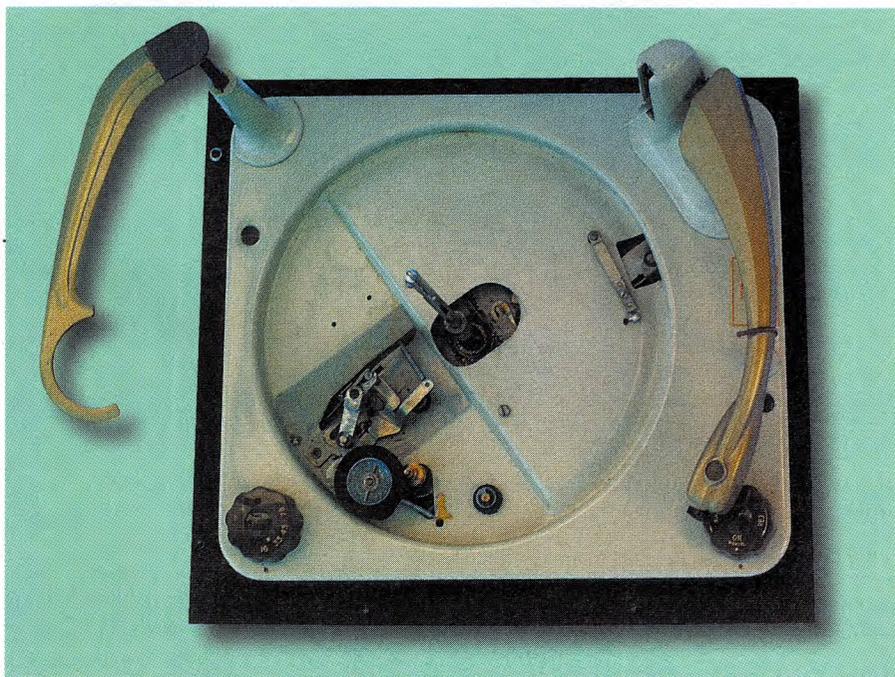
This view shows the top side of the changer with the turntable removed. A stepped pulley on the motor is used to set the turntable speed, via a stepping mechanism attached to the record speed control.

This problem was solved by undoing the grub screws on the motor shaft and shifting the pulley enough so that the idler contacted the middle of each section. The pulley and speed control system were now working well, or so I thought.

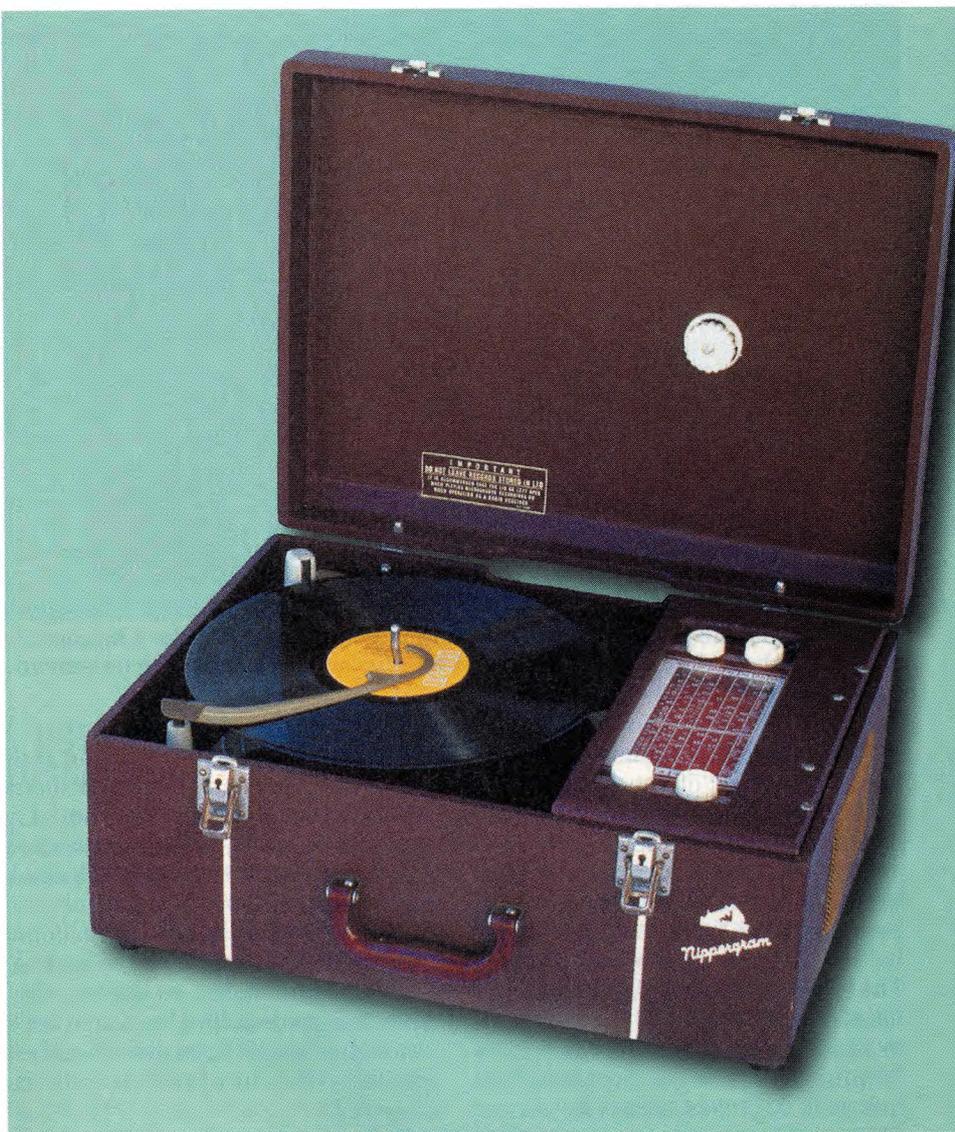
The HMV Nippergram, fully restored and ready to go. Note the position of the stabiliser arm now that the turntable has been installed correctly.

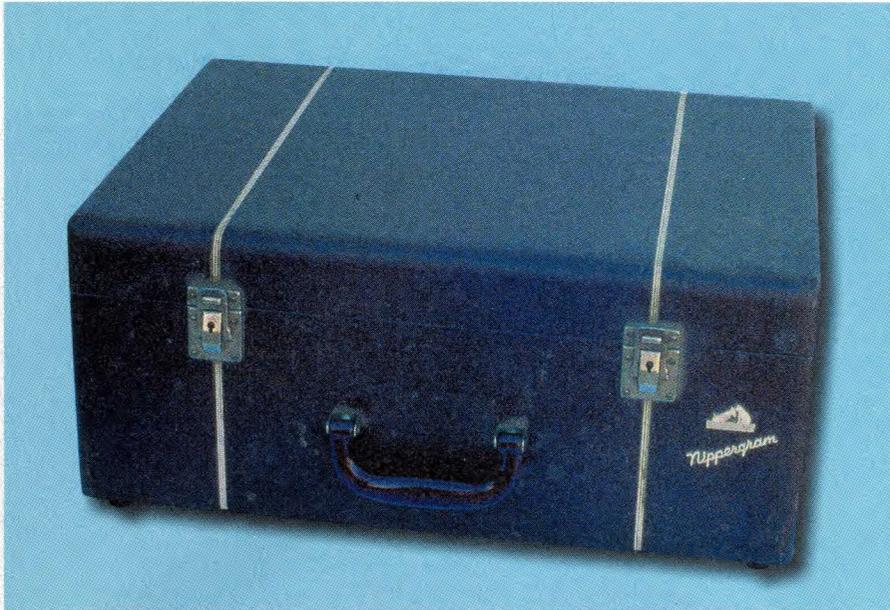
When it's all folded up, the HMV Nippergram looks very much like a luggage case. This photo shows the unit before it was given the vinyl restorer treatment, which made the case look like new again.

When it was dry, vinyl restorer was sprayed on and rubbed into the leatherette. This took the tired look away and the cabinet is now almost like new – if you ignore the marks that cannot be removed, such as burn and scuff marks.

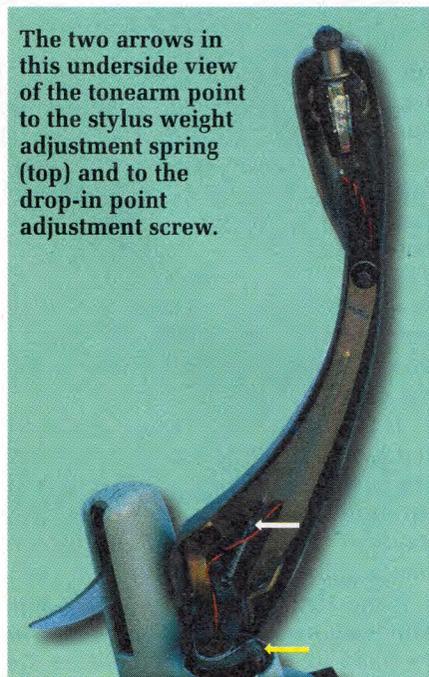
The two arrows in this underside view of the tonearm point to the stylus weight adjustment spring (top) and to the drop-in point adjustment screw.

Having got the mechanism working properly, it was time to adjust the drop-in position of the pickup stylus onto the run-in groove on the discs. This is done by adjusting a screw under the tonearm, as indicated by the white pointer in the photograph. The stylus weight should be around 3-4 grams. This is hard to measure but a good approximation is achieved by adjusting the position of the spring in the holes, this time indicated by a yellow pointer.

It should be adjusted so that the pressure is the lowest that will allow the stylus to track properly and not skip on the run out groove.
