VINTAGE RADIO

By RODNEY CHAMPNESS, VK3UG

Elegance from the 1920s : the 1929 AWA C58 Radiogram

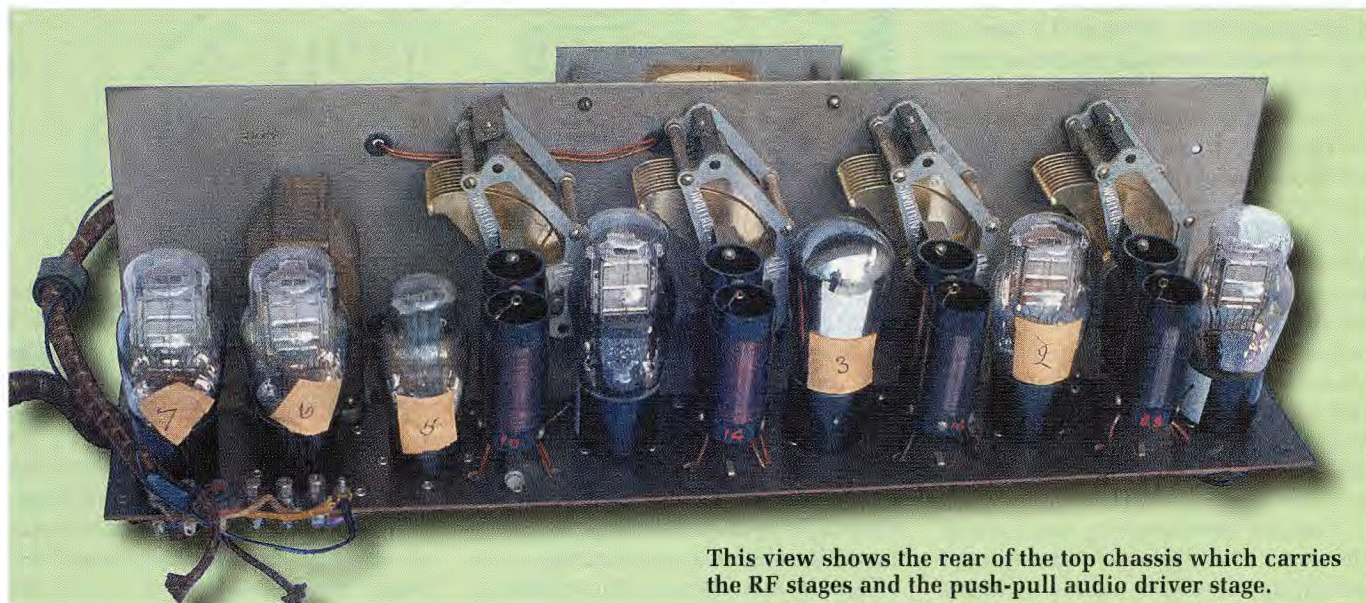
This view shows the rear of the top chassis which carries the RF stages and the push-pull audio driver stage.

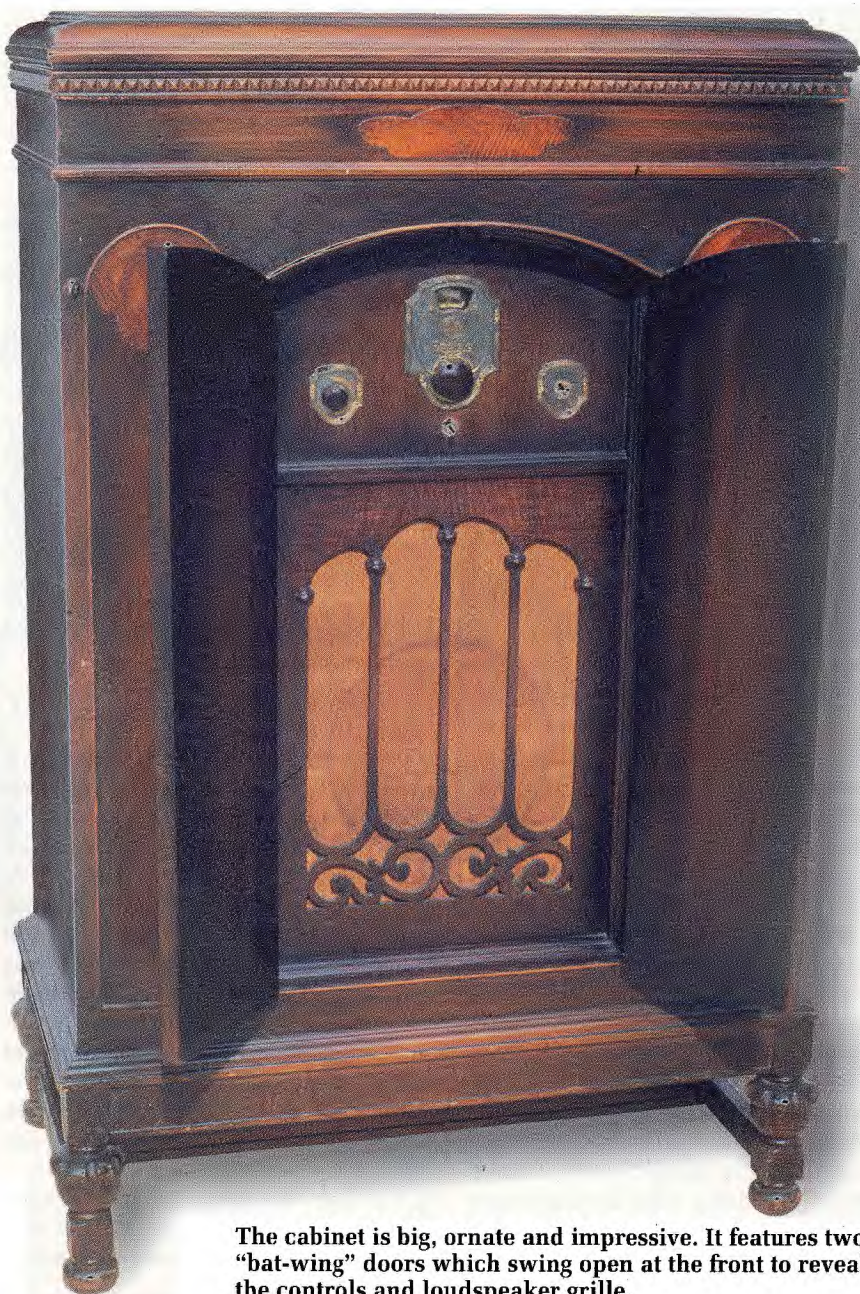
The cabinet is big, ornate and impressive. It features two "bat-wing" doors which swing open at the front to reveal the controls and loudspeaker grille.

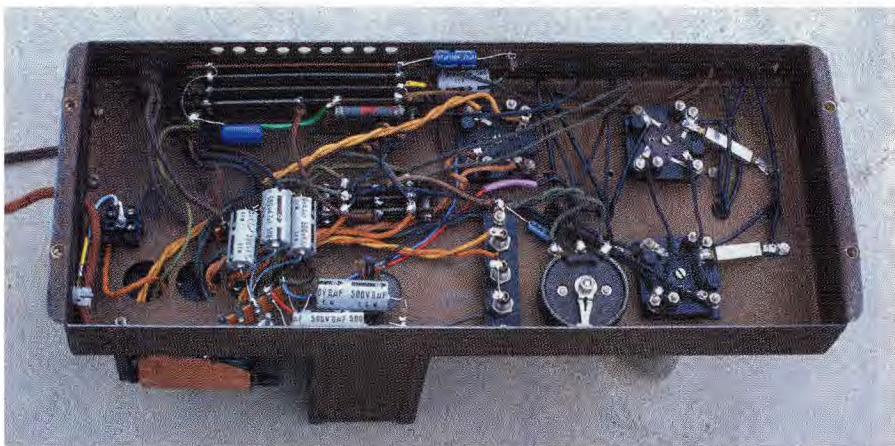
The electrolytic capacitors in the power supply and audio output chassis were all replaced with modern equivalents.

box was full of paper block capacitors, all of which were faulty (the second box was full of filter chokes). As a result, these capacitors were all replaced with polyester or electrolytic capacitors as appropriate.

Finding exact replacements is not easy these days, so the new capacitors all have greater capacitance than the originals (the voltage ratings are the same). The set's owner wanted the set to look as original as possible, without going to extremes to make everything absolutely authentic under the chassis. Once the faulty capacitors were bypassed (they are still there in the can), the HT voltage remained constant at nearly 500V with no load.

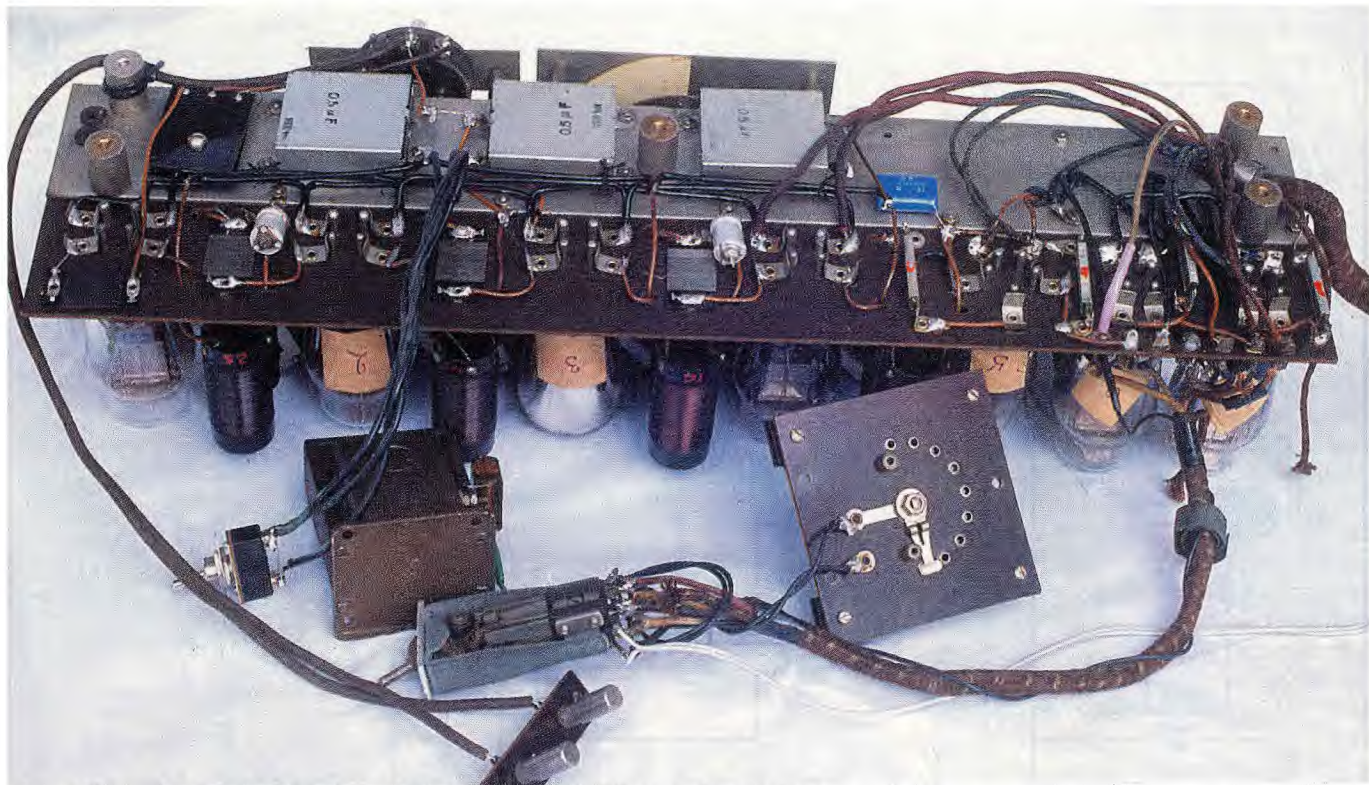
The valve sockets and RF coils in the RF, detector and first audio stages are mounted on a phenolic sheet attached to the rear of the metal chassis. The metal (front) part of the chassis carries the tuning capacitors and an audio transformer.

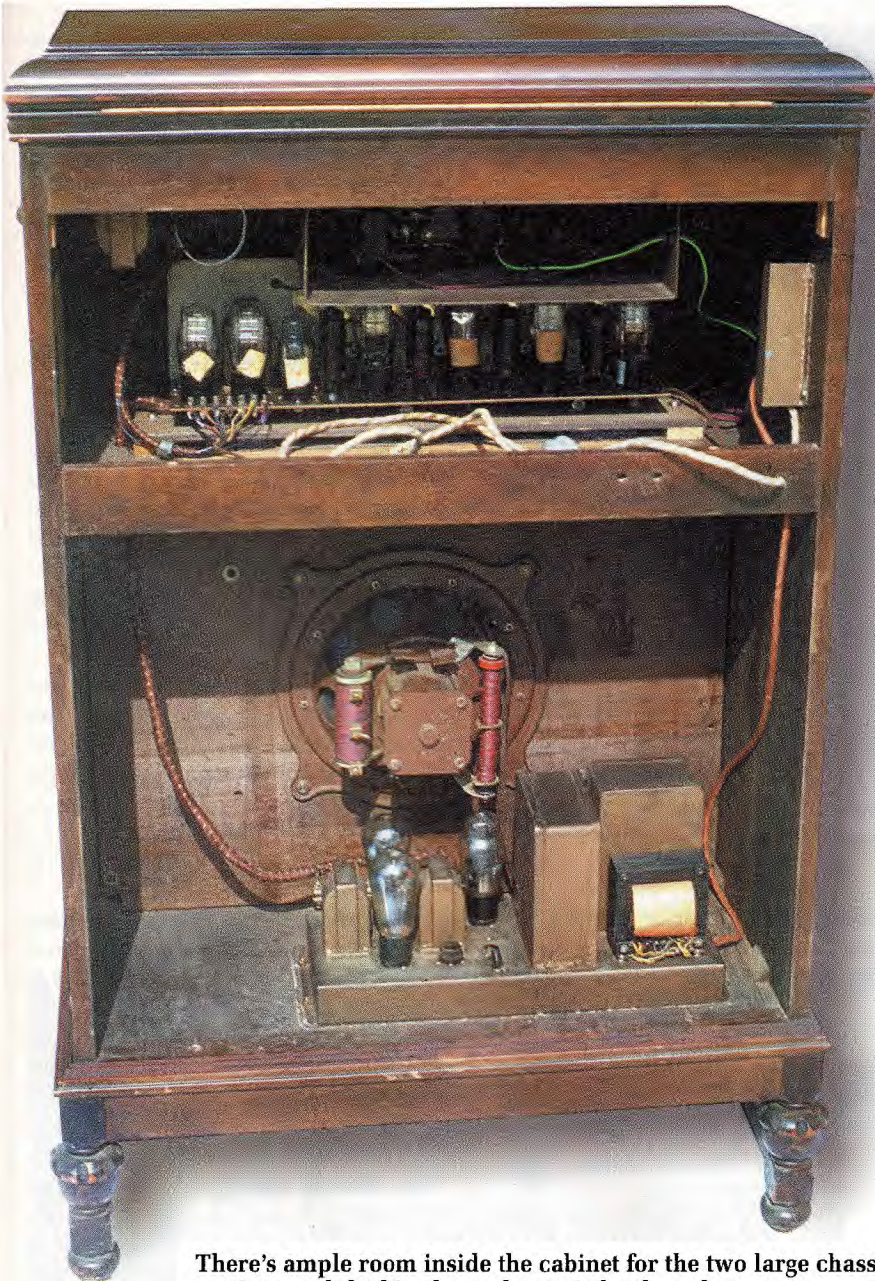
There's ample room inside the cabinet for the two large chassis sections and the big electrodynamic loudspeaker.

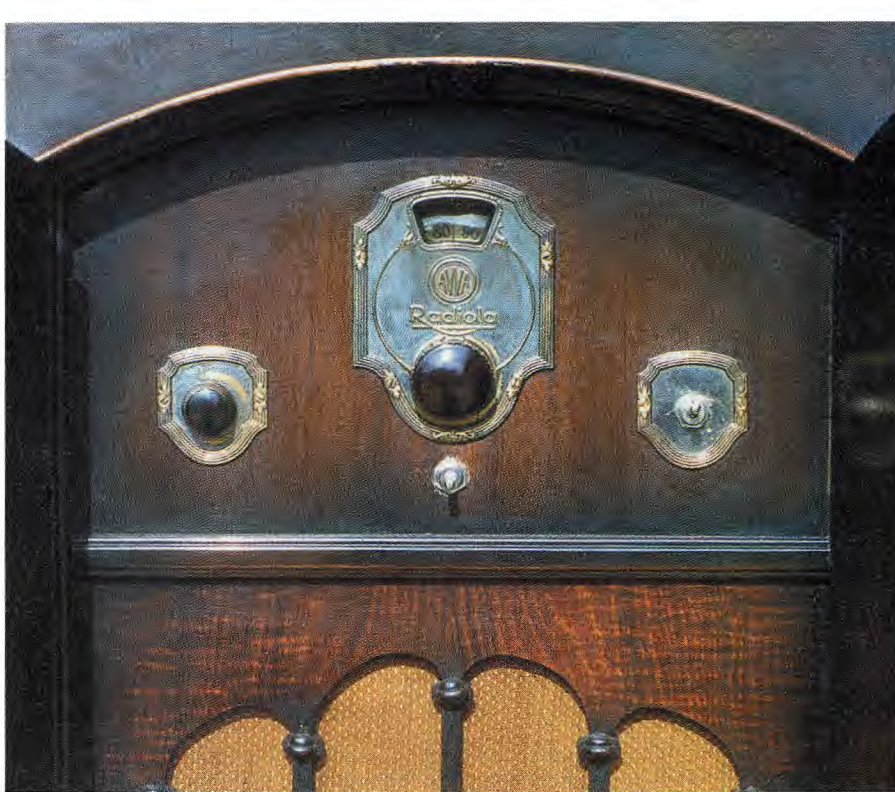
The controls are relatively simple and include a volume control (left), a central tuning knob and a power switch (right). The local/DX switch below the tuning knob is probably not an original feature.

As shown in the circuit, the first RF stage is untuned but all the others are tuned. A switch between the second and third stages bypasses the primary of one RF coil to lower the gain in high signal strength areas. This switch is mounted beneath the tuning knob and has no escutcheon which makes me suspect that this was an addition sometime during the life of the set.

The tracking is reasonably good and no double-spotting or odd tuning characteristics were observed. The volume control works quite well and the local/distance switch is quite effective. However, the latter appears to be unnecessary as no sign of overload was evident and there are a couple of reasonably powerful broadcast stations within 20km. As mentioned earlier, I suspect that it was an add-on.
