# VINTAGE RADIO

## The miniature STC A-141 mantle radio

**Miniature is a relative term – what was classed as a miniature valve radio in the late 1940s is considered huge today. The set described here is a basic receiver, designed to fit as much as possible into a small cabinet. The parts are crammed together and there is very little space above the heat-producing valves for ventilation.**

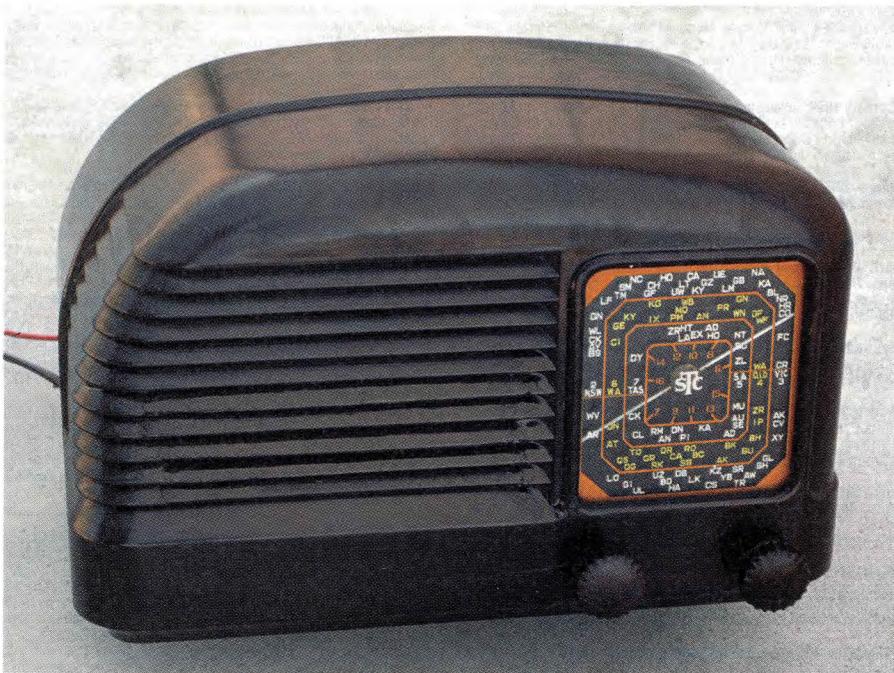
The STC A-141 came in a very compact case and was regarded as a miniature set in its time.

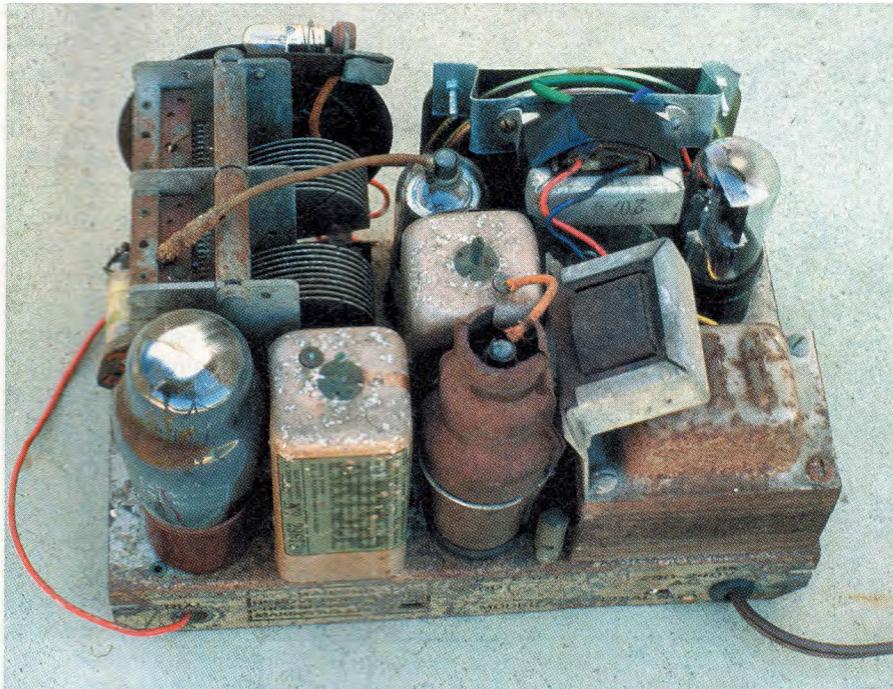
The parts on the top of the A-141's chassis are very tightly packed together, although access is reasonable.

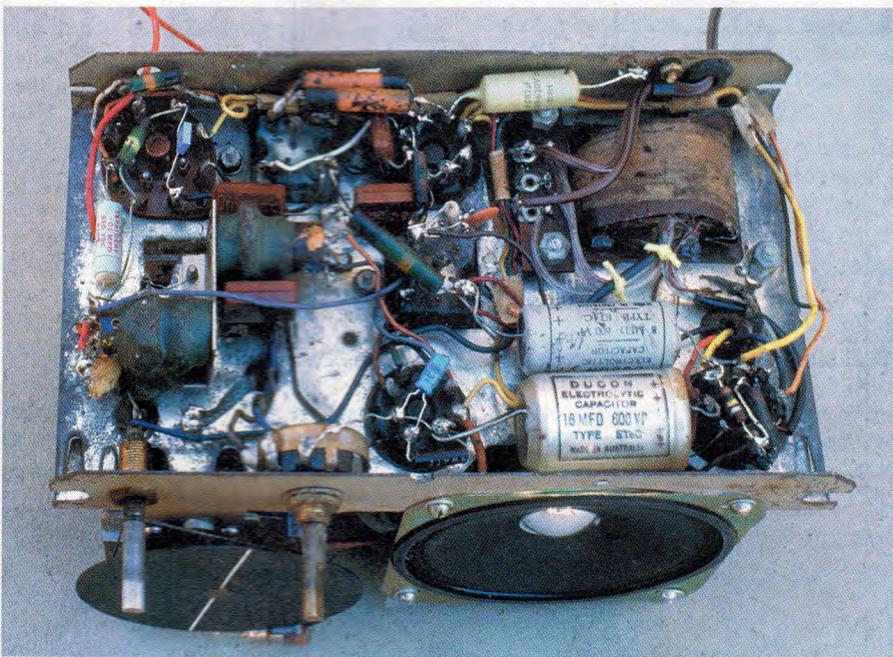
The under-chassis view of the STC A-141. Note that the dial scale stays inside the cabinet.

The aerial and oscillator circuits are a bit more complex. As I mentioned earlier, the dial scale stays in the cabinet so the dial pointer has no real reference point. Firstly, slide the chassis into the cabinet and make sure that the pointer coincides with the one of the end of scale markings when the gang is closed or fully open. At the low end of the dial, tune to a station that you know well around 600kHz. It might not coincide with the markings on the dial.

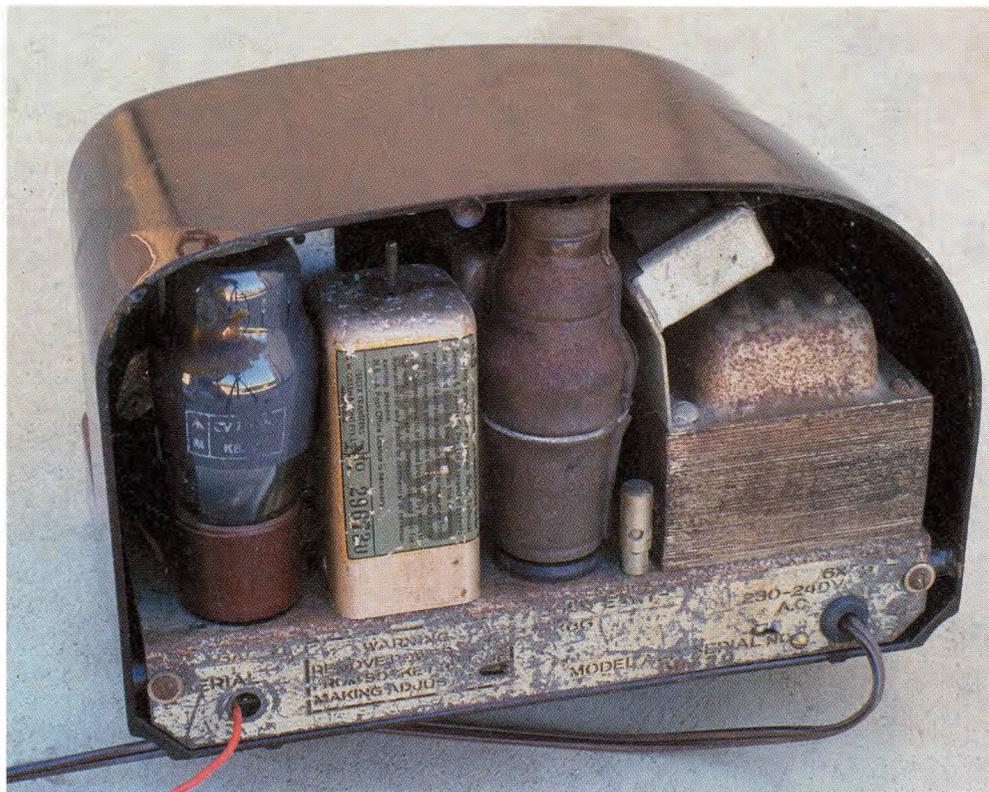
**The rear view of the A-141. Restoring the chassis to pristine as-new condition would be a lot of work and then would raise questions about its authenticity. In this condition, you know it's the genuine article.**

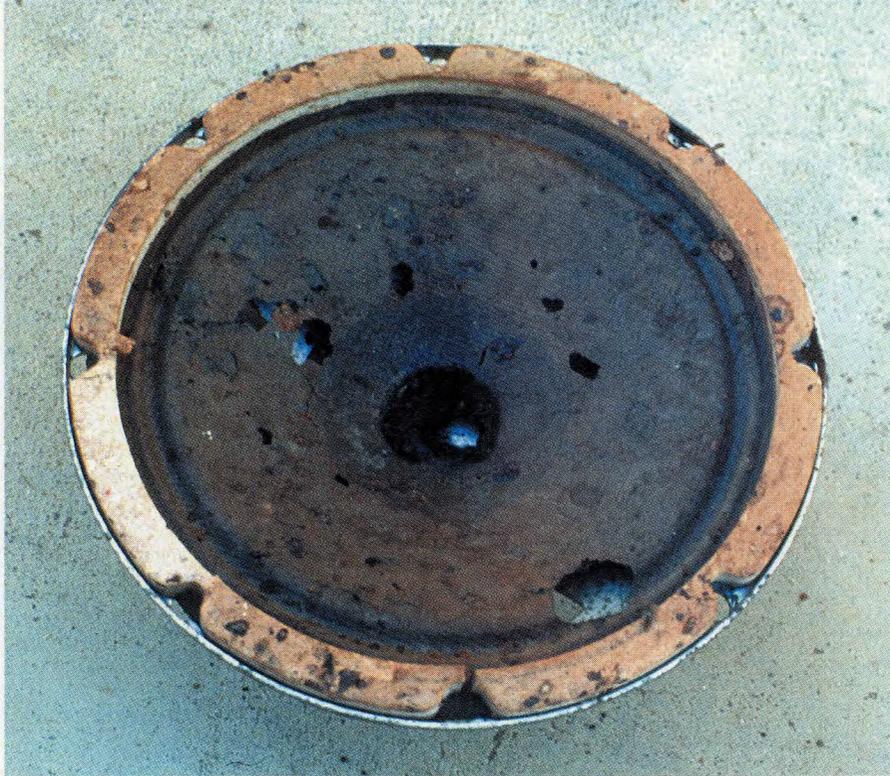
The speaker was a sorry mess, as can be seen in one of the photographs. It had been eaten by moths and it didn't sound the best either. An exact replacement was not available, so a slightly smaller speaker of the same impedance was fitted. The original speaker had a bracket for the speaker transformer and I had to make one so that the transformer could fit into the same place as the original. There was

The loudspeaker cone was badly motheaten which meant that the speaker had to be replaced.

no room to fit it anywhere else, plus it was necessary to keep it as far away from the power transformer as possible. Even then, the speaker transformer had to be orientated so that minimal hum was induced into it.
