# VINTAGE RADIO

## Philips Philetta & the Titan Tiny

**This month, we publish a few more details on the intriguing Philips Philetta and take a close look at the Titan Tiny. The latter is a compact, hot-chassis set and is a real death-trap for the unwary.**

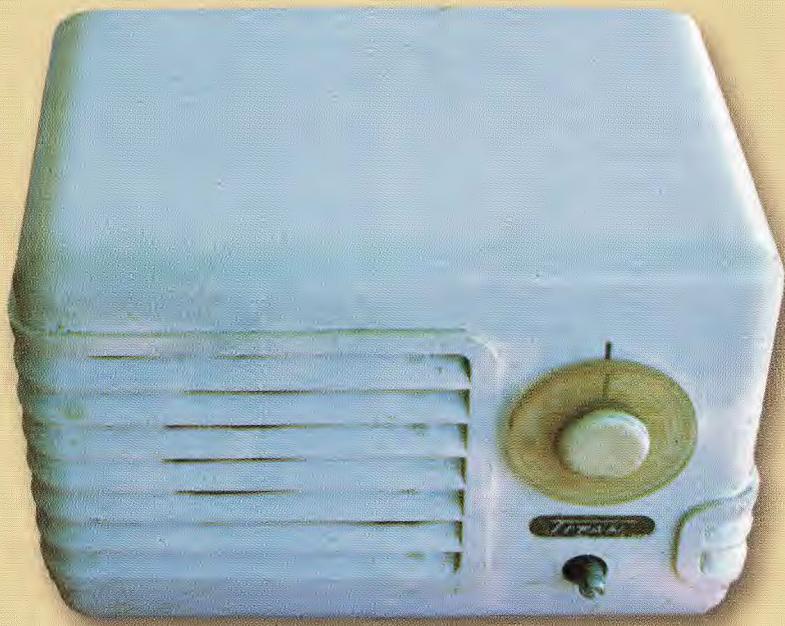
**The Titan Tiny was a basic compact 4-valve receiver designed for the bottom end of the market. It was housed in a white bakelite cabinet and has just two controls: a handspan tuning knob and a combined on-off/volume control.**

I was visiting Brian Lackie at Urunga on the north coast of NSW some time back and he showed me an intriguing little set called the Titan “Tiny” – and “tiny” it is. This set has yet to be restored, as can be seen from the various photographs. The front view shows a very plain small white Bakelite cabinet, with what appears to be a direct drive tuning control and an on/off switch/volume control (with its

knob missing) underneath. The tuning control is quite small, so tuning the set with its “hand span” type dial is a little tricky.

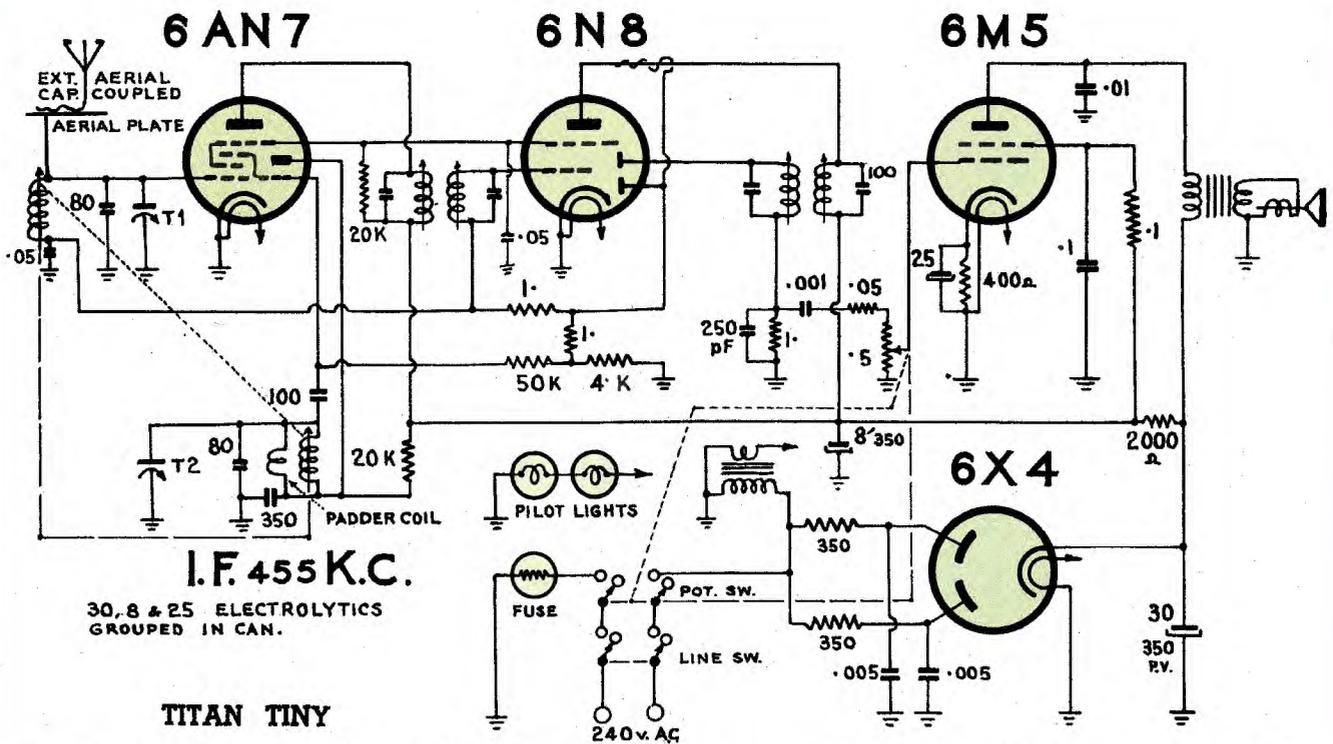
Fig.1: the Titan Tiny is a 4-valve superhet design with inductance tuning. This is a “hot-chassis” set with one side of the mains directly connected to chassis (via a fuse) and the other side connected to chassis via a transformer winding. Hot-chassis sets are real deathtraps, since the metal chassis (and anything connected to it) can operate at 240VAC.

Fig.1 shows the circuit details of the Titan Tiny. It’s a conventional

superhet which uses a 6AN7 converter, a 6N8 IF amplifier and detector, and a 6M5 audio stage. The HT is rectified by the ubiquitous 6X4.

Most vintage radio restorers have become used to padders being either fixed or adjustable capacitors of around 400-450pF. There is no such thing in this set. If you believe the circuit notations implicitly, it has a padder coil across the oscillator coil. So how does this work?

The inductance of the oscillator coil is less than the aerial coil in most domestic receivers. In this set, however, it appears that the oscillator and aerial coils are the same – both electrically and physically. By paralleling another inductance, the effective inductance of the oscillator coil is reduced to a value equivalent to what other sets use in this position. It also includes a conventional 350pF padder capacitor as well.

The aerial coil has a capacitor to couple it to the aerial proper. This is a low value “gimmick” capacitor, which ensures that the aerial does not load the aerial tuned circuit to any degree.

This receiver also includes bias and delayed AGC for the 6AN7 and 6N8 valves. This bias (about 0.8V) and de-

laid AGC is provided by a voltage divider consisting of 50k $\Omega$  and 4k $\Omega$  resistors from the oscillator's grid.

The audio output stage is a little strange in that the screen of the 6M5 appears to be operating almost in a starvation mode. Most receivers have the screen coming directly off the HT line at the junction of the 2k $\Omega$  resistor and the HT supply to the receiver RF stages.

Yes, it does have a transformer in it but it is still hot-chassis. In this set, the transformer only supplies the valve filaments and dial lamps. The HT is achieved by wiring the 6X4 as a half-wave rectifier, with one side of the mains connected to the plates via two 350 $\Omega$  resistors (these limit the peak rectifier current through the 6X4). In

addition, a .005 $\mu$ F capacitor (mains rated) is fitted to each plate to suppress interference on the mains.

The Neutral (hopefully) side of the mains goes to the chassis via a fuse, which is actually another dial lamp.

But here's the rub – this set is still dangerous even if it's the Neutral that's connected to the chassis via the fuse. As shown on the circuit, the Active is connected to the chassis via the power transformer's primary. This means that if the fuse blows, the chassis will be at nearly 240V!

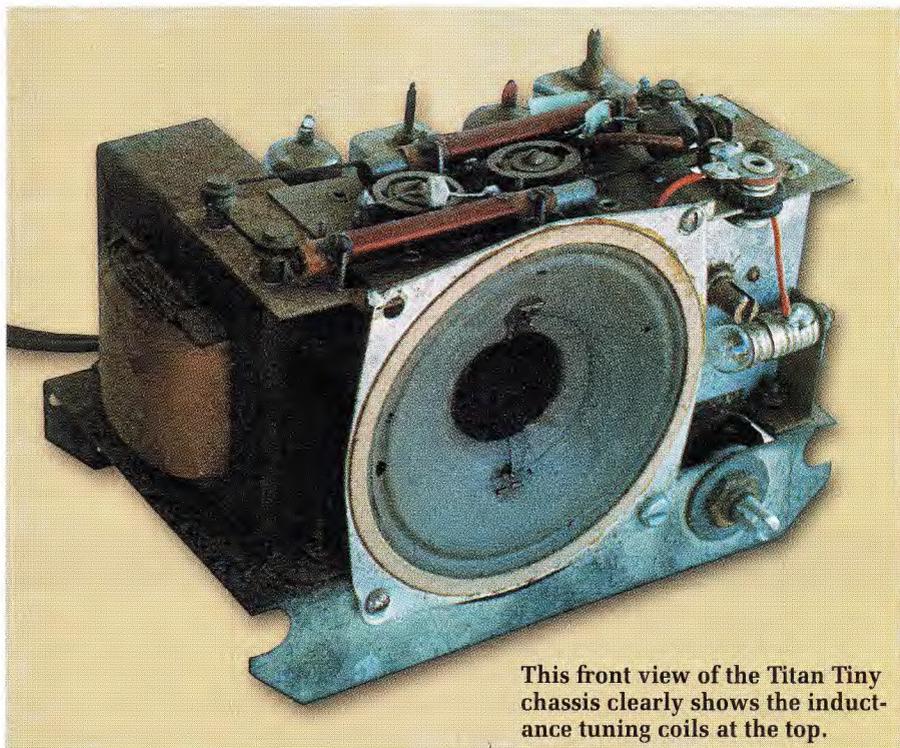
What intrigued me was the size of the set and this can be gauged by comparing the chassis size with a ball-point pen (see photo). However, despite its small size and the number of components used, the chassis isn’t too crowded and this makes it relatively easy to service.

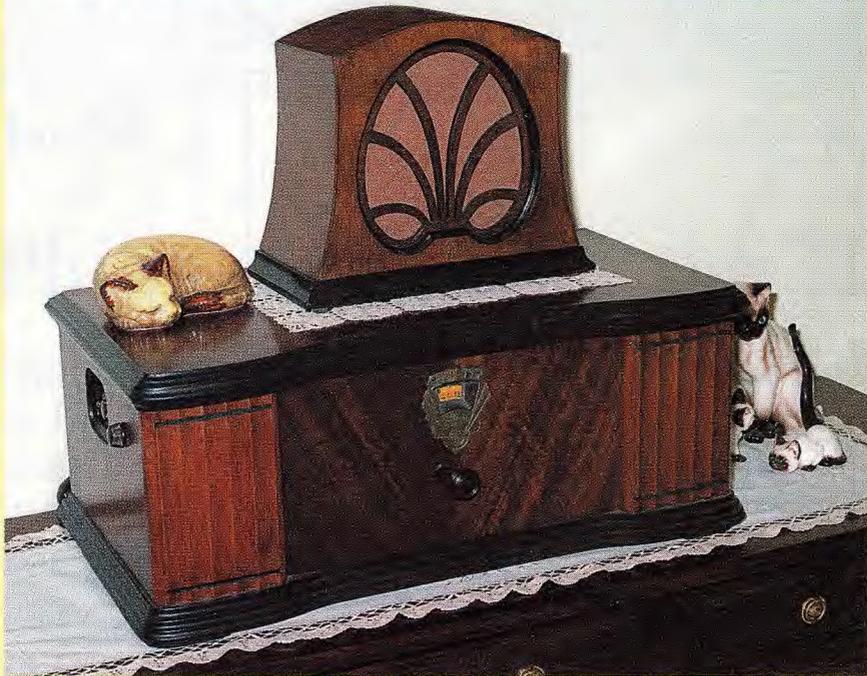
## Photo Gallery: AWA Radiola 80 TRF Receiver

Manufactured by AWA in Sydney in 1930, the Radiola 80 featured a “coffin top” style cabinet and a matching loudspeaker in a separate cabinet. This set is a 6-valve TRF receiver and employed the following valve line-up: 3 x type 22 (1st RF amplifier, 2nd RF amplifier & detector), 2 x L410 (1st and 2nd audio) and P410 (audio output). (Photo and information courtesy Historical Radio Society of Australia).

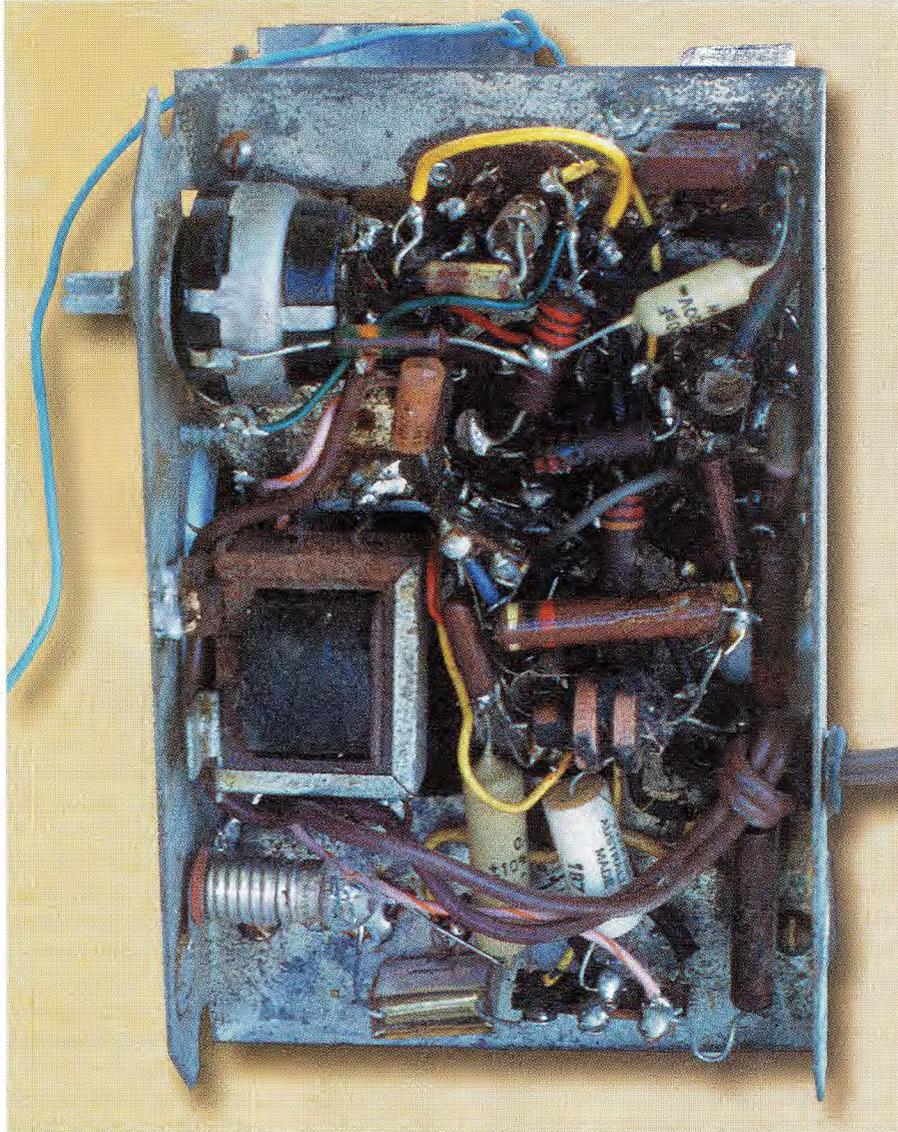
The parts were all tightly packed in, as this under-chassis view reveals. The lamp in the bottom lefthand corner served as the mains fuse – crude and potentially lethal for the inexperienced serviceman!

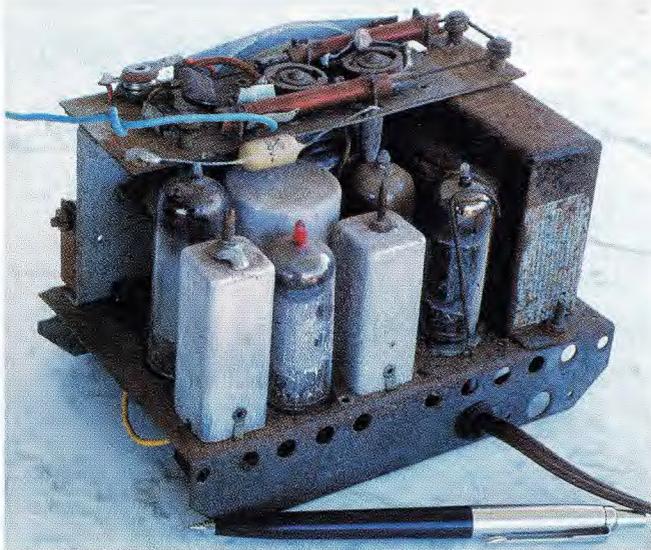
This rear view shows how the major parts fit into the space. The dial-cord is connected to tuning slugs which slide backwards and forwards inside the tuning coils.

The rear view of the set reveals a tightly-packed chassis. However, there is sufficient room to remove and replace the valves if necessary. The rear view also shows that the cabinet has a series of “slits” (near the power transformer) – these ensure that there is enough airflow to keep the temperature inside the set at a reasonable level.

Behind the tuning knob, the dial cord is attached to a shaft in much the same way as in many Astor sets. One end then comes up to the top of the set and does a right angle turn around a dial cord pulley so that it runs parallel to a horizontal metal plate. As it progresses across the plate, an iron-dust core is attached to it at a strategic point and this is then threaded through one of the coils. The cord then contin-

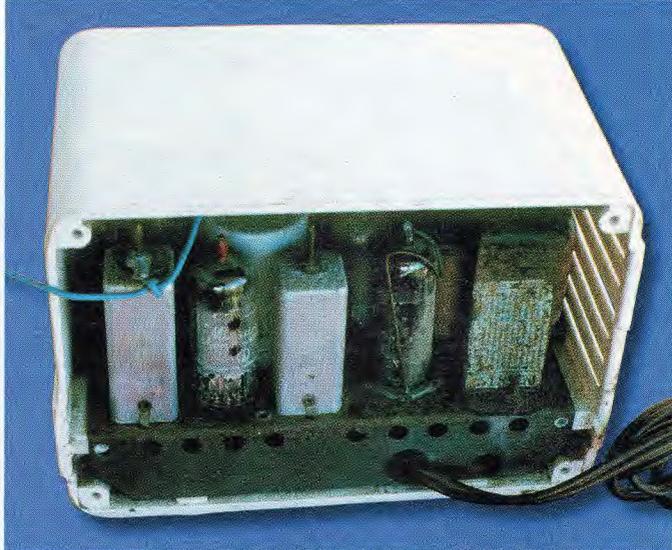
A vital part is missing from this Titan Tiny and that's the back. During operation, the chassis could be at 240V AC and that make it potentially lethal.

Also shown are the four mounting screw-holes (one in each corner) that are used to secure the back of the set. This particular set is missing its back cover and that’s an extremely serious safety issue, as will be explained later.

We now return to the missing back on this set. Without a back, this set would be lethal if it's the mains Active (and not the Neutral) that's connected directly via the fuse to the chassis. In other words, the chassis and much of the circuitry – including the dial lamps – would all be at 240VAC!

I don't know what sort of back was originally attached to this set but I suspect that it was probably a thick cardboard type with perforations for ventilation. The circuit shows a line switch but Brian's set has no such line switch. Perhaps it was removed at

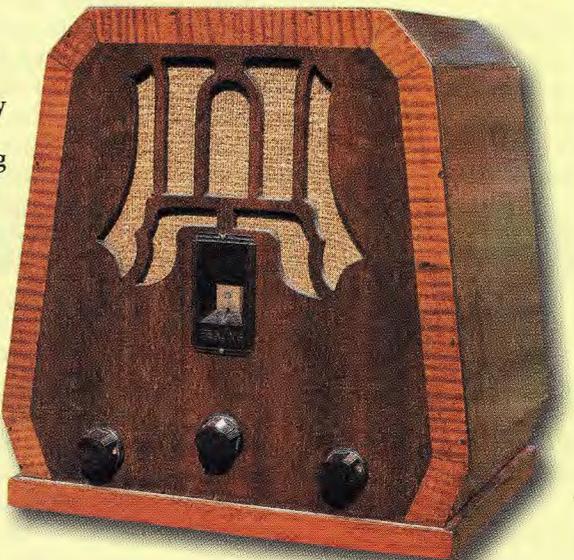
**Photo Gallery: Healing Model 24 TRF Receiver**

The Healing Model 24 is a small wooden 3-valve receiver manufactured by A. G. Healing in 1934. The set uses the following valves: 57 detector, 2A5 output and 80 rectifier. (Photo and information courtesy of Historical Radio Society of Australia).
