# VINTAGE RADIO

## The AWA 719C Console; Pt.1

During the 1940s, AWA produced some very impressive sets and some of the best were the 7-band radio receivers. The first models were produced in the early 40s but arguably the best were produced after World War II.

An overview of the various 7-band models was given in the May 2001 issue. In this article, we'll take a close look at one of the magnificent console models, the 719C, and the work involved in restoring it to its former glory.

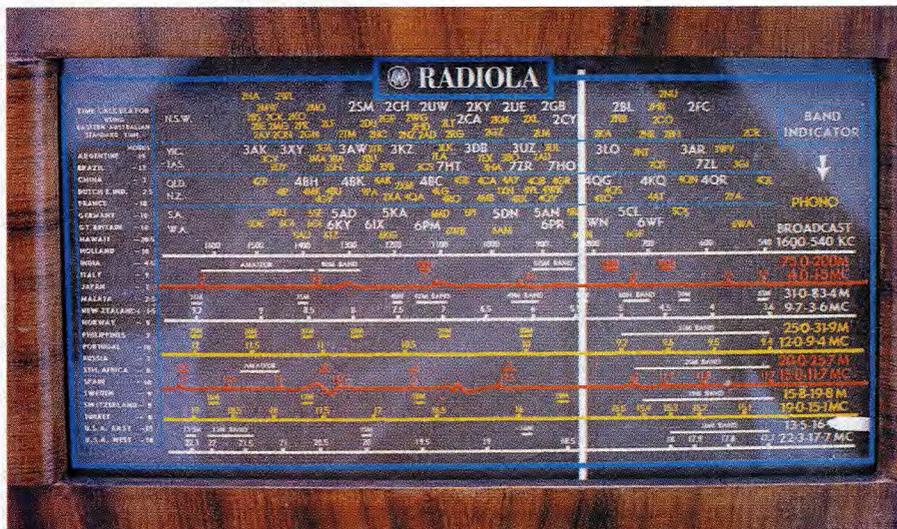
The dial-scale cleaned up like new although there is some damage to some of the markings for the shortwave bands.

Next, the dial-scale was carefully washed and the dial-pointer repainted white. Before washing the dial-scale though, I tried washing a small section of the print in an inconspicuous spot, to make sure it wouldn't come off. In this case, the print remained in place – unlike some I've tested where the dial markings are starting to fall off without even touching them.

Unfortunately, the dial-scale on this set does have some damage on the shortwave bands, as is evident from the photograph. This damage was present before any work was done on the dial and is not due to cleaning.

Apart from this, the dial-scale came up like new. The same goes for the valves, which were also removed and cleaned with soapy water. When cleaning octal valves like this, the trick is to keep them upside down – that way, the glass envelope can be cleaned without water getting into the base.

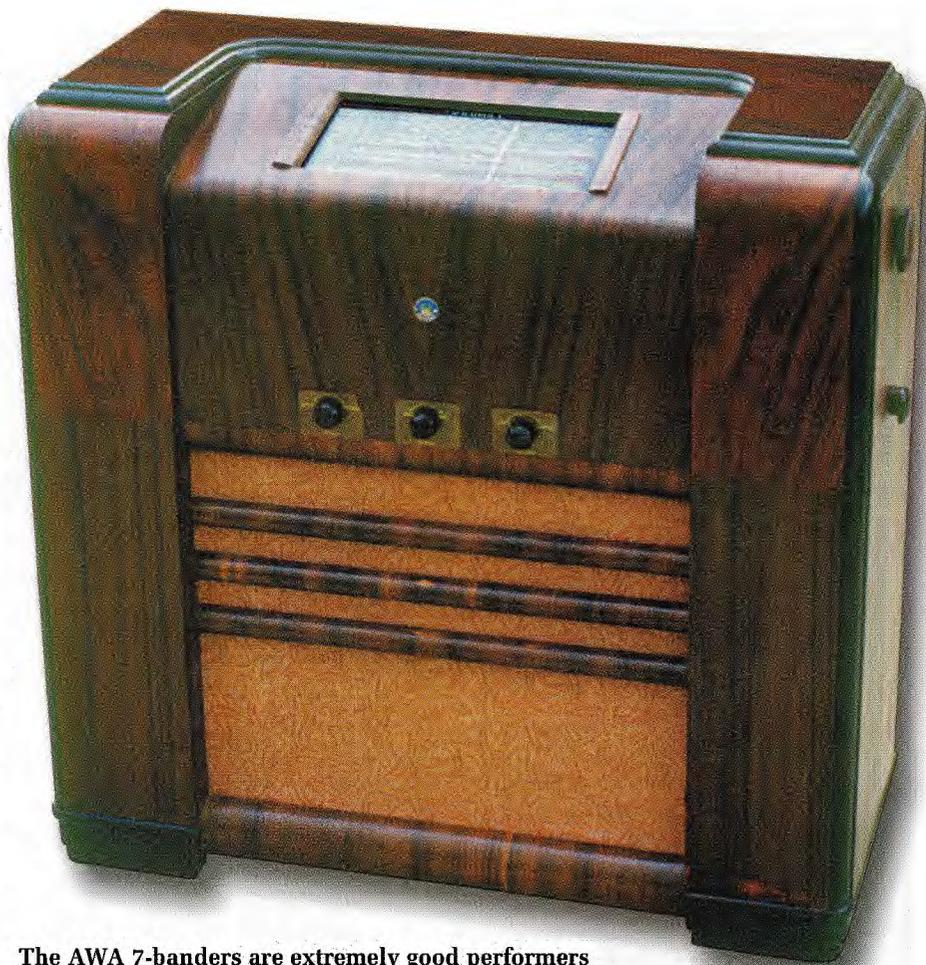
**The AWA 7-banders are extremely good performers and have an impressive cabinet. In this case, the cabinet came up looking like new.**

While I'd been solving the circuit problems, Laurie Tilley had been restoring the cabinet as near as practical to its original condition. It looks good, as the photograph shows, and the owners are happy with the their family heirloom.

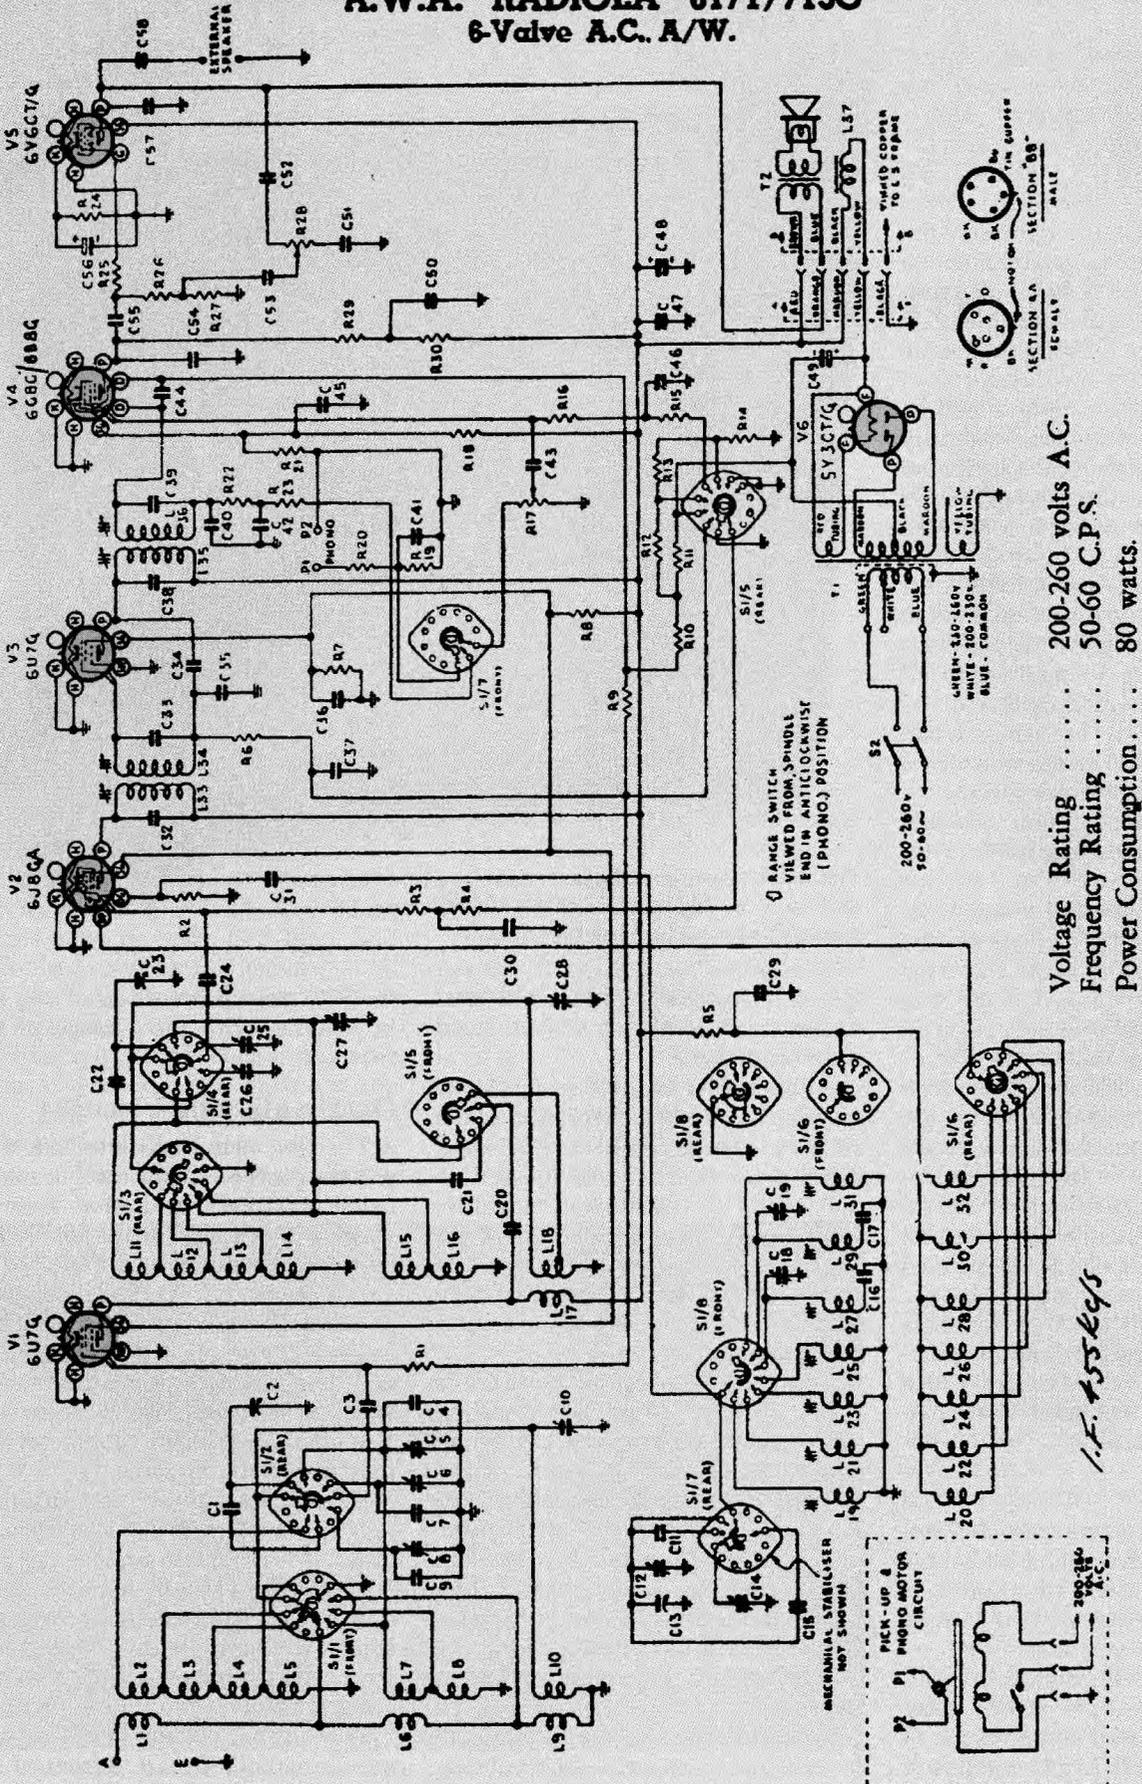
# A.W.A. RADIOLA 617T/719C 6-Valve A.C. A/W.

Fig.2: the set employs a 6-valve superheterodyne circuit with a multi-pole rotary switch for the band switching. Alignment is a complicated procedure but is necessary for top performance.

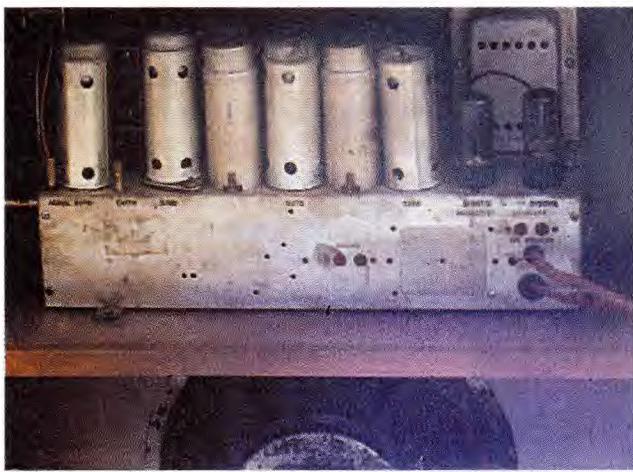
**There's plenty of room in the back of the cabinet for the chassis. The loudspeaker fits in the cabinet immediately beneath the chassis shelf and is just visible at the bottom of the picture.**

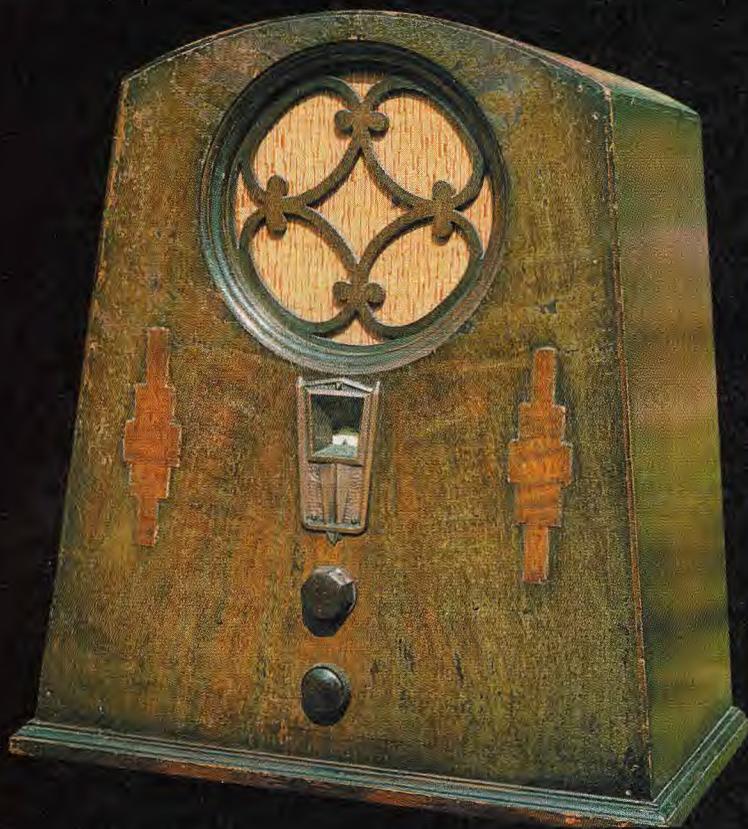
## Photo Gallery: Tasma Model 22

The Tasma Model 22, manufactured by Thom & Smith, Sydney, in 1931 is a 3-valve TRF receiver. It used the following valves: 224 detector, 247 output and 280 rectifier. (Photo and information courtesy of Historical Radio Society of Australia).

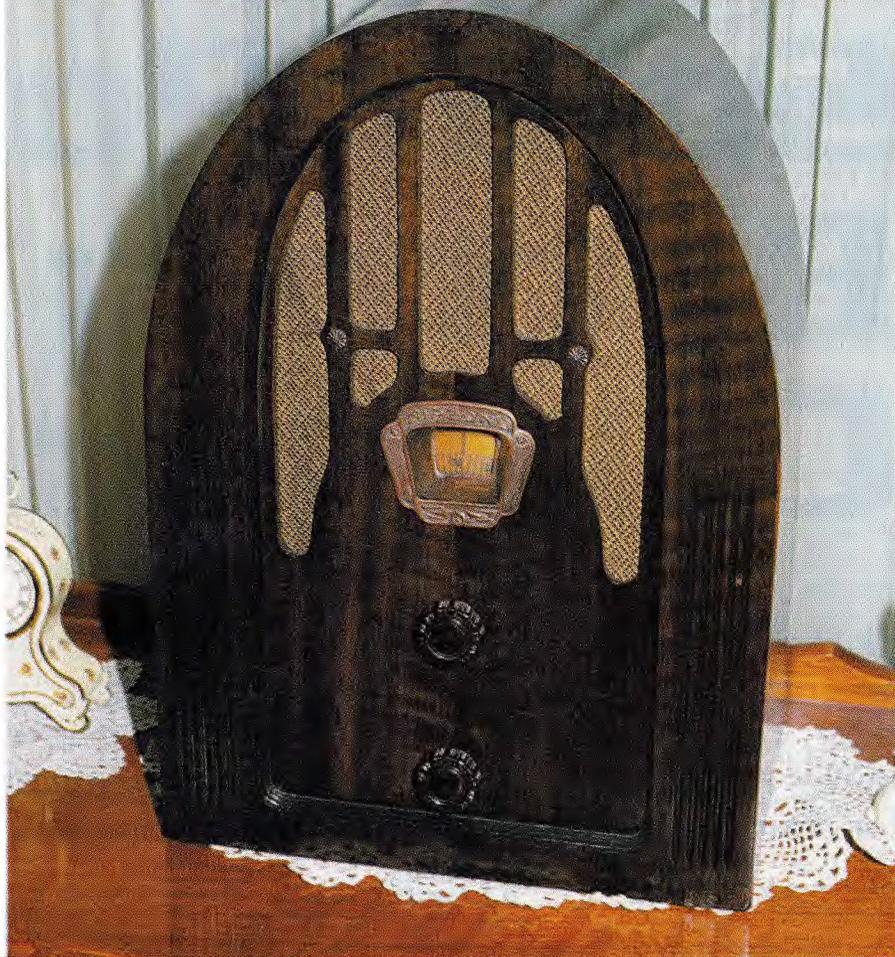
## Photo Gallery: Airzone Model 300

Manufactured by Airzone, Sydney, in 1934, the Model 300 is a typical Australian “cathedral” style set. It is a 4-valve superheterodyne set with the following valve types: 57 autodyne mixer, 50 amplifier, 59 anode bend detector/output and 80 rectifier. (Photo and information courtesy of Historical Radio Society of Australia).
