VINTAGE RADIO

The 1935 Tasma M290 Console

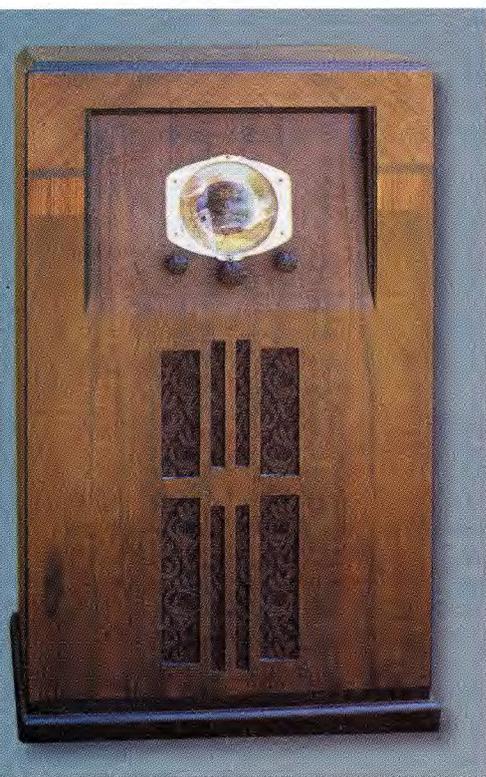
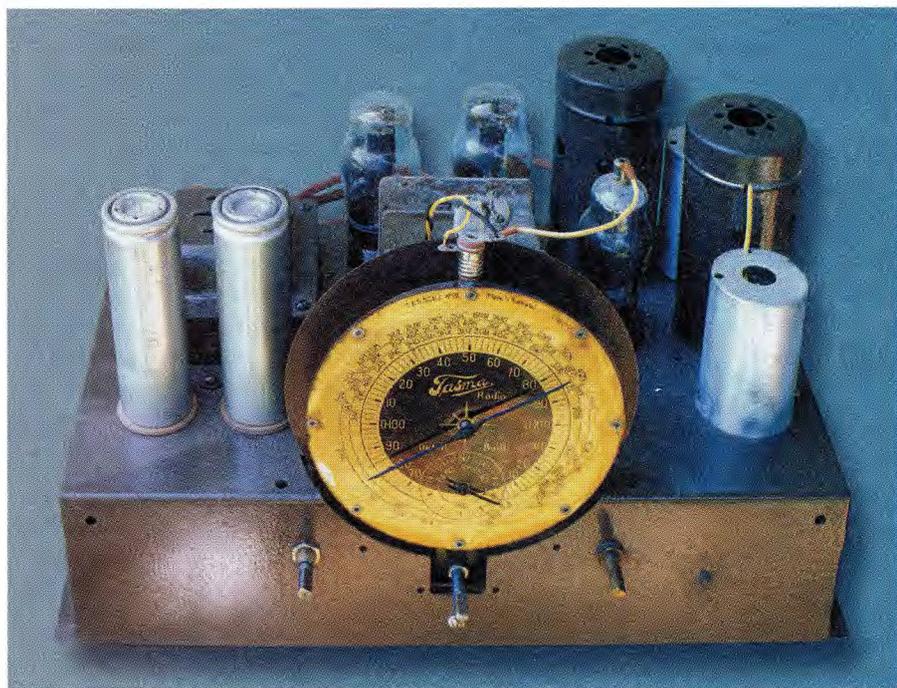
The Tasma M290 console has a rather boxy cabinet but quite an ornate dial. As shown above, this dial is attached to the chassis, making service and alignment that much easier.

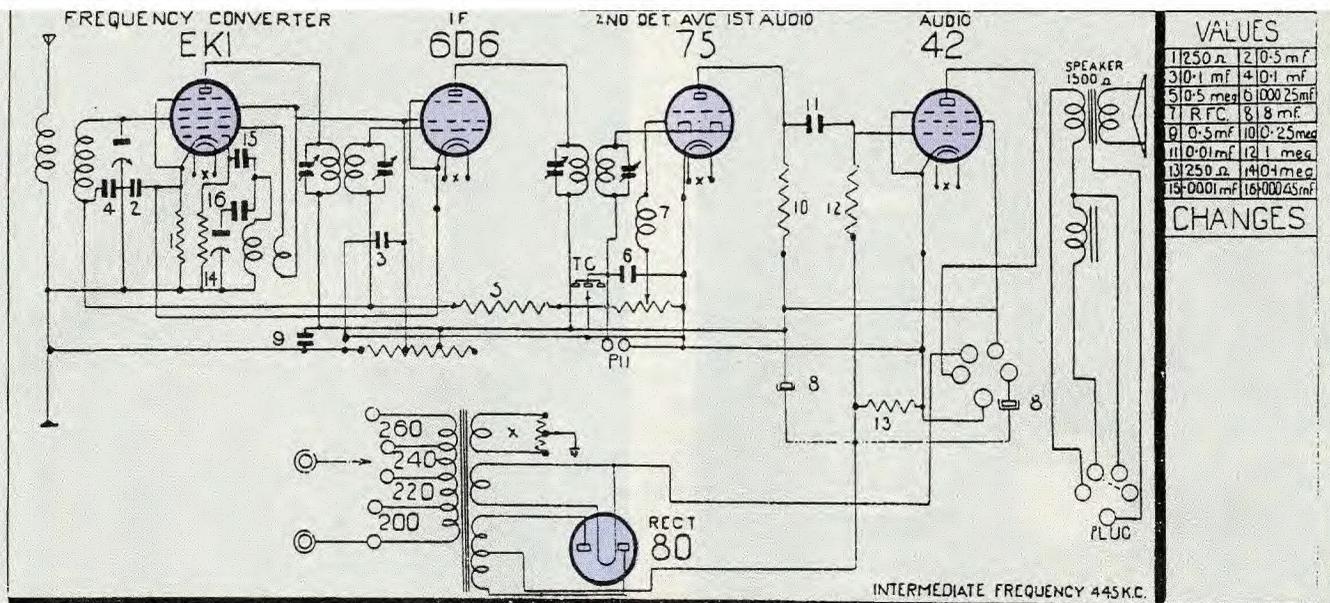
Tasma SUPERHETERODYNE M290
ALL ELECTRIC 4 VALVES & RECTIFIER

Fig.1: the circuit of four valves and a rectifier was typical for a 1930s radio receiver. Note that this circuit has a number of errors which are referred to in the text.

Close inspection of the circuit diagram reveals some errors, as the 75 would be destroyed if they were correct. "TC" is the tone control, shown with one capacitor on a 3-position switch. However, inspection of the set reveals that the it switches various capacitors and the moving arm (wiper) goes to earth. In the circuit as drawn, high tension (HT) is applied to the

detector/AGC diode which would destroy the valve and maybe also the IF transformer.

It seems that a DC blocking capacitor and a resistor are missing from this part of the circuit. The use of an RF choke (7) to filter out any remaining IF energy on the signal to the audio amplifier is uncommon. If it has an inductance of around 2.5 millihenry (a common value) the reactance (RF resistance at 445kHz) would be around 9k Ω . Most manufacturers found it was more effective and cheaper to use a resistor of around 50k Ω to act as an intermediate frequency filter element.

The speaker is shown as 1500 Ω . Perhaps the field coil is 1500 Ω as the 42 requires a plate load impedance of around 7k Ω .

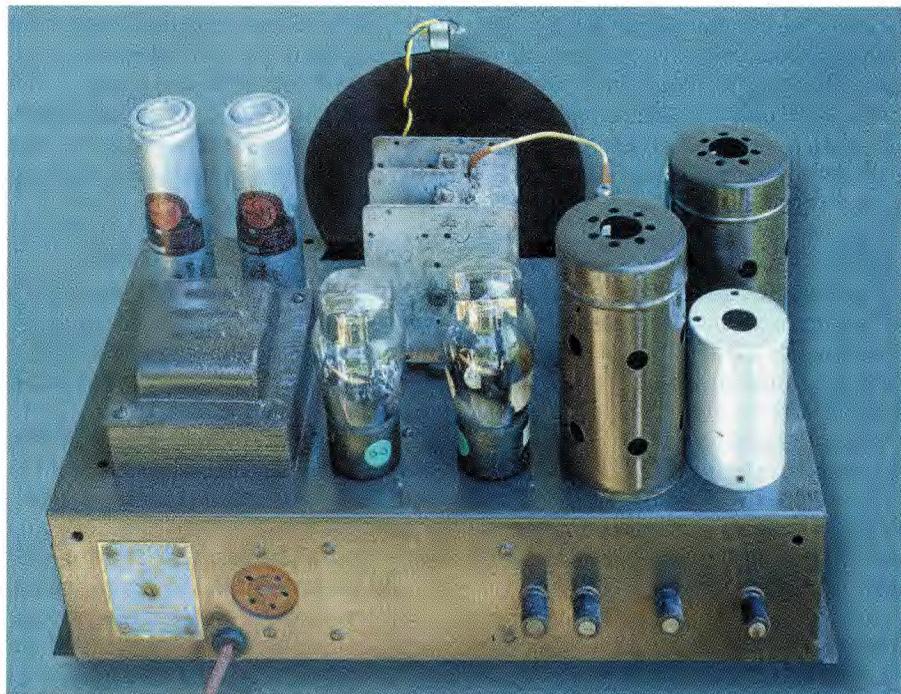
This rear view of the chassis shows a conventional layout. The chassis-mount electrolytics are now dummies, having been replaced by modern capacitors under the chassis.

Inspection of the chassis electronics revealed that the EK1 had been replaced by a 6A8G at some stage in the past. This also required replacement of the valve socket. Most of the paper capacitors and electrolytic capacitors were replaced. The large chassis-mount electrolytic capacitors were left in-situ to keep the set looking as authentic as practical. The replacement capacitors can be seen in the under-chassis view near the power transformer. A few out of tolerance resistors required replacement too.

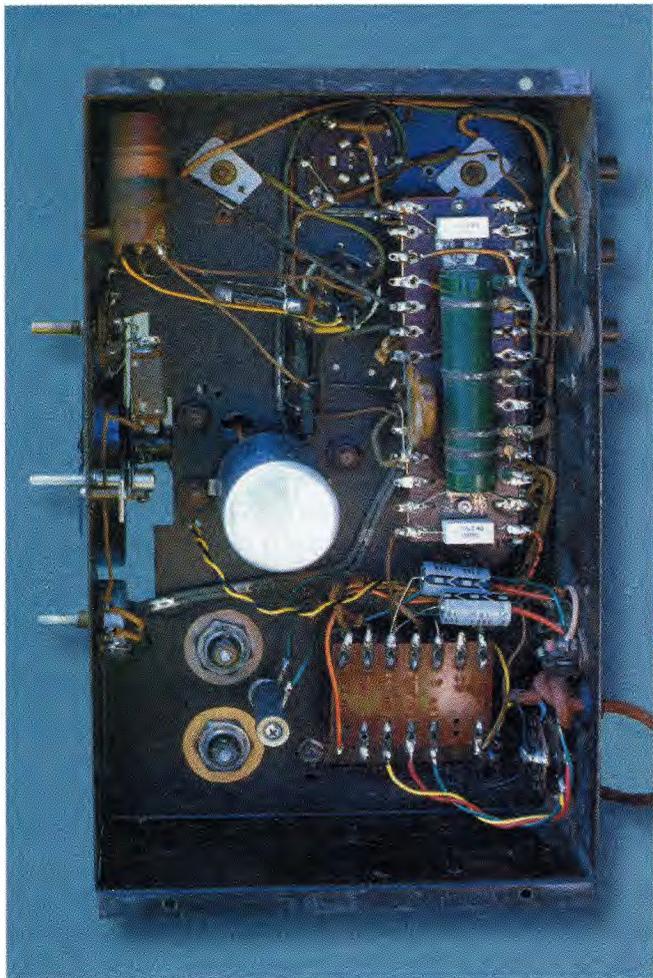
Access under the chassis is only average, with the tag-board obscuring the valve sockets. Note the replacement pigtail electrolytics near the transformer.

Manufacturers of the era tended to put most components on tagstrip boards. Thom and Smith were no exception. They, like many others, put these boards over the top of other components or valve sockets which often made access and troubleshooting a slow job.

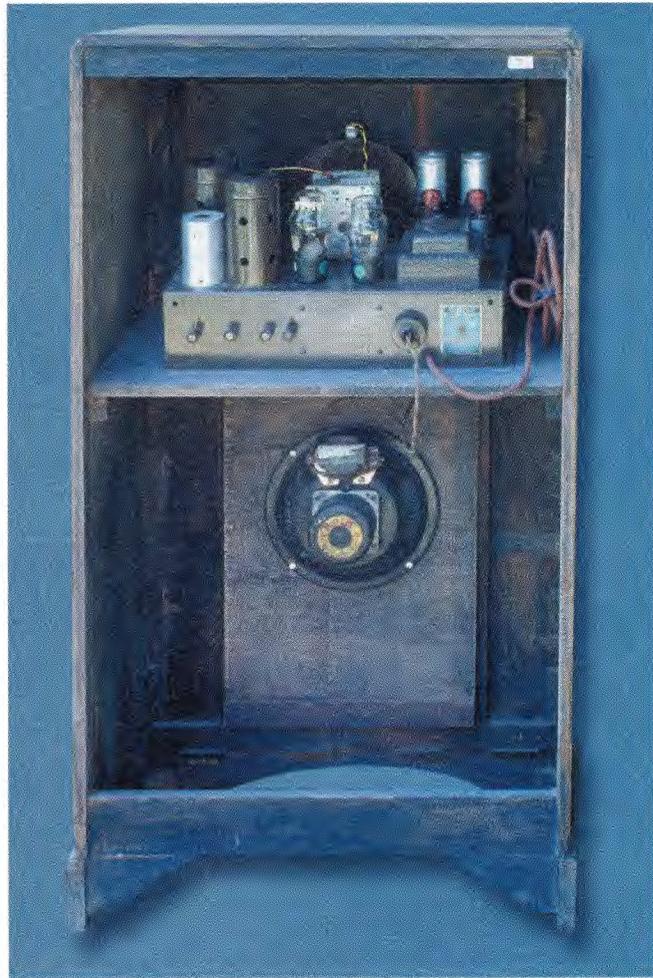
This rear view of the console shows the sloping shelf for the chassis, made necessary by the sloping front of the cabinet.

The front of the set where the controls are is sloped, which means that the shelf the chassis sits on is also at an angle. To remove the chassis from the cabinet requires the removal of the three control knobs, the speaker plug and finally, four nuts and bolts which secure the chassis to its mounting shelf. These nuts and bolts are awkward to remove or reinstall.

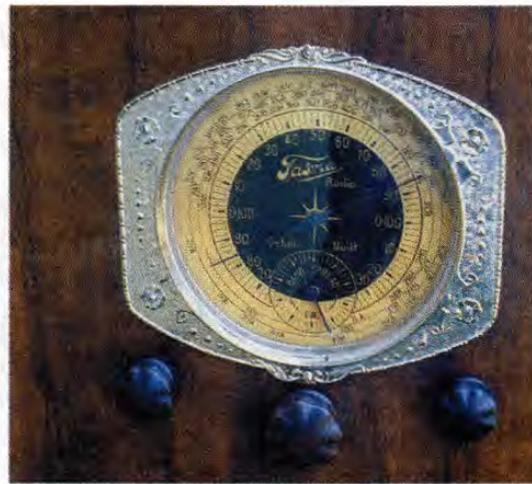
This dial is almost in mint condition. Note the smaller bandspread dial for fine tuning.

The yellowed celluloid dial protection was replaced with a piece of acetate sheet from a shirt packet and now the dial looks like new. Acetate sheet can also be obtained from art and craft shops. The dial mechanism

itself is dual speed with a "band-spread" dial at the bottom; quite handy for accurate tuning.
