# VINTAGE RADIO

## The AWA R154 Battery Console

**Intended for use in country areas without mains power, the AWA R154 battery console was first sold in 1935. It operated from three different battery types and there were no less than 11 battery leads to hook up to the chassis.**

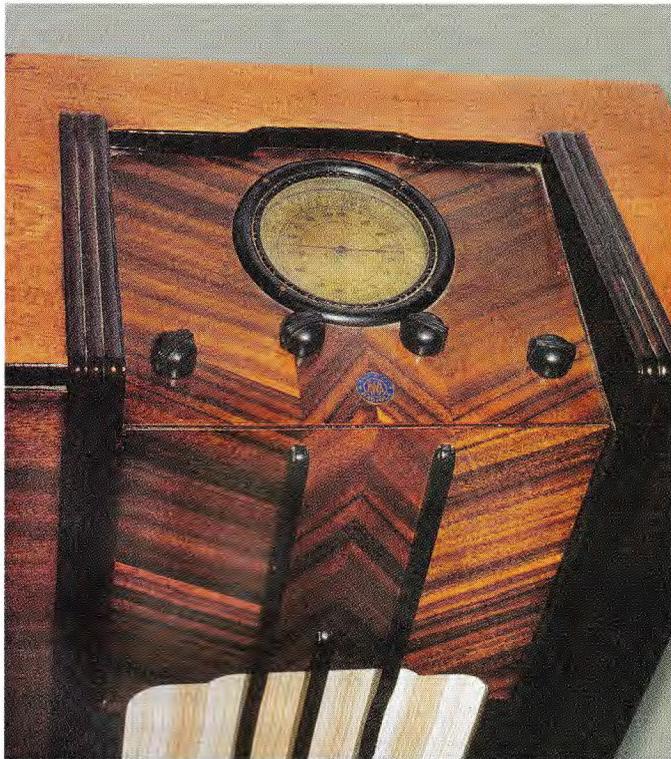
**Above:** the top of the set carried the controls and dial scale. The set is a good performer and is well worth restoring.

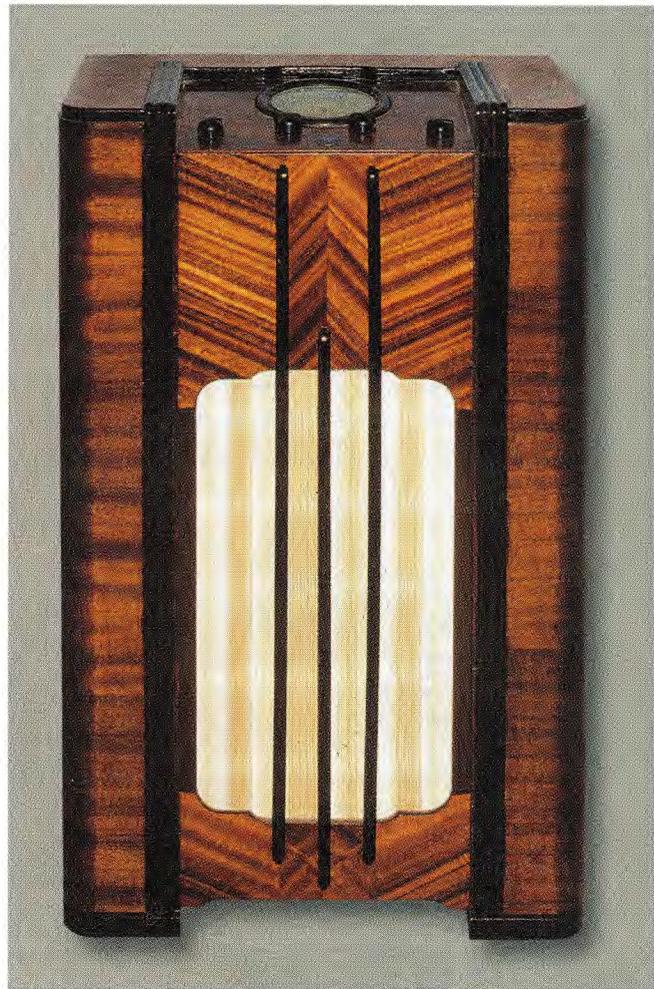
**Right:** this photo shows Keith's fully restored AWA R154 console. This particular unit has been converted to mains operation, to avoid battery hassles (see text).

Although originally designed as a battery set, this particular set has been converted to operate on 240V AC. Keith says that even battery sets should be able to be used – even if the batteries to operate them are no longer available.

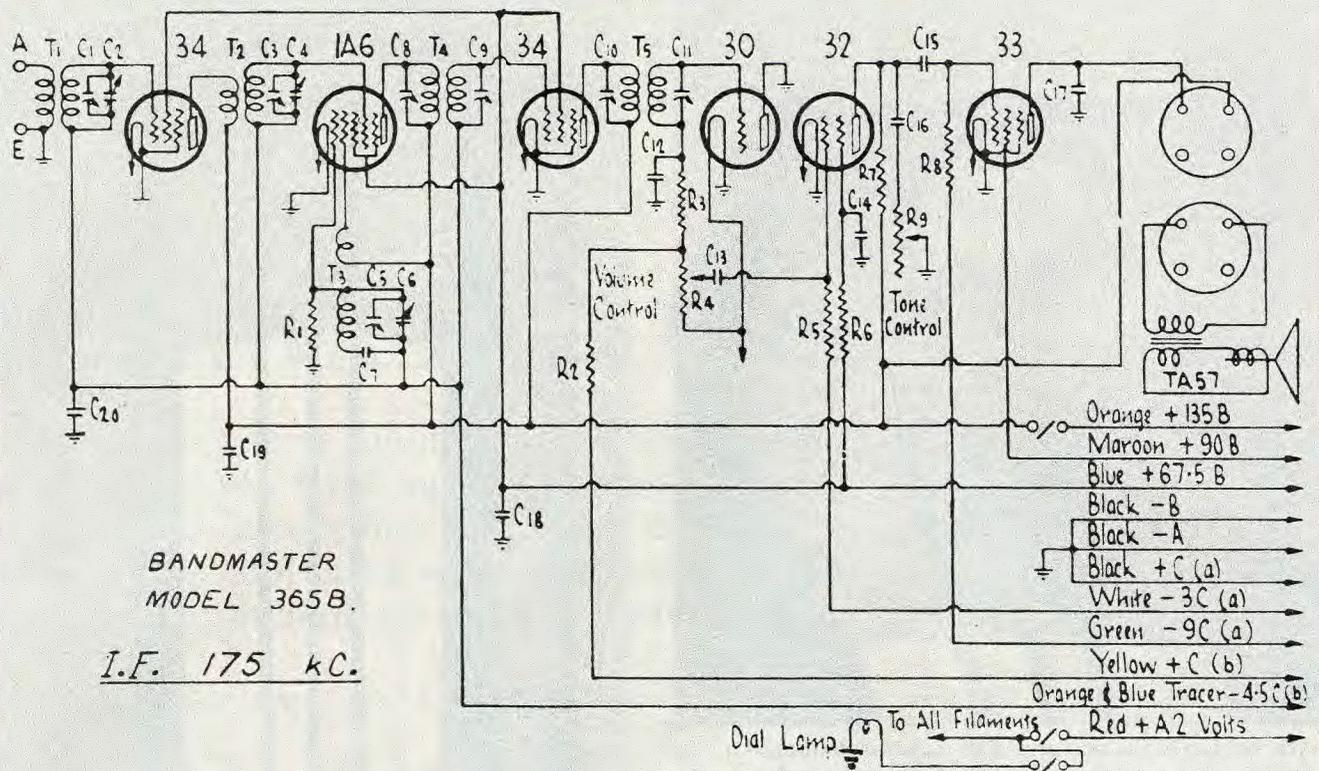
## "Bandmaster" Battery Operated Broadcast Console Model 365B

Fig.1: the circuit diagram for the Bandmaster 365B is the same as for the AWA R154. The set used six valves: a 34 RF stage, 1A6 converter, 34 IF amplifier, 30 detector, 32 first audio stage and a 33 audio output stage.

– it is quite conventional with one or two unusual quirks.

For example, the tuning gang is mounted on rubber insulation which isolates it from the chassis. This is necessary because the gang is nominally at -4.5V with respect to the chassis (this is the bias applied to the two 34 valves). AWA did this with a few of their sets but the reason for this and its advantage, if any, is unknown.

The purpose of R2 across the volume control is not clear at first glance. Usually, the C battery positive goes directly to chassis as happens with the bias battery (a). However, this set has two bias batteries and the second one (b) applies -4.5V to the front end of the receiver as a standing bias via R2 and R4.

In operation, the detector develops a negative voltage across R3 and R4

that increases with the signal strength. This voltage is effectively in series with the bias voltage and so the RF and IF valves have their amplification controlled via the automatic gain control (AGC) circuit.

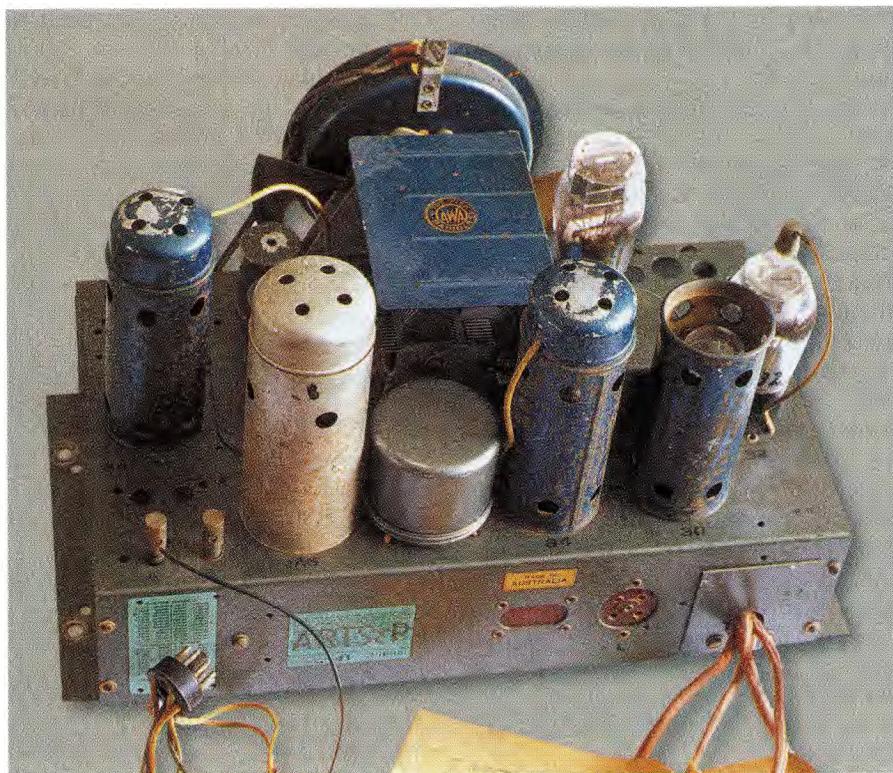
This rear view of the chassis shows some of the non-original valve shields that had to be pressed into service to complete the restoration.

Some of the valve shields were also missing and the correct ones were unavailable, so it was necessary to use whatever would fit. These will be replaced further down the track if the correct shields can be obtained.

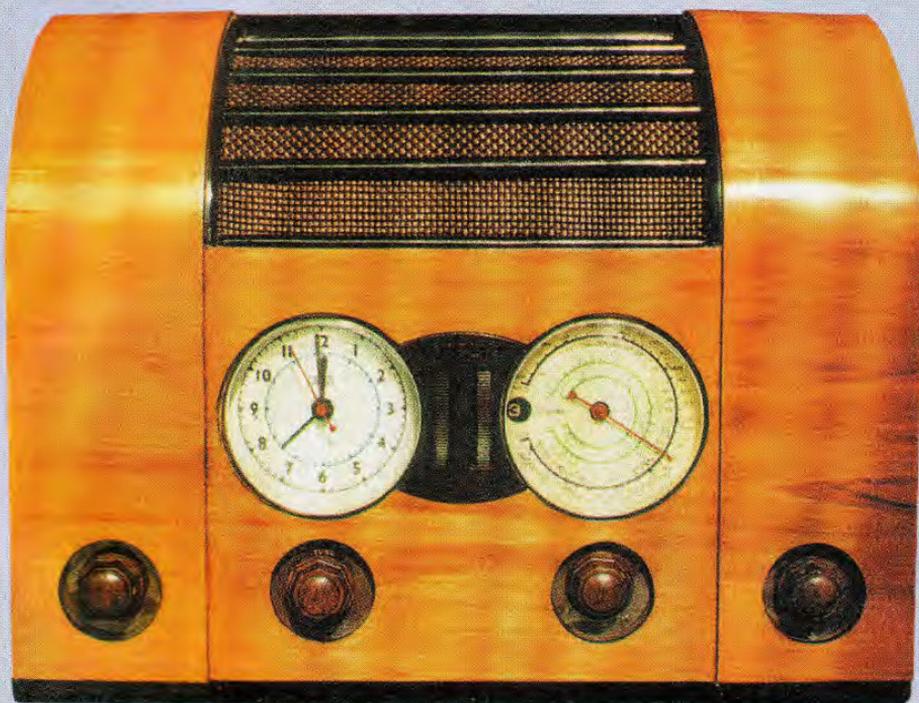
## Photo Gallery: Goblin Model CR Mantel Radio

Introduced in 1947 as the "Time Spot", this unusual 5-valve 3-band radio featured an 8-inch Plessey speaker and a clock-timer unit (lefthand dial). The set is actually a Goblin Model CR and was made by the British Vacuum Cleaner Company (England). It was obviously intended for export to Australia, as the dial scale is embossed with Australian stations.

The clock setting was activated by a shaft at the rear and by a large-diameter thumb-wheel on the front (between the two round dials). A similar wheel was used for the volume control, a peephole in the dial scale showing the setting.

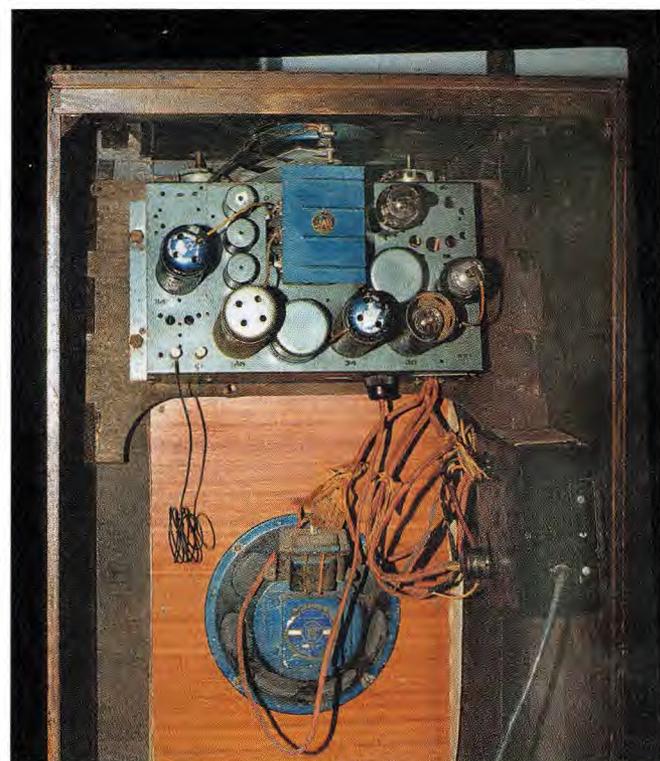
The chassis was mounted vertically in the cabinet, above the baffle (not the original) and the loudspeaker. Note the bunched battery leads and the added AC power supply (in the black box on the righthand side).

As can be seen in the photograph of the back of the set, a black box has been attached to the side of the cabinet. This box contains a power supply that provides all the DC voltages necessary to operate the receiver from the AC mains.

This particular supply was made from a kit but Keith has also made a number of supplies to his own design and all work well. The 11 power leads are wired to two plugs, so that they can be easily plugged into the power supply with no confusion as to where each lead should be connected.

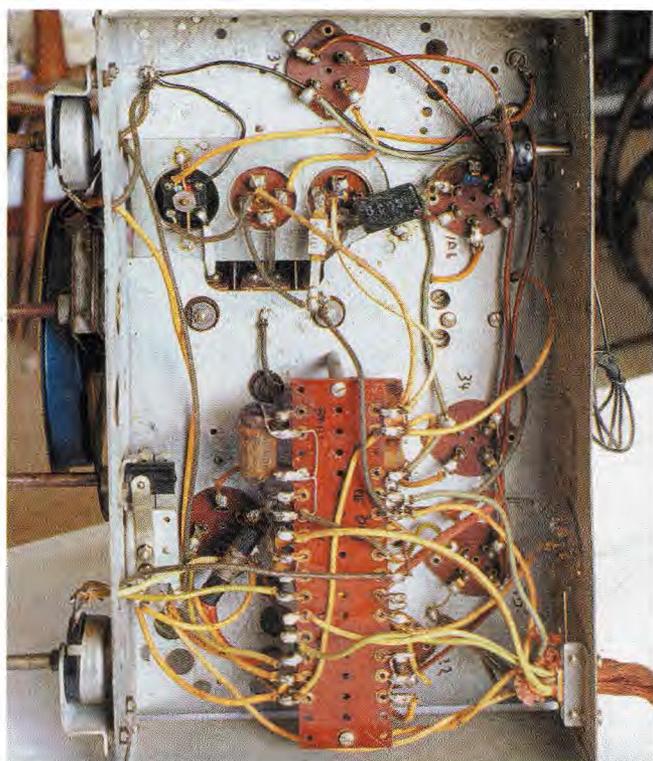
This under-chassis view of the R154 show the paucity of components and the ready access to the circuit. The only drawback is that some components are mounted on the underside of the terminal board.

Like many sets of the era, a large terminal board was used in this receiver. The components are mounted in bulk on this board which is then mounted and wired into the receiver. Unfortunately, some of the components are mounted under the board, which is fine until service work is required.

The second feature I dislike is the "floating" gang. It appears to serve no useful purpose and makes for more complexity in manufacture. And third, I'm not too keen on the way some of the components have been mounted on the underside of the terminal board.
