VINTAGE RADIO

The HMV C43B console radio

Generally considered a “step-up” from mantel radios, console receivers enjoyed an extended period of popularity from the 1930s to the early 1950s. Typical of the era was the HMV C43B console, a 5-valve receiver with an impressive cabinet and performance to match.

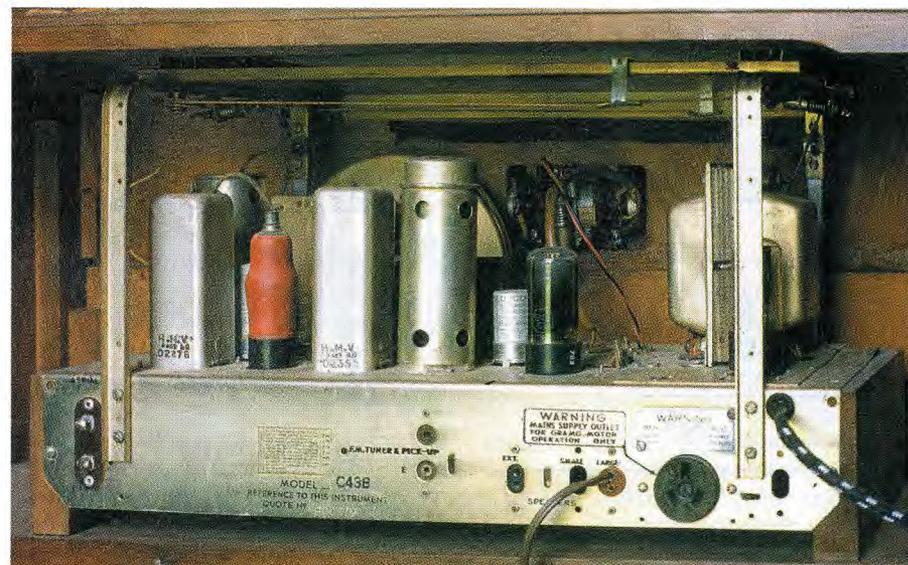
This rear view shows the C43B receiver chassis mounted in the cabinet. Note the large metal brackets at either end.

The chassis is easy to remove and simply involves removing the bolts that fasten the chassis to the mounting shelf, then removing the knobs and disconnecting the loudspeaker and tone controls. The chassis can then be removed and, thanks to the large "roll-over" brackets located at either end, stood on its end for service.

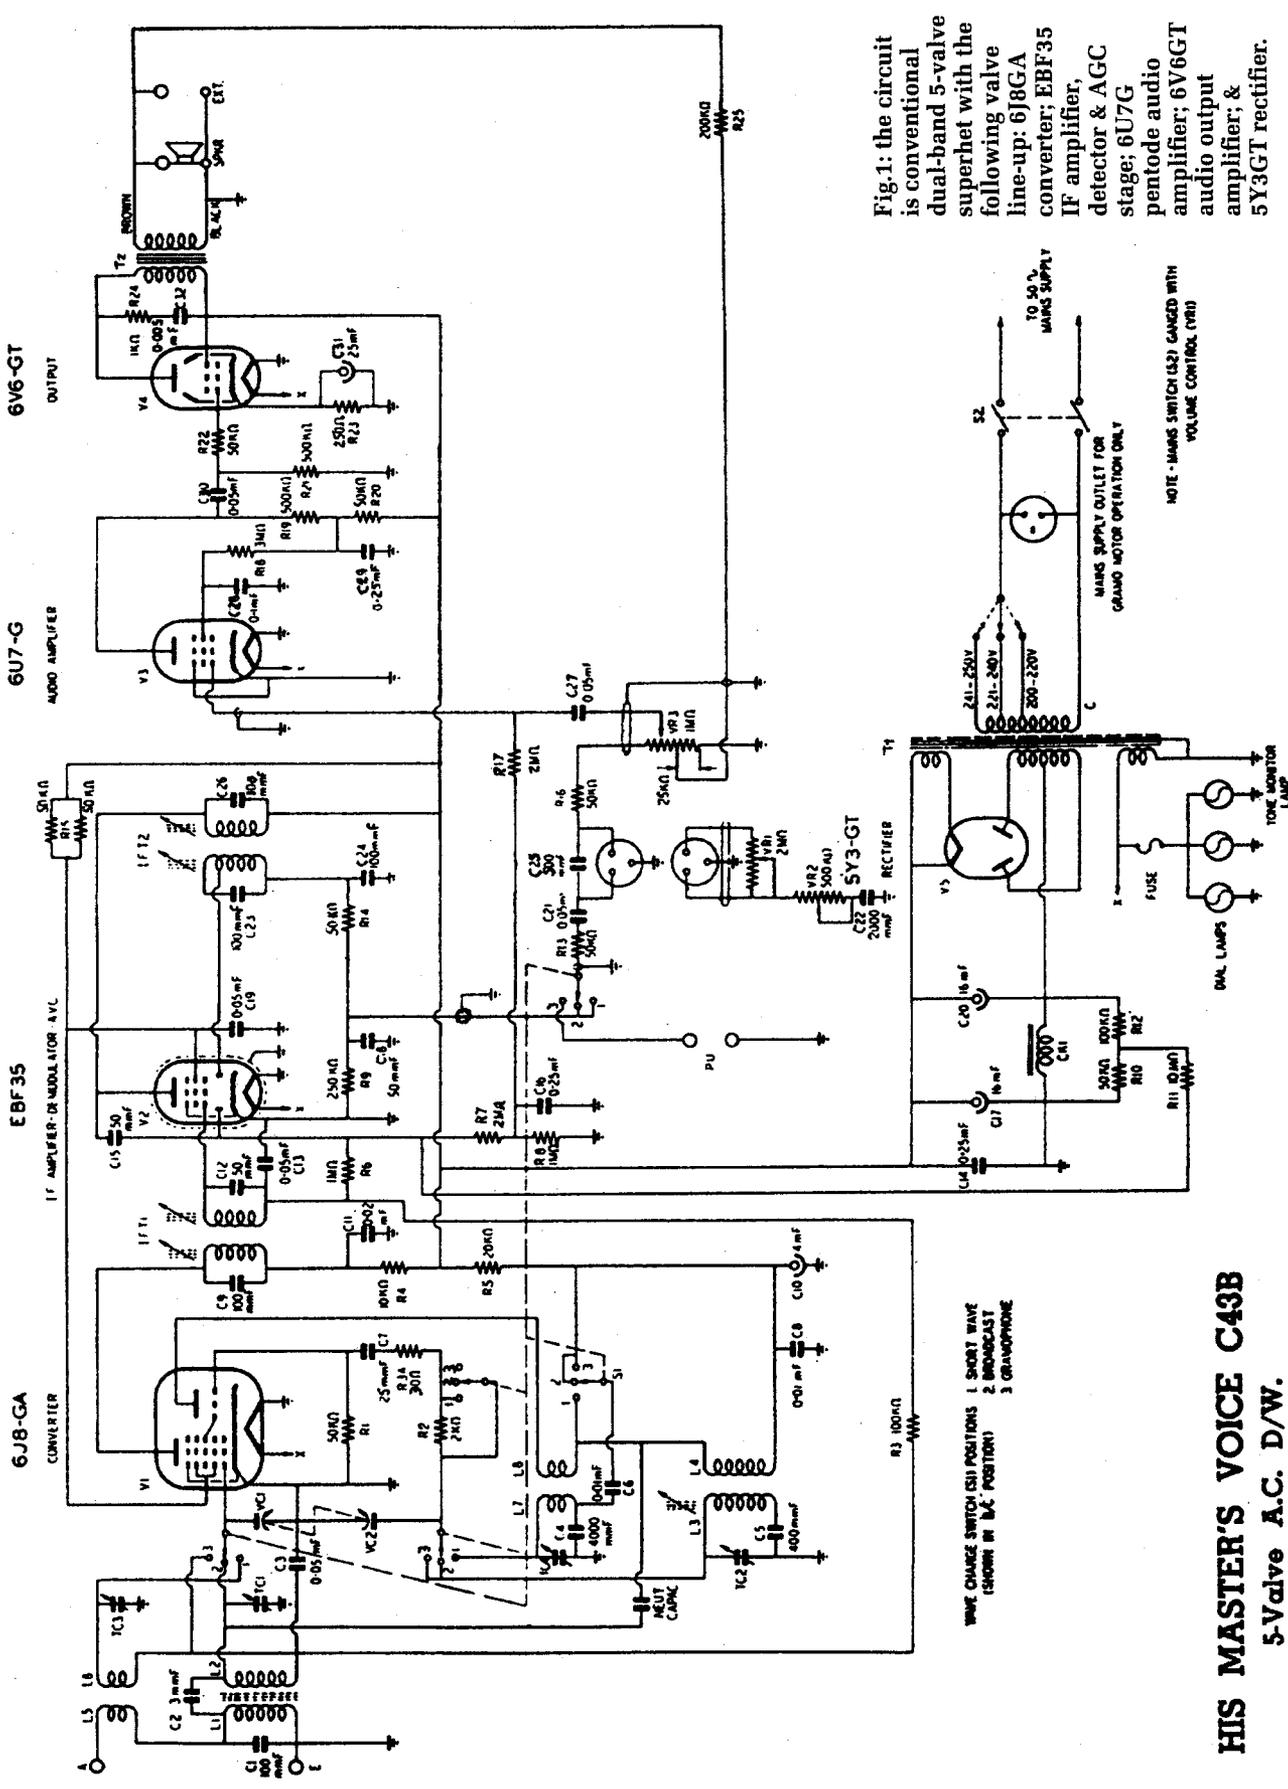
HIS MASTER'S VOICE C43B
 5-Valve A.C. D/W.

Fig. 1: the circuit is conventional dual-band 5-valve superhet with the following valve line-up: 6J8GA converter; EBF35 IF amplifier, detector & AGC stage; 6U7G pentode audio amplifier; 6V6GT audio output amplifier; & 5Y3GT rectifier.

WAVE CHANGE SWITCH (S1) POSITIONS
 1. SHORT WAVE
 2. BROADCAST
 3. GRAMOPHONE

NOTE - MANS SWITCH (S2) GANGED WITH VOLUME CONTROL (P2) FOR GRAMMO MOTOR OPERATION ONLY

The receiver will operate with the tone controls disconnected, although it will lack bass performance. That's because, with the tone controls disconnected, there's just a 500pF coupling capacitor in the audio chain. Fig.1 shows the tone control circuit (VR1, VR2 & C22) and shows how it is attached to the main circuit.

The circuit is quite conventional – it has a 6J8GA converter; an EBF35 IF amplifier, detector and AGC stage; a 6U7G pentode audio amplifier; and a 6V6GT audio output amplifier. The power rectifier is the common 5Y3GT. The set is dual-wave, covering 540-1600kHz and 5.9-18.1MHz, and it also features a pickup input ("PU") so that records can be played through the audio amplifier stage.

The broadcast coil primary is tuned by L1 and C1 so that it resonates at a frequency just below the broadcast band. This is done to get the best performance on the lower frequency stations. C2 is a "top-coupling" capacitor and its inclusion ensures good performance at the high-frequency end of the dial.

On shortwave, L1 acts as a radio frequency (RF) choke and prevents L5 from operating effectively. However, while L1 acts as an RF choke, C1 has very little reactive effect at shortwave and so the bottom of the shortwave winding is effectively connected to earth. This saves the use of a switch section and is quite effective.

The intermediate frequency (IF) amplifier is quite conventional, operating on 457.5kHz. As shown, the detector diode takes its signal from a tap on the secondary of the second IF transformer. This gives higher selectivity as opposed to extracting signal from the top of the winding.

The signal for the AGC diode is taken from the plate of the IF amplifier valve, where the signal is stronger but the selectivity is reduced. This method helps to smooth the operation of the AGC system and ensures that it starts to work before the signal is fully tuned in, thereby preventing momentary "blasting" before the AGC becomes fully operational.

On shortwave, padder feedback capacitor (C6) is used to ensure that the converter oscillates reliably across the entire tuning range. An unusual feature here is the inclusion of a 2kΩ resistor (R2) in the grid lead circuit of the local oscillator for the broadcast band. Obviously, the oscillator was

The aerial/antenna input circuit is one that HMV commonly used. Note that the shortwave primary winding (L5) is in series with the broadcast band coil (L1) primary. On the broadcast band, the inductance of L5 is quite low and it actually acts as a

The AGC is delayed by the bias supplied through R11 (at the bottom of Fig.1). Note that about a third of the AGC voltage is applied via R17 to the 6U7G audio valve! This technique is rather unusual but was often favoured by HMV in particular.

The power supply has an unusual feature in that the filter choke has been placed in the negative lead. The advantage of this is that the voltage between the winding and the frame is quite low. The delay bias for the AGC system is obtained by a voltage divider across this choke.

Note that a third of the voltage across the choke is used for this bias. This is dropped by another two thirds by a voltage divider consisting of R11, R7 and R8.

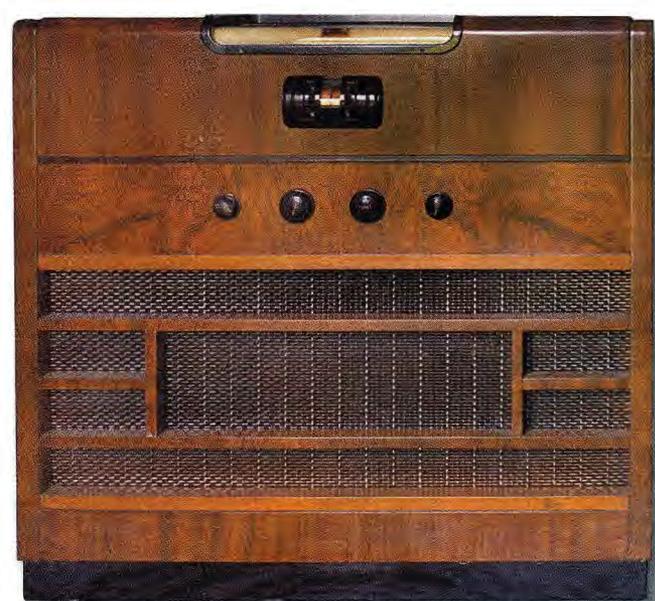
It may be a little plain from the front but the cabinet is still an impressive piece of furniture.

As can be seen in the photos, the dial sits horizontally along the top front edge of the cabinet (perhaps that is what is meant by “horizontal” in the identification table). The dial doesn't impress me as much as some of the early HMV dials but it is still quite functional. It's also simpler than some of the earlier units, so it is less likely to give trouble with wear over an extended period.

That said, if it had been set down a little from the top and at an angle (like most of its contemporaries), the set would have looked better. As it stands, the set looks a little bland when viewed from the front.

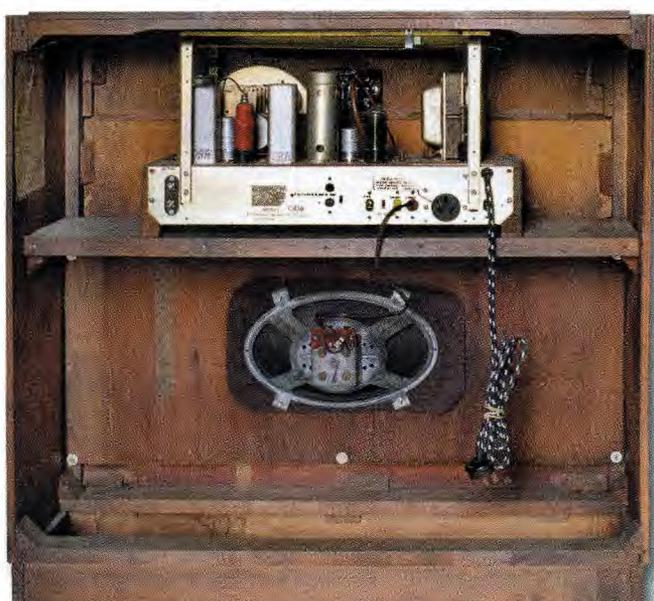
The large oval-shaped loudspeaker is properly baffled by the cabinet, which contributes to the audio quality.

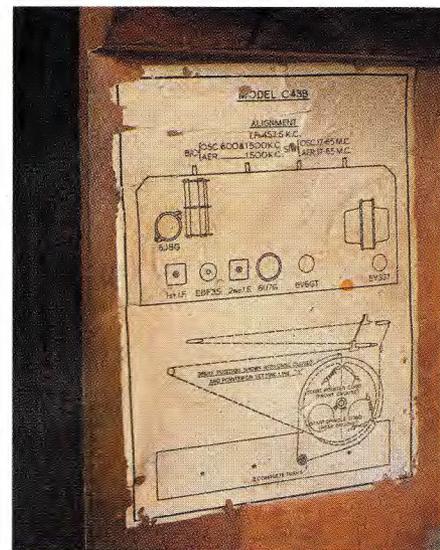
This label is attached to an inside panel and shows the dial stringing arrangement and the valve positions.

A sheet of paper glued to an inside panel of the cabinet details the dial drive system and indicates the valve type used at each location. This valve location guide is handy for ensuring that the valves are correctly replaced in their respective sockets after they have been removed for testing.

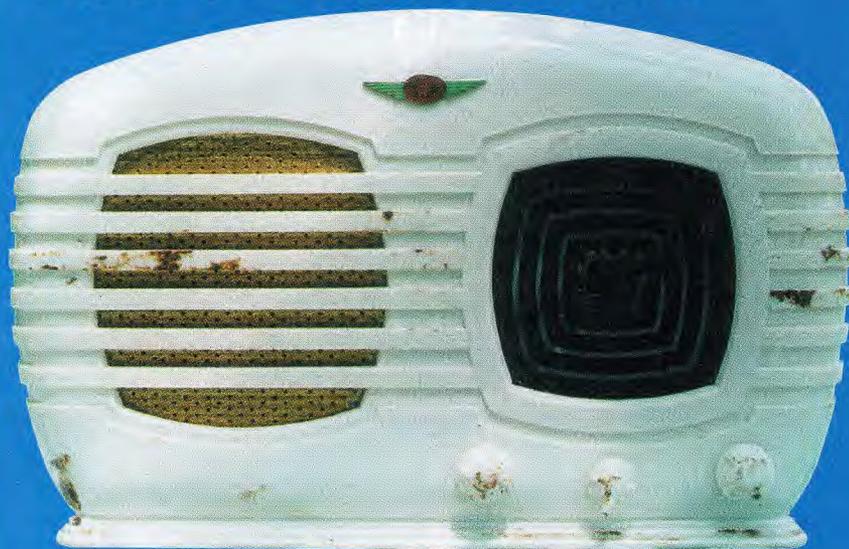
Photo Gallery: 1940 Tasma Model 710 5-Valve Radio

Manufactured by Thom & Smith Pty Ltd in 1940, this Tasma Model 710 from was a compact 5-valve dual-wave mantel set. It featured an unusual "rust-stained" white bakelite cabinet and this was manufactured using a process that ensured no two cabinets were ever like.

Band switching was controlled by a central winged knob, although this became the tone control on broadcast band only models. The valve line-up was as follows: 6J8G frequency converter, 6U7G IF amplifier, 6G8G audio amplifier & detector, 6V6G audio output and 5Y3G rectifier.
