By RODNEY CHAMPNESS, VK3UG

## The “Jelly Mould” STC 205 Mantel/Table Receiver

**The 1948 STC 205 dual-wave receiver was a rather unusual set, especially when it came to cabinet design. In addition, there were some rather unusual circuit “quirks” in what was otherwise a fairly conventional 5-valve superhet.**

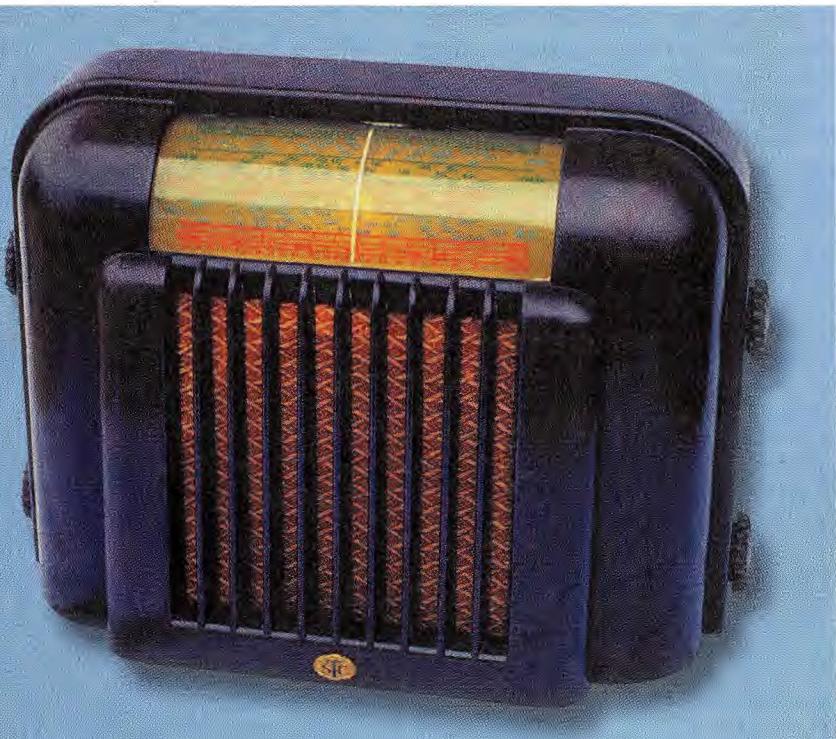
The STC 205 featured an angled dial-scale and an unusual cabinet that slid over the chassis from the top.

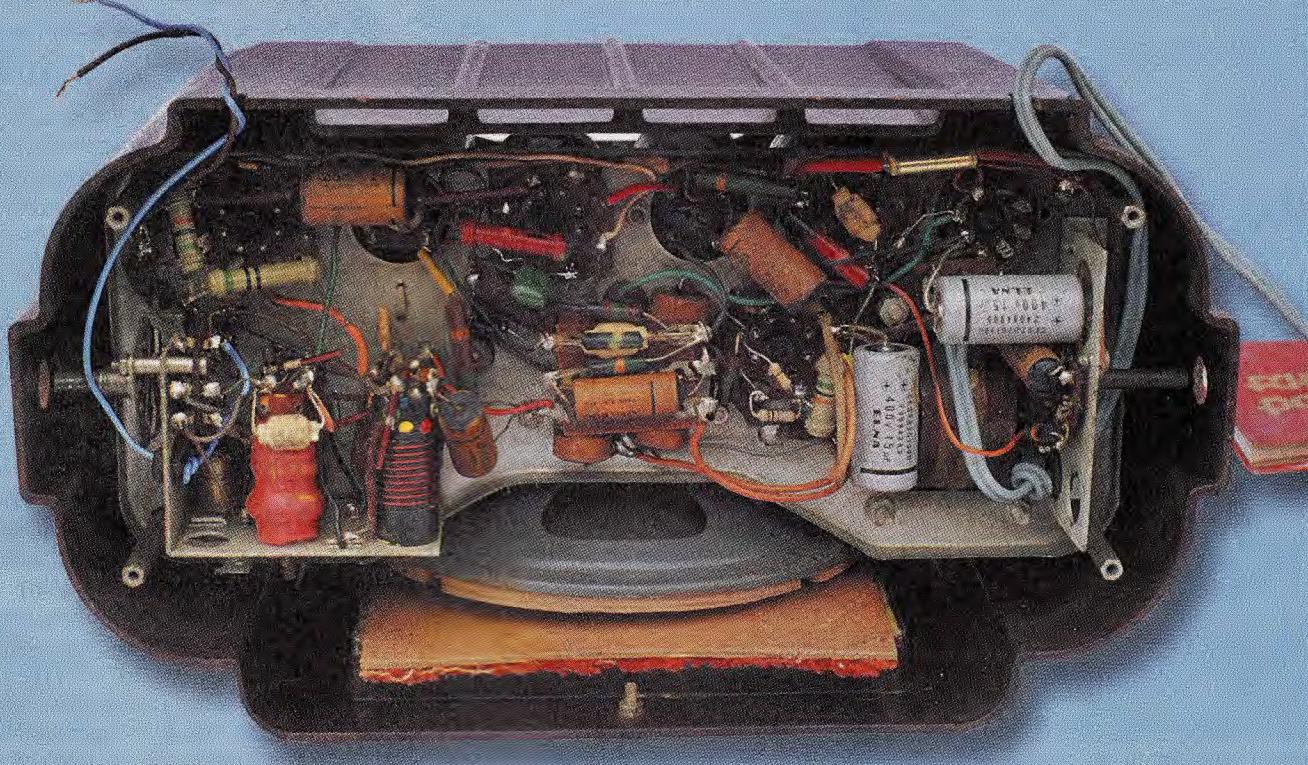
This view shows the bottom of the set with the cardboard cover removed. Access to the various components is quite good, although the cabinet has to be removed to allow access to the valves which are on the top of the chassis.

From the photographs, it can be seen that the chassis is well-populated with components and there is not much spare space. Despite this, access to the various components and to the valves is quite easy.

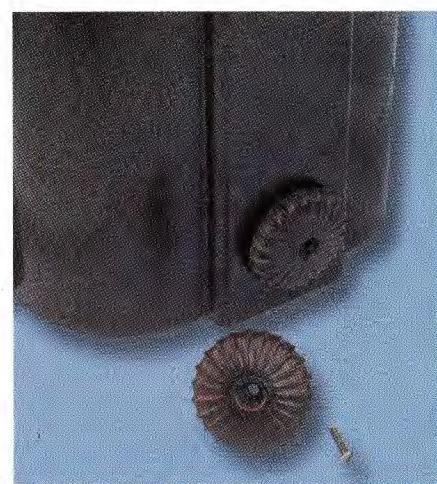
As shown in the photos, the STC 205 has four control knobs and these are located on either side of the cabinet. Each of these is slid onto the shaft and held in place using a machine screw which goes through the centre of the knob and into the end of the control shaft. I am not aware of any other domestic receivers that use this method of securing the control knobs.

Each knob is secured using a screw which passes through the centre and into the end of the control shaft.

The chassis isn't all that hard to get out of its cabinet, although the procedure is somewhat different to normal. First, the four knobs are removed by undoing the screws that go into the

control shafts, then sliding the knobs off (see photo). That done, you have to undo the four screws through the rubber buffers on the base of the set, after which the buffers and the cardboard bottom plate are removed.

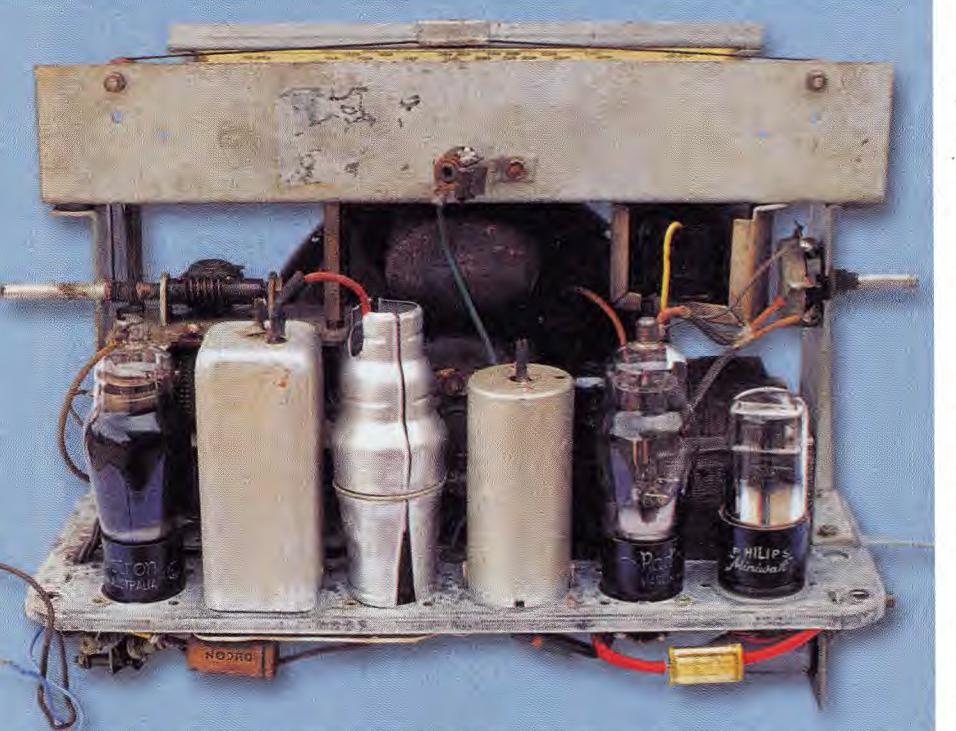
This rear-view of the chassis show just how easy it is to access the valves once the cabinet has been lifted off.

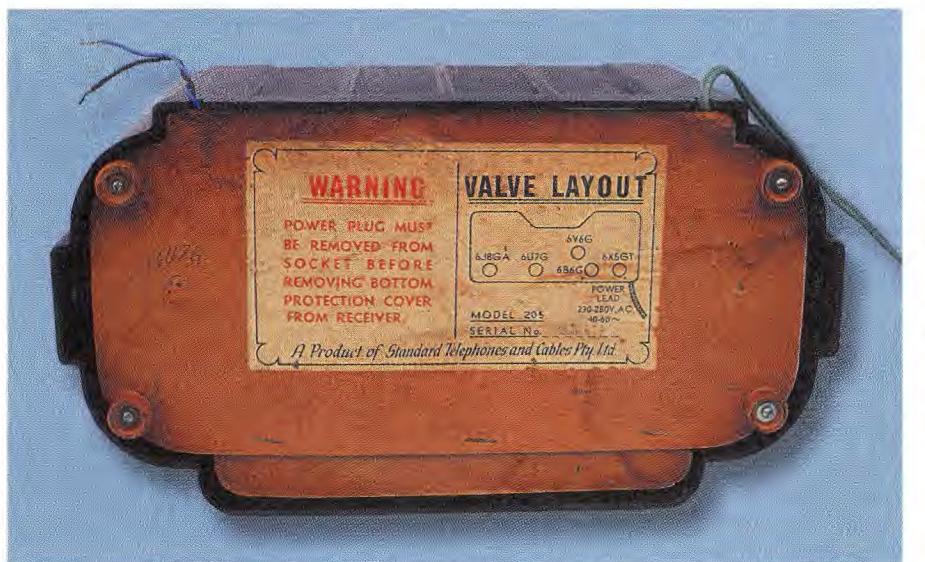
The bottom of the receiver is fitted with a cardboard cover and a sticker that shows the valve layout.

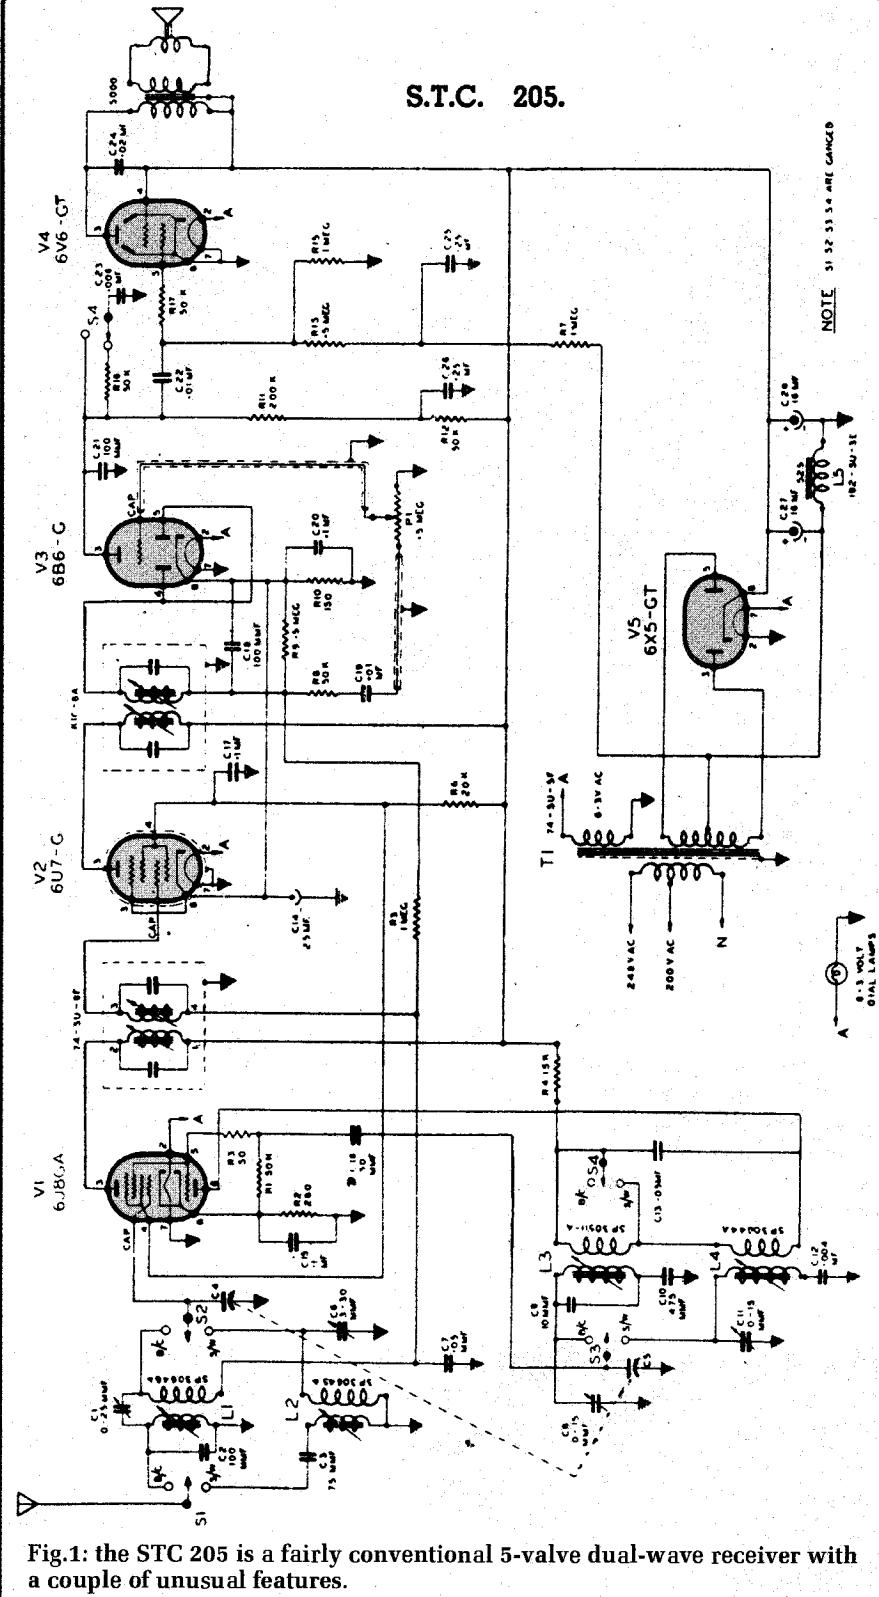
S.T.C. 205.

Fig.1: the STC 205 is a fairly conventional 5-valve dual-wave receiver with a couple of unusual features.

Fig.1 shows the circuit details of the STC 205. The first thing to note is that the antenna tuned circuits are a little different to other receivers. For starters, the broadcast-band antenna coil's primary resonates below the broadcast band and this gives improved performance at the low-frequency end of the dial.

high-frequency end of the dial) is wired across the tops of the two windings in the antenna coil. This boosts the coupling from the antenna to the tuned circuit, although it is unusual to have the trimmer in this position. Most sets have this trimmer going from the grid of the RF valve to chassis.

By contrast, the shortwave coil has a capacitor (C3) in series with its primary winding. A capacitor placed in this position has the effect of electrically shortening the antenna and perhaps this was the intent. Using an "average" antenna of around 6-7 metres, the antenna system would resonate somewhere near the high end of the shortwave band.

By the way, if you look carefully at the two antenna coils you will see a drafting error – both coils show the coil adjustment in the untuned winding! Someone didn't spot this when checking the circuit diagram.

The oscillator circuit is conventional but there is a right royal blunder in this circuit too! C13, which has a value of 50nF (0.05 $\mu$ F), is shown wired across the feedback windings of both oscillator coils. However, if this had really been done, the oscillator would have no feedback due to the heavy damping of the winding by the capacitor. The bottom end of C13 should in fact go to earth.

The IF stage is conventional and uses a 6U7G followed by a 6B6G as a combined detector, simple AGC and first audio stage. The 6U7G and the 6B6G share a common cathode bias resistor and common bypass capacitors. This is unusual, as the 6U7G will draw less current as the AGC voltage increases which will mean that the voltage across R10 will also drop. This in turn will reduce the bias on the 6B6G and alter its operating conditions.

The audio output stage is also quite conventional and uses a 6V6GT audio output valve. However, I find it puzzling that cathode bias is not used in this stage, as all other stages of the receiver use this method. It would also have been quite practical to use back bias on all stages instead of just the 6V6GT stage.

As with a great deal of other STC equipment, the filter choke is in the negative power supply lead. This reduces the voltage stress between the

choke frame and the winding. And as is common in other receivers of this vintage, there is no decoupling between the audio output plate circuit and the plate circuits of any other amplifying stages. As far as I am concerned, this is poor design and can lead to receiver instability.

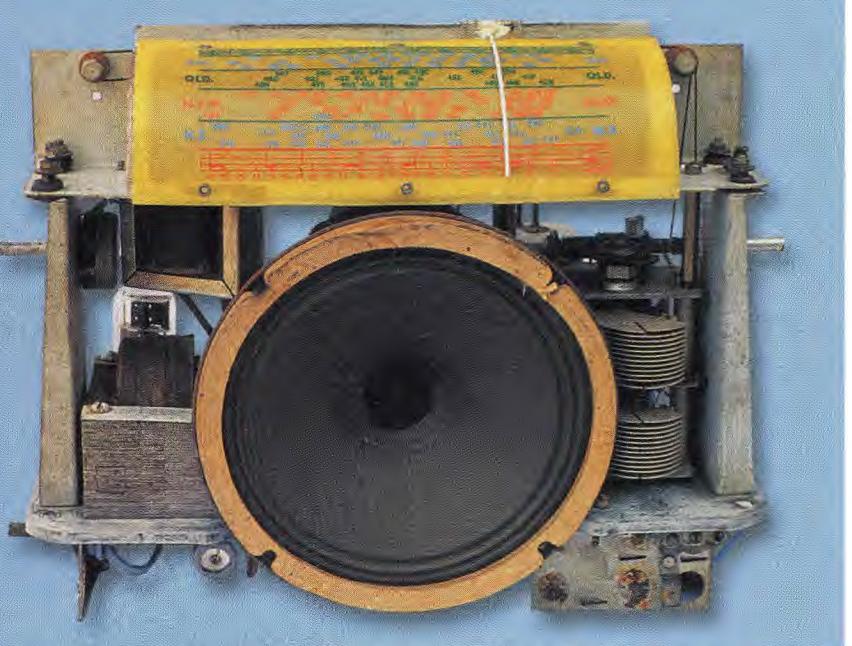
This view shows the chassis from the front. The angled dial-scale is mounted on an L-shaped bracket which is supported on the chassis base using a couple of metal pillars.

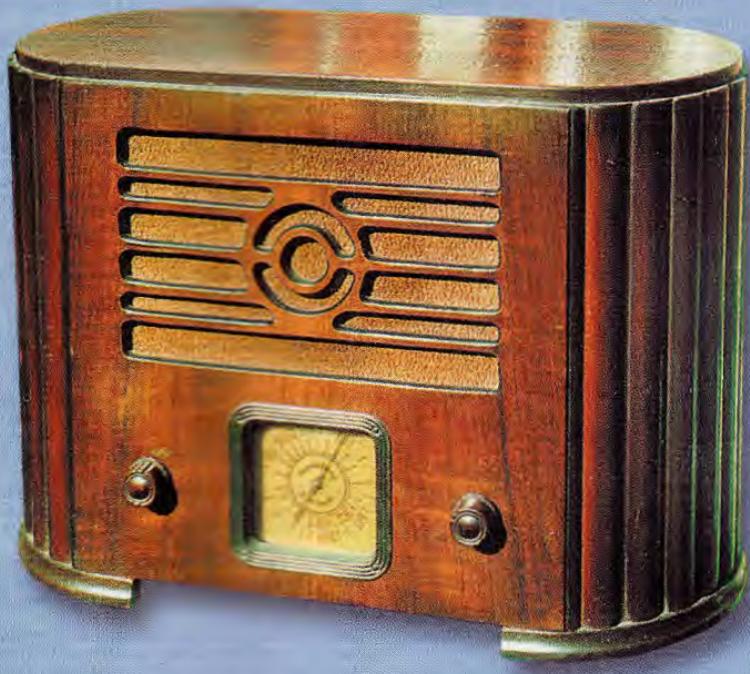
Manufactured by Stromberg Carlson (Sydney) in 1936, the Model 496 is a 4-valve superhet housed in a substantial wooden mantel cabinet.

The set used a mixture of valve types which required individual 4V, 5V and 6V heater windings on the transformer. The valve types used were: 6C6 (autodyne mixer), 6F7 (IF amplifier and detector), AL3 (audio output) and 80 (rectifier).

The high-gain AL3, with its 4V heater and "P" type base, was probably chosen to compensate for the lack of a separate audio preamplifier stage. It would have been one of the few high-gain output pentodes available at the time, with a "gm" nearly four times that of the more commonly-used type 42.
