VINTAGE RADIO

The AWA PF 11B-6V car radio and the Ferris “Tranimate”

AWA VW-1200 car radio

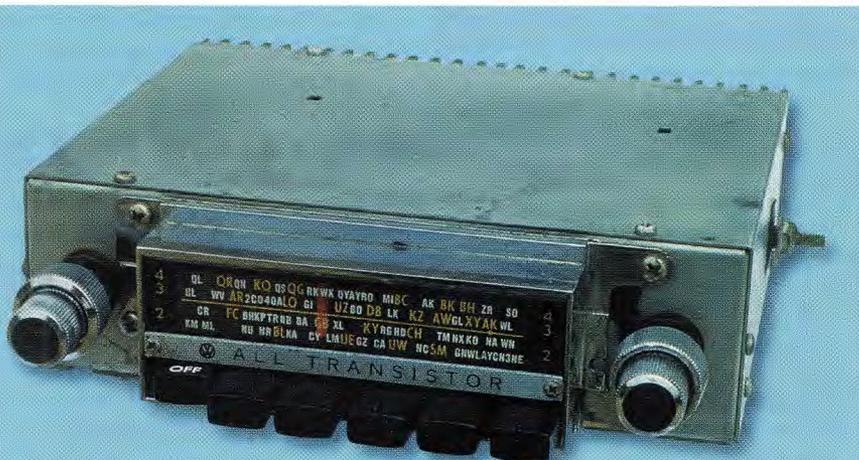
This old AWA car radio receiver cleaned up quite well and will certainly look the part inside the restored Volkswagen. Note the press button tuning.

stuck to it which I scraped off. I then used a eucalyptus-soaked rag to clean the case and the front panel. A kitchen scourer was then used to remove some of the more stubborn marks although this was done rather gently because I didn't want to destroy any of the wanted markings on the case.

In the end, both the case and the front panel looked quite good, although they still weren't exactly in pristine condition.

Having got the set working correctly, I then proceeded to clean up the case as much as practical. The knobs were washed in the laundry sink in soapy water and I used a small nail brush to remove the dirt from between the ridges in the knobs. In addition, the two smaller knobs had peeling black paint in their centres so I put a small amount of flat black enamel paint on them to make them look original.

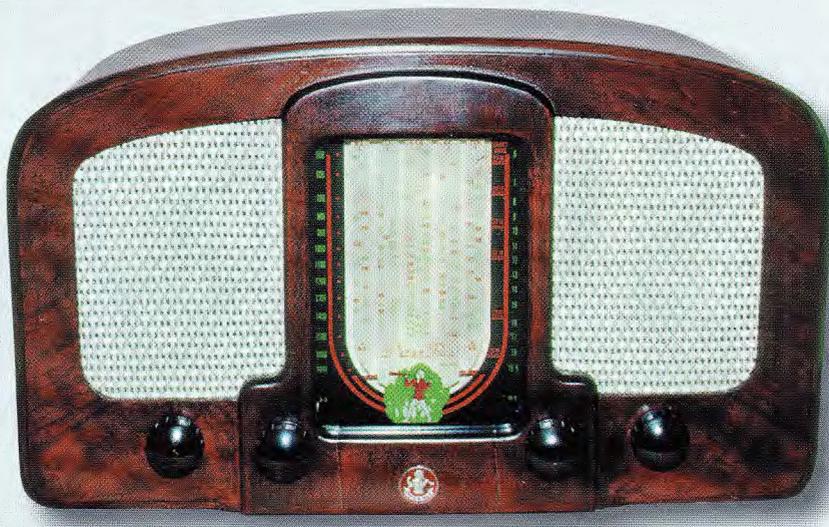
Photo Gallery: Peter Pan Model BKJ 5-Valve Receiver

Housed in a stylish wooden cabinet, the Peter Pan BKJ was a 5-valve dual-wave mantel receiver which covered the medium-wave (broadcast) and the 5.88-18.75MHz shortwave bands. It was manufactured around 1946 by Eclipse Radio Pty Ltd (Melbourne) and used the following valves: 6J8-G frequency changer; 6U7-G IF amplifier; 6B6-G detector, AVC detector and first audio amplifier; 6V6-G audio output; and 5Y3-G rectifier. (Photo courtesy Historical Radio Society Of Australia (Inc.).)

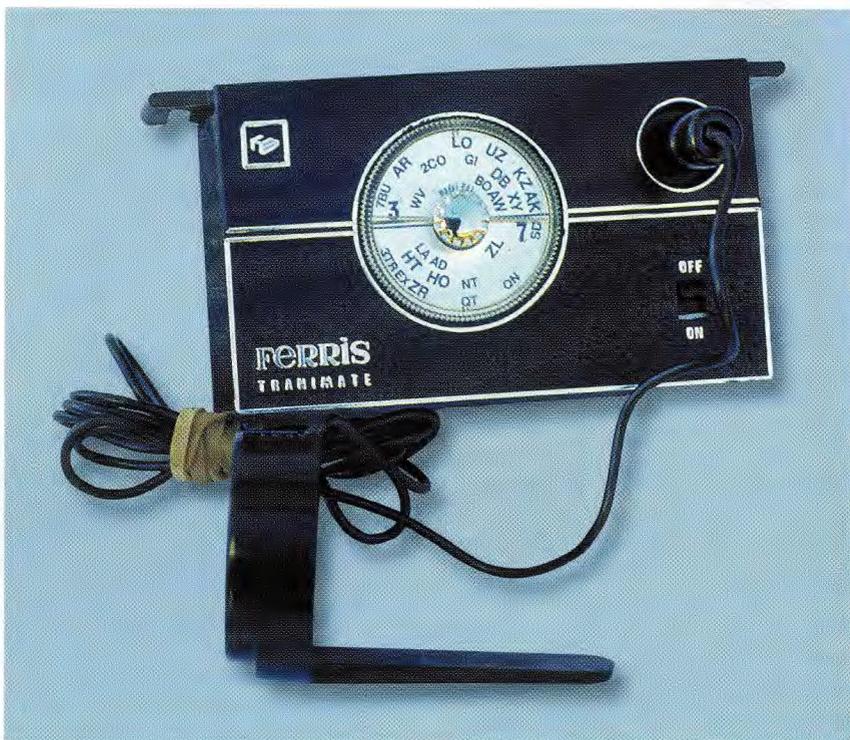
The Tranimate was powered by a 216 battery slipped into the case at one end. The circuitry inside the plastic case is shielded from interference within the vehicle by metallic plating of the inside of the case. The tuning dial on the front is peaked up for best reception of the station being received.

The top view shows the Ferris "Tranimate", complete with its coupling coil and connecting coaxial cable, while immediately above is the view inside the case. The complete unit is around the size of a packet of cigarettes.

Ferris Radio (Australia) were renowned for making many innovative devices and the "Tranimate" was one of them. "What's the Tranimate?", you may well ask. Well, the Tranimate was a 2-transistor tuned amplifier designed to accept a signal from a car radio antenna and output it to a domestic portable transistor radio.

It worked like this: a car radio antenna was installed on the car, complete with its coaxial cable lead. This lead was then plugged into the Tranimate which was screw-mounted to the underside of the dash panel of the car (remember, you could do those things in 1960s cars).

The Tranimate had an input tuned circuit and this was manually tuned by a small tuning gang. The dial was calibrated with some stations but being so small, only a few representative stations were marked.

The tuned signal was first amplified by a transistor operating in common emitter configuration and then fed to a second transistor wired as an emitter follower. From there, the resulting RF output was then fed down a thin coaxial cable to a ferrite-cored coil which was clipped to the transistor radio so that it was in line with the portable's loopstick antenna. As a result, the signal in the Tranimate's coil was induced into the loopstick antenna and so the portable received a clear signal.
