Vintage Radio

Those troublesome capacitors, Pt.1

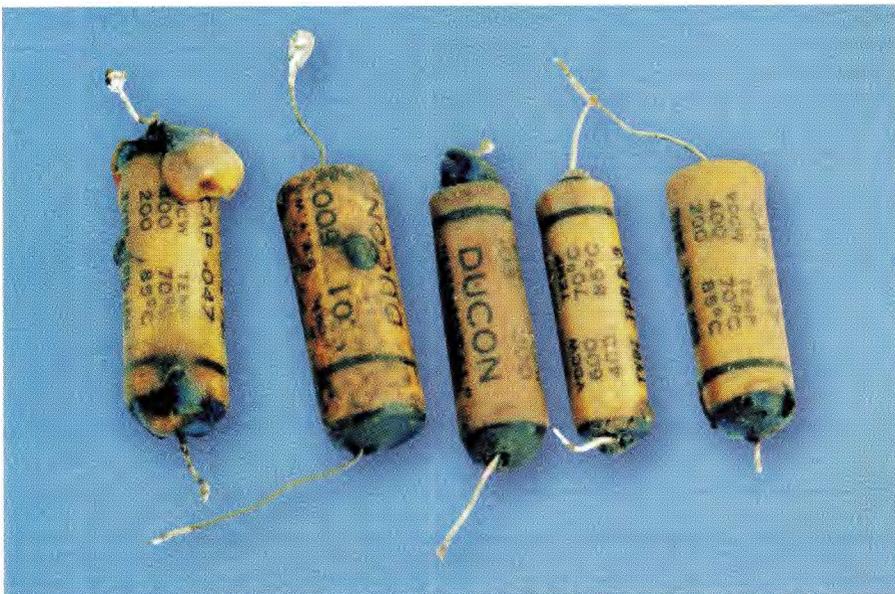
Capacitors that are deformed should be replaced. However, if a capacitor appears OK, it may still be used in many circuit locations even if it is leaky.

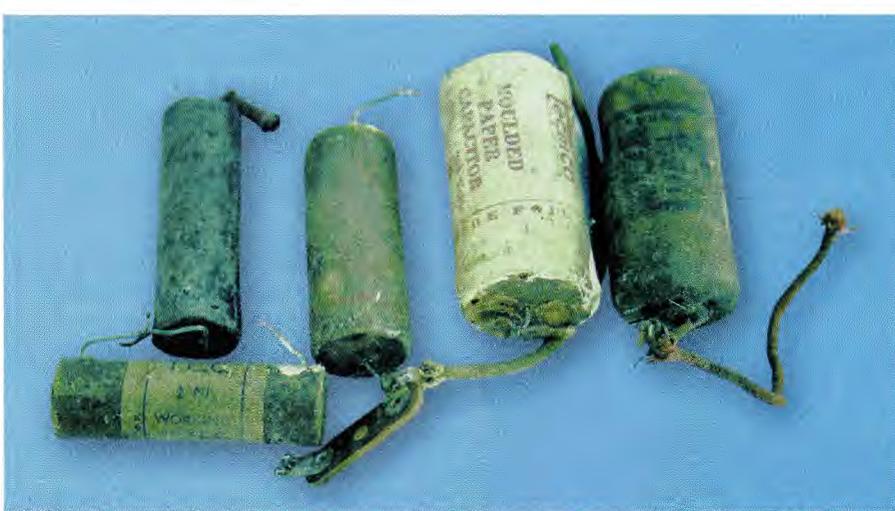
These old paper capacitors have obviously seen better days and have been replaced. If you want to maintain authenticity, you can often use the “shell” of an old capacitor to hide a modern replacement.

In addition, needlessly replacing all the original paper capacitors detracts from the set's authenticity – at least when it comes to appearance. There is an alternative though and that is to remove the innards of the paper capacitors and hide polyester capacitors inside the vacated cases. That way, the capacitors look authentic but now work reliably.

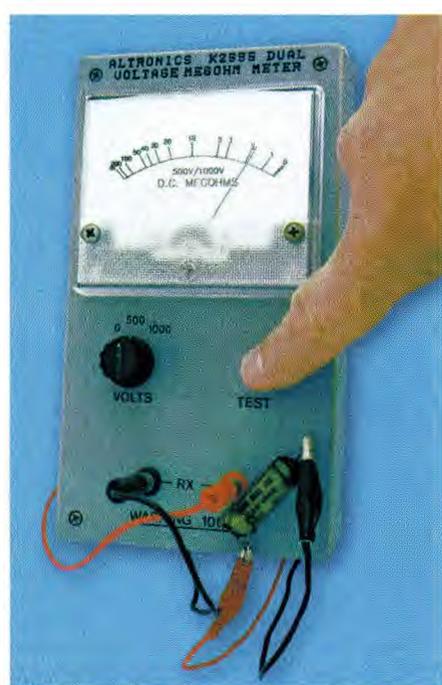
A high-voltage insulation tester is useful for checking capacitors out of circuit.

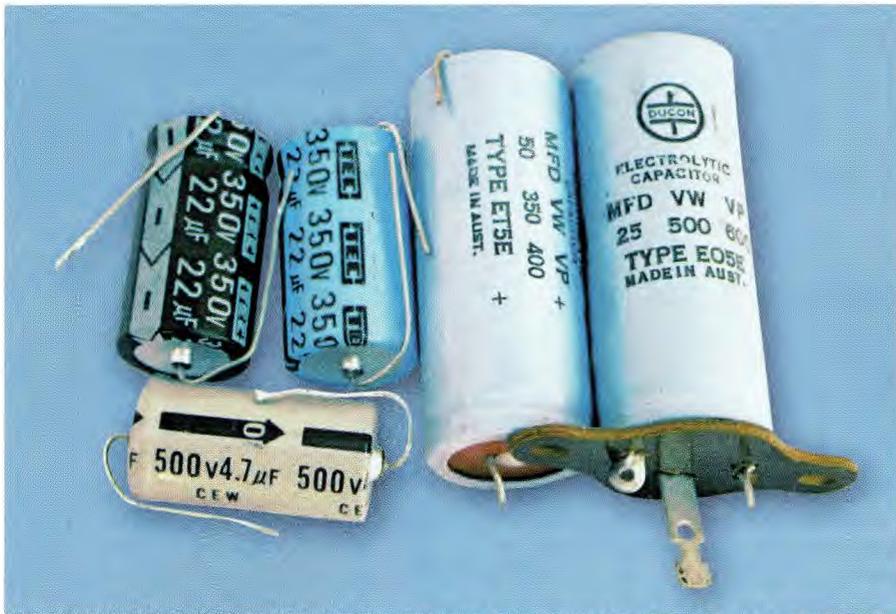
Electrolytic capacitors can also be unreliable and need to be carefully checked, both for leakage and for capacitance value. Again, you can hide modern units inside the “shells” of the originals to keep the appearance authentic.

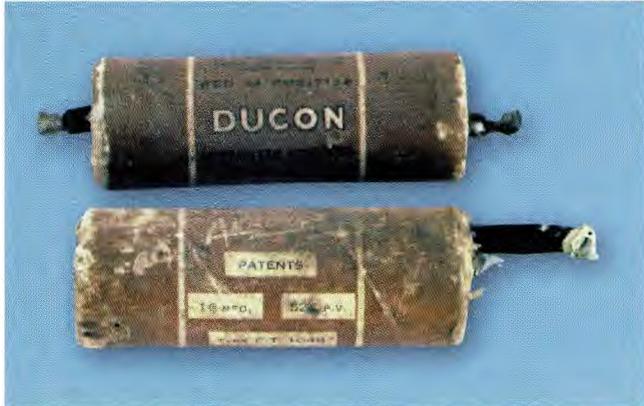
This photo shows a couple of old Ducon paper capacitors. They were notoriously unreliable.

Or would they? Unfortunately, at that time, the replacements were the Ducons and UCC capacitors of the 1950s and early 60s. These proved to be quite troublesome in service.

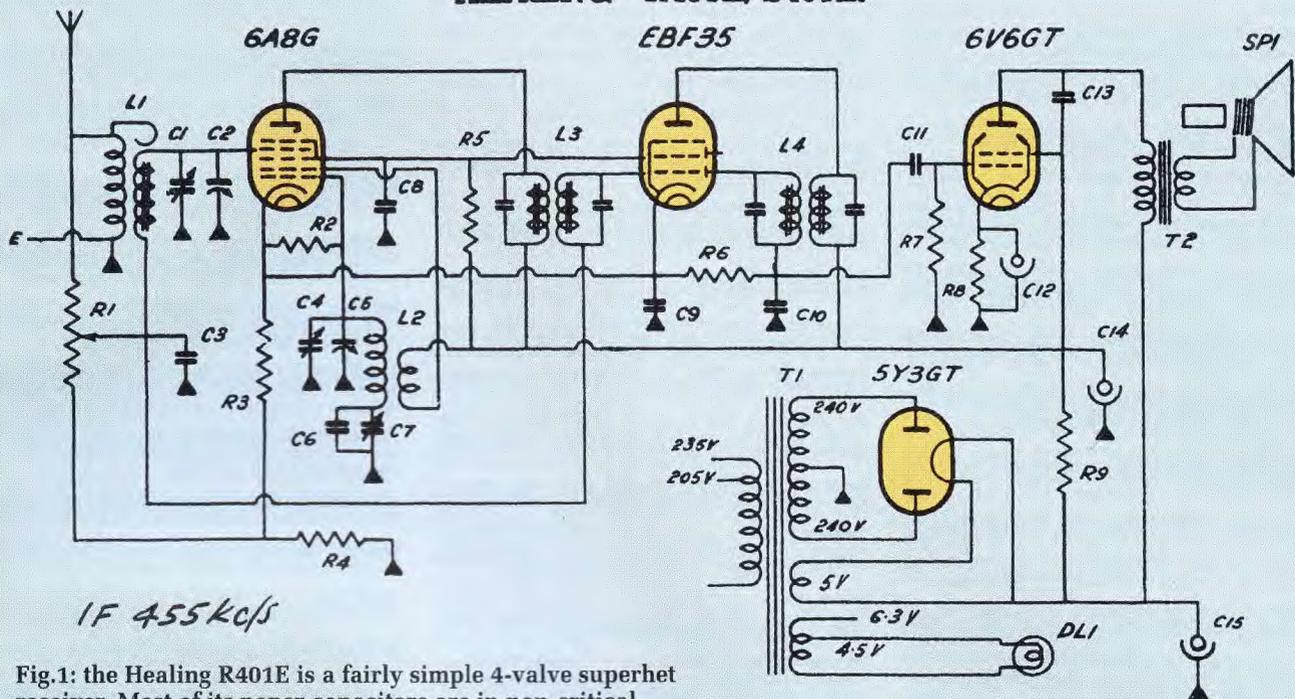
HEALING R401E/S401E.

Fig.1: the Healing R401E is a fairly simple 4-valve superhet receiver. Most of its paper capacitors are in non-critical locations when it comes to leakage.

The R401E has no AGC and only one audio stage, so that greatly simplifies matters. Generally, bypass capacitors (such as a screen bypass) can have a leakage resistance of 10 times the value of the screen dropping resistor and the performance of the set will be little affected (if noticeable at all).

20 times, with a minimum of around 2MΩ. In this case, screen bypass capacitor C8 could have a leakage of 20 times the value of R5 (20kΩ) which is 0.4MΩ but as just stated, I would replace it if it were below 2MΩ just to be on the safe side.

Note that C8’s voltage rating is 400V, although the operating voltage is around 116V. However, the voltage across this capacitor could be as high as 330V just after switch-on, as the 5Y3GT is operating and supplying peak DC voltage well before the other valves start drawing any current.

C3 is used as an RF bypass and is connected to potentiometer R1 which has a resistance of 50kΩ. Even with R1’s moving arm at the centre of its travel, the maximum resistance to earth is around 14kΩ and so the maximum voltage across C3 is only about 35V. As a result, C3 isn’t highly

C9 is the cathode bypass for both of the radio frequency (RF) valves (6A8G & EBF35). This capacitor is in parallel with R3 which in turn is in series with R4 and R1 in parallel. As a result, the resistance from the cathodes of these two valves to earth is around 3kΩ and so the leakage across C9 could be as low as 60kΩ without causing problems.

By contrast, C10 is a mica capacitor and it must have very low leakage – ie, greater than 20MΩ internal resistance. In practice, mica capacitors generally have extremely low leakage (high resistance) and rarely need replacing.

Next, we come to the critical audio coupler – capacitor C11. Resistor R7 has a value of 1MΩ, so as a rule of thumb, I would expect C11 to have greater than 20MΩ of resistance or I would replace it. There’s not much voltage across this capacitor though, so it’s quite unstressed in this circuit.

The voltage across C10 will vary from around +35V to perhaps +20V, depending on the setting of the volume control and the strength of the received station. Assuming that C11 has a resistance of 20MΩ, this means that the voltage at the junction of R7 and C11 will be just under +2V. This voltage is applied to the grid of the 6V6G and will cause it to draw more current, so the voltage across R8 rises by almost 2V to almost bring the stage back to its correct bias.

In this set, a 20MΩ leakage across C11 is probably acceptable as the valve is not being pushed hard. However, I would still replace it if it were below 50MΩ leakage resistance. Note that although the maximum voltage across this capacitor is only 35V, it is rated at 600V!

“screechy”) and as an RF bypass to filter out any residual 455kHz energy in the audio amplifier. Once again, there is only around 40V DC and about 150V of audio impressed across this capacitor which is also rated at 600V.

R9 and output transformer T2’s primary are connected in series across C13 and have a combined resistance of about 4.5kΩ. Once again, this capacitor could theoretically be quite leaky at around 20 times this value (ie, 90kΩ) without having any real affect on the set.

In summary, there’s only one paper capacitor in this set that’s under any real stress and that’s screen bypass capacitor C8. The others all have quite an easy life and can have quite high leakage without upsetting the operation of the receiver. This means that you may not have to replace any paper capacitors when restoring this set (except for C8), which is contrary to what many people have believed in the past.

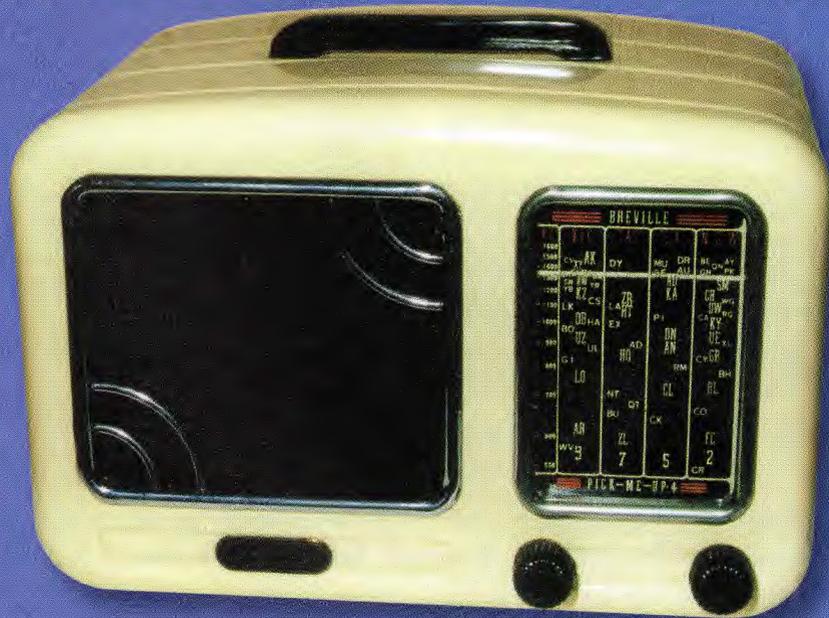
Photo Gallery: Breville 621 Pick-Me-Up-4

Introduced in 1947 by Breville Radio, Sydney, the 621 was housed in a painted metal cabinet fitted with a carrying handle. However, the set wasn’t really a portable, being designed for mains-only operation. The valve line-up was as follows: EK2G frequency changer; 6G8-G reflexed IF/audio amplifier/AVC rectifier; 6V6-GT audio output; and 5Y3-GT rectifier. Photo: Historical Radio Society of Australia, Inc.
