Vintage Radio

Those troublesome capacitors, Pt.2

Some vintage radio receivers are far more tolerant of leaky capacitors than others. It all depends on the circuit configuration and the role of each individual capacitor.

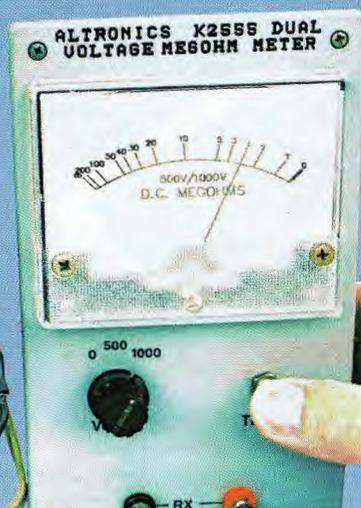
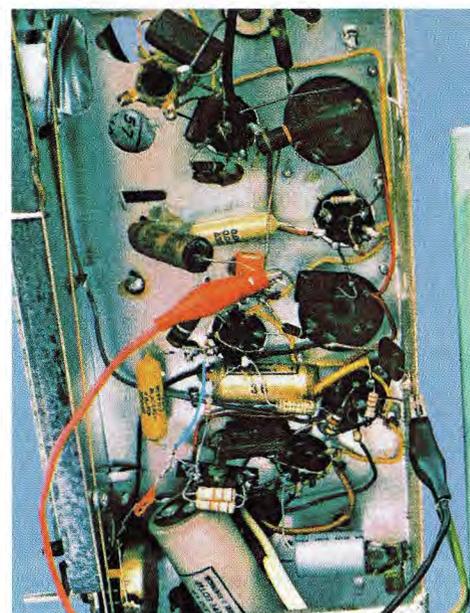
A high-voltage tester is necessary for testing capacitor leakage resistance.

There are two test procedures that will usually sort good paper capacitors from the bad ones. A check of the resistance between the two terminals of the capacitor is one such test. However, a normal multimeter will not give a reliable indication of the leakage resistance, as the applied voltage will be no higher than around 9V. Instead, it must be done using a high-voltage tester.

Altronics have such a high-voltage tester as a kit (Cat. K-2555) and the price is quite reasonable. It can test capacitors for leakage at either 500V or 1000V and is invaluable for test-

A high-voltage test will usually show up any capacitor with a leakage resistance of 200M Ω or less. 200V capacitors can be tested on the 500V range, as they usually have a peak rating well in excess of their normal operating voltage. Similarly, 400V units can be tested at 500V, while 600V (or 630V) capacitors can be tested at 1000V.

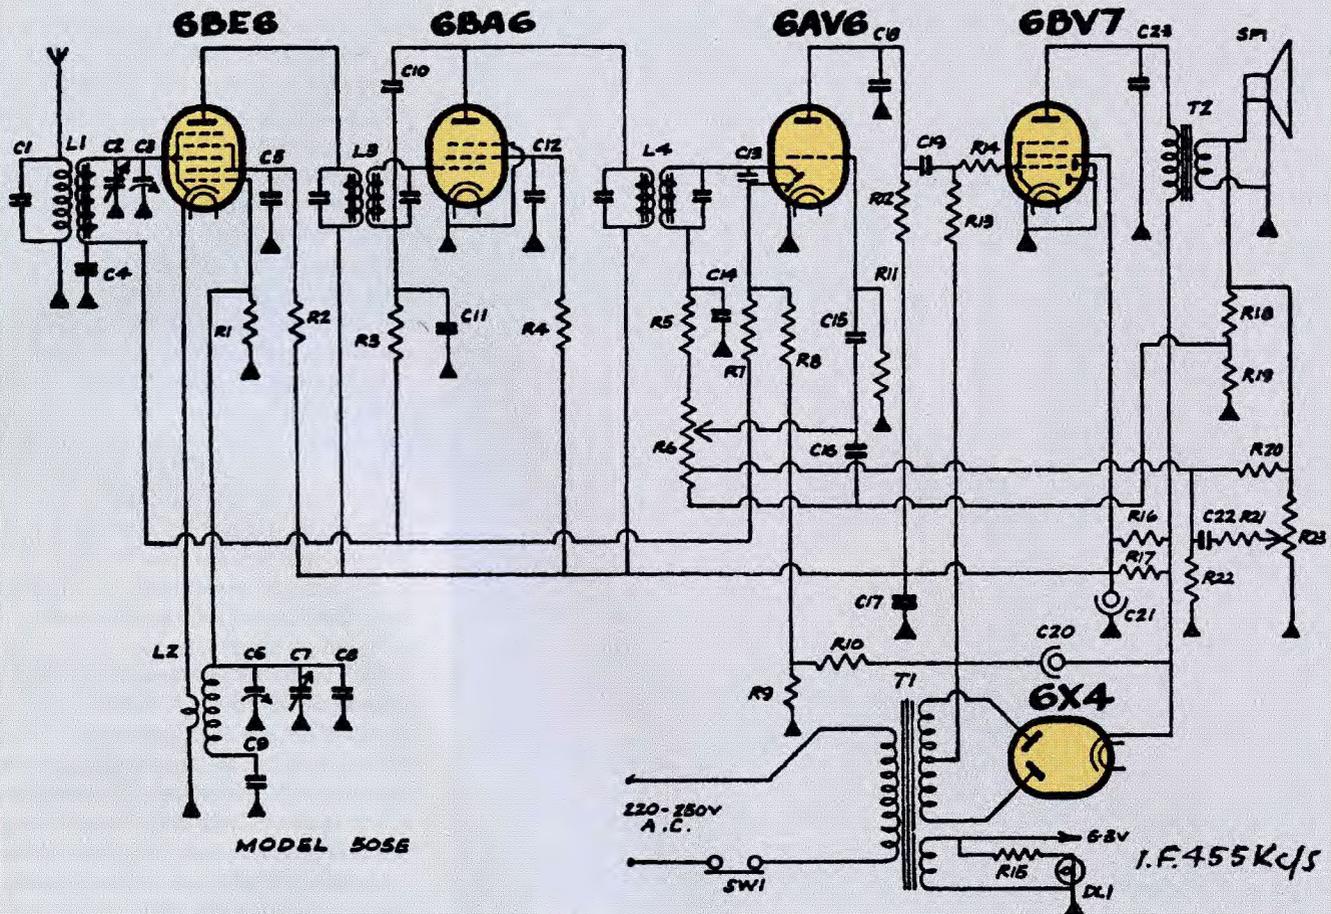
HEALING 505E

Fig.1: unlike the Healing R401E, the circuit operation of the 505E model is easily upset by leaky capacitors.

As shown in Fig.2, this set is quite different to its older brother. We'll

start by considering capacitors C5 and C12. These are screen bypasses and the leakage across C12 should not be less than $20 \times R4$ (ie, $20 \times 100k\Omega$) which is equivalent to $2M\Omega$. If C12's resistance is much less than this, the voltage on the 6BA6's screen will be noticeably less than intended and the performance of the set will suffer.

By contrast, C5's leakage can be somewhat greater (less resistance), as R2 is only $22k\Omega$.

C4 (the AGC bypass) is supplied with AGC voltage via R7 ($1M\Omega$) and both the 6BE6 and 6BA6 valves receive back bias via a combination of R7 and R8. If C4 were to become leaky to any extent, the bias on the valves would

We now come to capacitor C15 which couples the audio from the detector to the first audio stage (6AV6). The maximum voltage across this capacitor will be no more than about 20V and yet it is rated at 600V! Note also that the grid resistor (R11) for the 6AV6 is a $10M\Omega$ unit.

Let's see how this occurs. As shown on Fig.1, the volume control (R6) wiper taps off a variable amount of audio and negative voltage relative to earth. This variable negative voltage is applied to the bottom end of C15, while the top end has around -1V on it relative to earth (ie, the contact potential bias).

Now let's assume that the voltage developed at the top of R6 (relative to earth) is -15V and that the wiper is at this position (ie, maximum volume). Further, let's say that the leakage resistance across C15 is R_L . In operation, R_L

and R11 will act as a voltage divider across R6. As a result, the voltage at the junction of C15 and R11 is $[(R_{11}/(R_L + R_{11})) \times -15V]$.

OK, now let's assume that C15's leakage resistance (R_L) is $50M\Omega$. By plugging this figure into the above equation, we get $[10M\Omega/(50M\Omega + 10M\Omega)] \times -15V = -2.5V$.

If this is added to the existing -1V contact potential bias, it means that there could be as much as -3.5V of bias on the 6AV6. In practice, however, the voltage will be probably be somewhere between -2.5V and -3.5V. But even -2.5V is enough to cut off a 6AV6 in this circuit, resulting in no output on a strong signal at "full" volume!

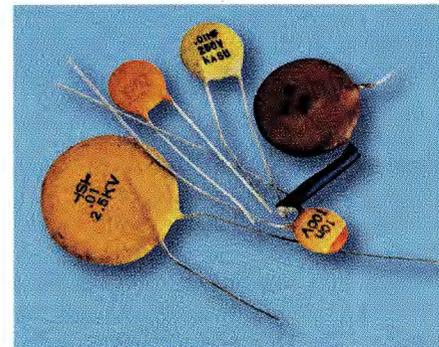
Disc ceramic capacitors are ideal for use as AGC bypasses. They are reliable, have very low leakage and easily hidden under other components.

My practice is to replace the AGC capacitor without even testing it and I like it to have a leakage resistance of at least $100M\Omega$. In fact, I usually replace AGC bypasses with 50V disc ceramic capacitors. They are reliable and easily hidden under other components.

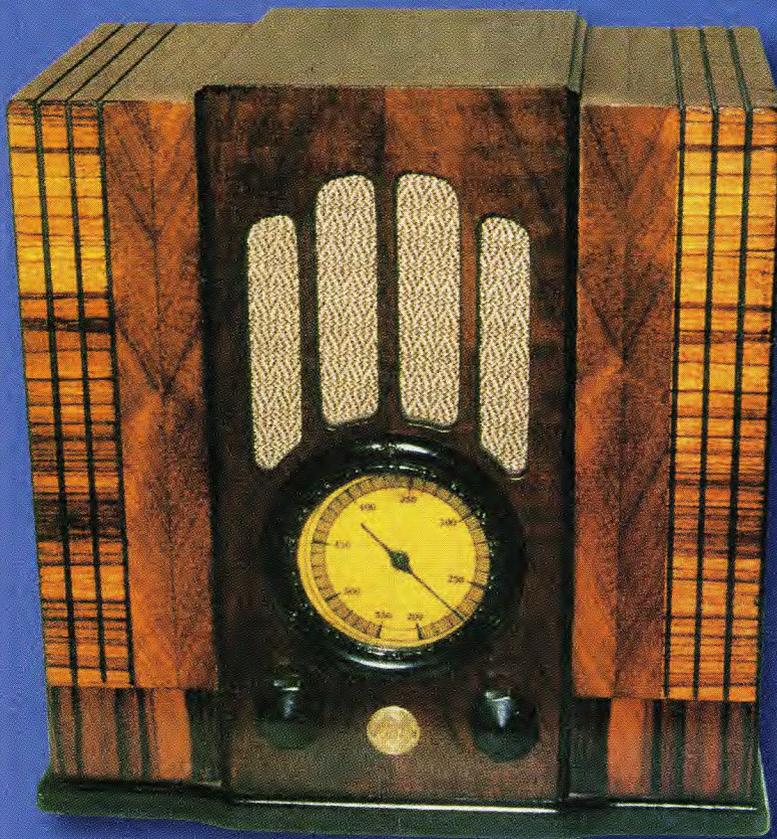
Photo Gallery: General Electric Duette

Manufactured in 1934 by AWA, the “Duette” was a 5-valve reflexed superhet receiver that was electrically equivalent to the AWA Radiolette Model 27. The valve line-up was as follows: 78 RF amplifier, 6A7 frequency changer, 6B7 reflexed IF/audio amplifier/detector/AVC rectifier, 42 audio output and 80 rectifier. Photo: Historical Radio Society of Australia, Inc.

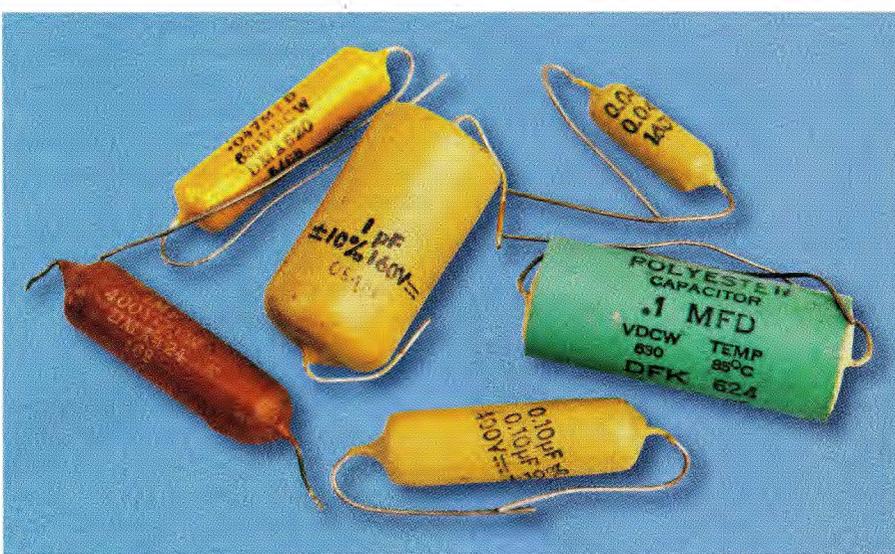
Polyester capacitors come in all sorts of sizes and voltage ratings. They have low leakage (although not as good as polystyrene types), are generally very reliable and can be easily hidden inside the cases of defunct paper capacitors.

(5.) To ensure authenticity, keep at least some non-critical paper capacitors in a set. A good trick is to remove the internals of paper capacitors and fit polyester capacitors (which are physically smaller) inside the cases of the old capacitors.

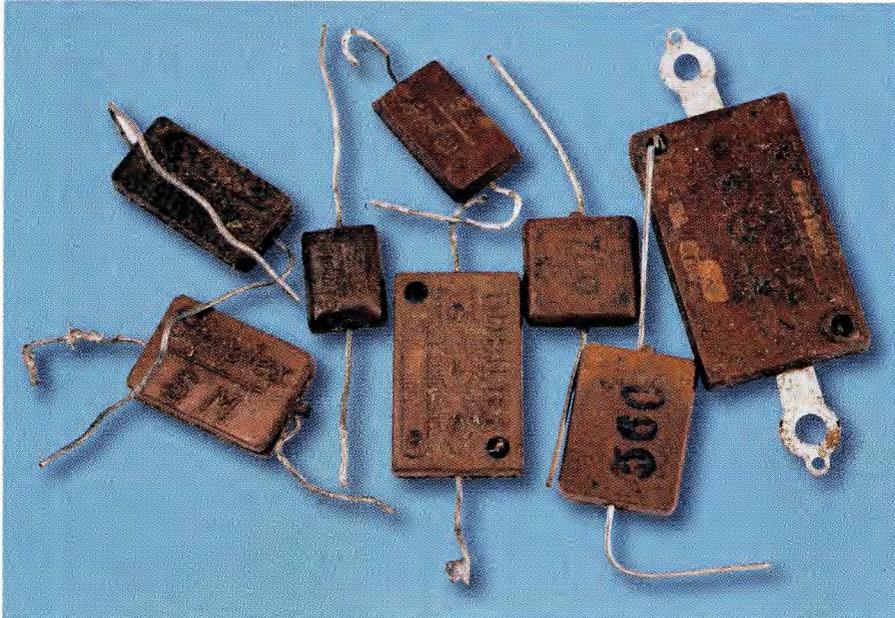
A selection of mica capacitors. Mica capacitors are usually quite reliable but when they do play up, they can be difficult to fault-find.

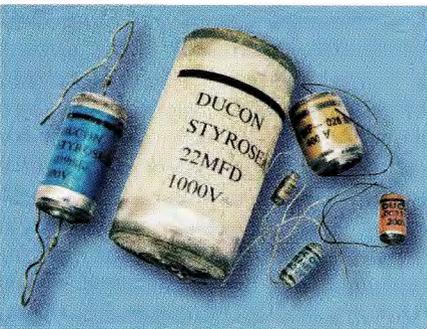
A selection of polystyrene capacitors made by Ducon. Polystyrene capacitors have extremely low leakage.
