# Vintage Radio

## The Astor AJS – an economy universal car radio

**Designed as an economy model, the Astor AJS car radio used six valves and could be used with both positive and negative earth vehicles. It also employed a vibrator power supply and was an excellent performer.**

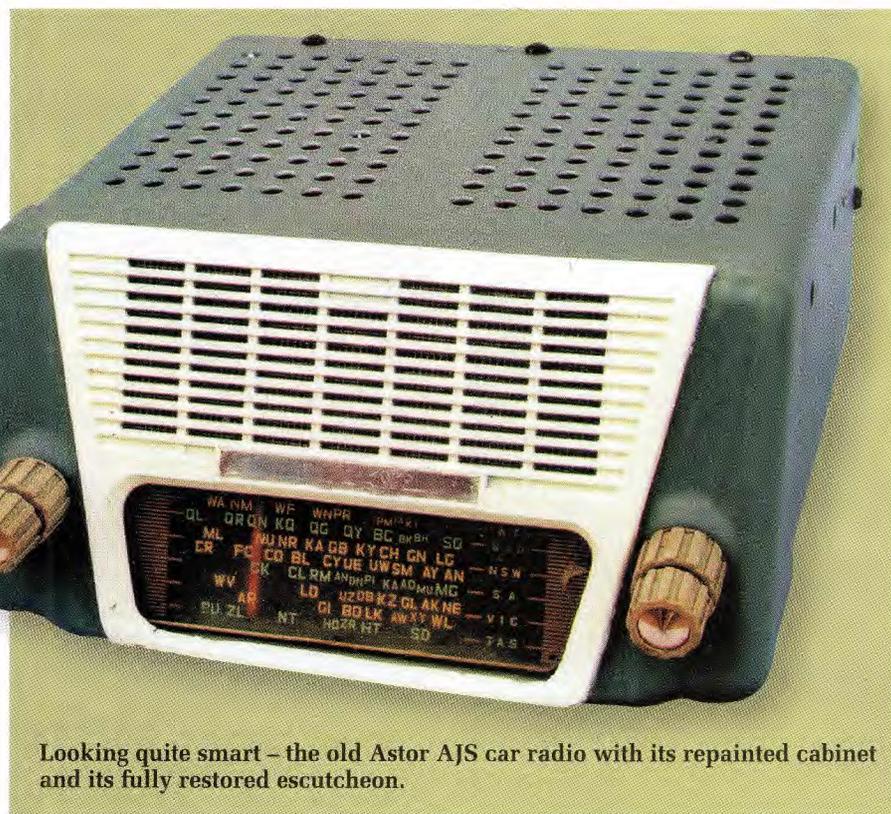
Looking quite smart – the old Astor AJS car radio with its repainted cabinet and its fully restored escutcheon.

receiver was in a rather sorry state. The first step was to give it a thorough clean-up. The case was given a good scrub in warm soapy water, then rinsed in clean water and allowed to dry – I didn't want it to rust any more than it already had! I then masked the escutcheon area and gave the case several coats of rust inhibiting paint from a spray can.

That done, I turned my attention to the broken front panel escutcheon. As had been suggested, I used Selley's "Knead-It" (available from hardware stores) to make a new piece to replace the missing section. However, I decided that the "Knead It" might also need reinforcing, so I obtained a short length of thin high-tensile wire and ran it along the area where the escutcheon would be.

First, a small hole was drilled into one end of the remaining escutcheon. One end of the wire was then placed in the hole and the other end was wedged under the other end of the escutcheon. That done, I then glued (with Araldite) the wire in several spots to the receiver case, along where the escutcheon would normally be. Finally, I got out the "Knead It" and laid it along and around the wire. I initially found it a little difficult to knead but warming up the material makes it more pliable

After about half an hour, it had set and using a knife and file, I was able to shape the hardened material to match the profile of the missing section. Once it had fully hardened, I spray-painted the whole escutcheon in the nearest colour available in a spray paint can.

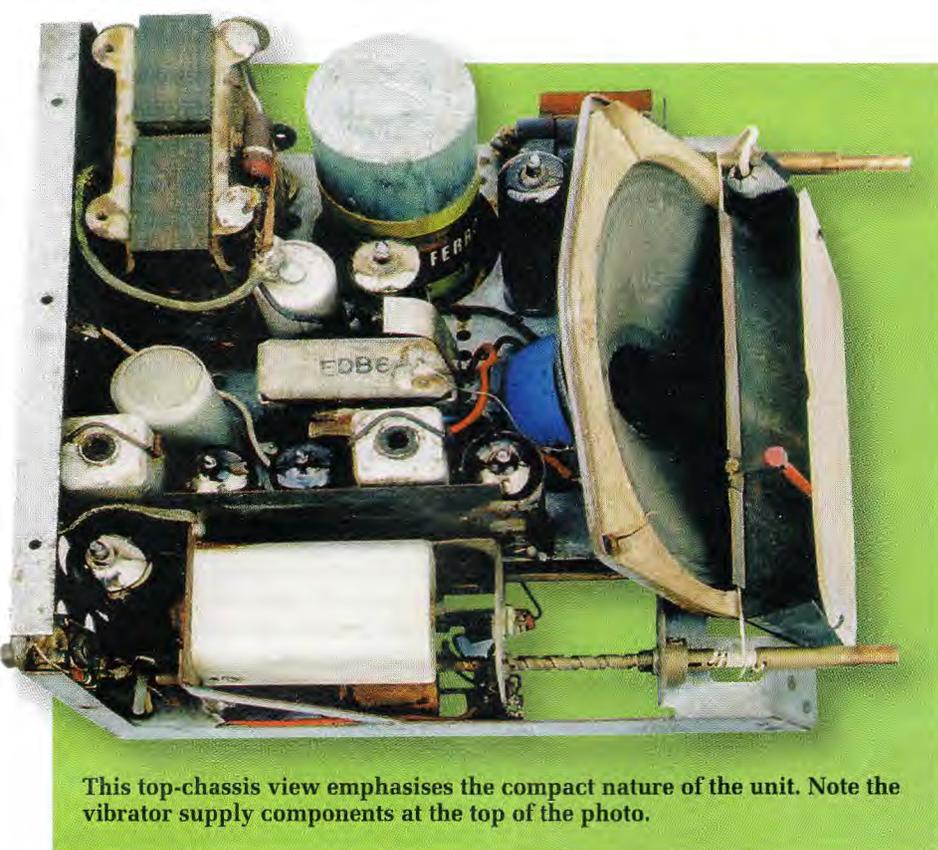
This top-chassis view emphasises the compact nature of the unit. Note the vibrator supply components at the top of the photo.

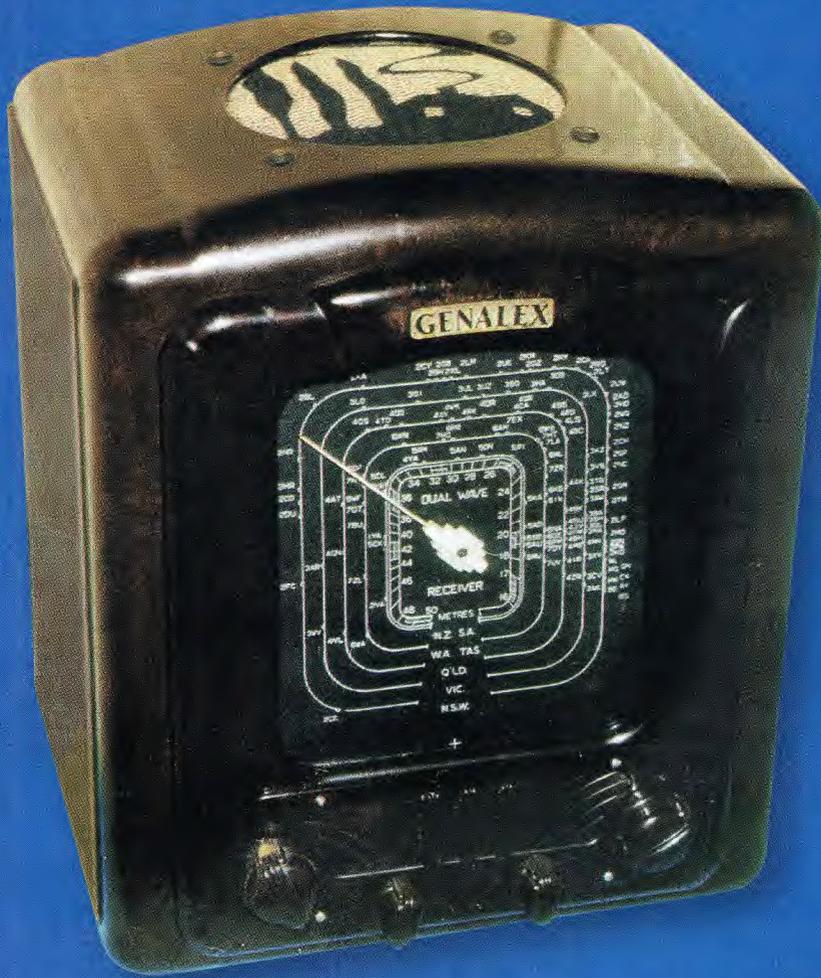
## Photo Gallery: Genalex Model 610

Manufactured by the British General Electric Company Ltd, Sydney in 1939, the Genalex Model 610 was a dual-wave superheterodyne set that covered both the medium-wave and the 6-18.75MHz short-wave bands. An extra large dial was fitted to the front of the receiver, while the speaker faced upwards, the sound exiting from the top of the receiver. The valves fitted were as follows: 6K8-G frequency changer, 6U7-G IF amplifier, 6G8-G audio amplifier/detector/AVC rectifier, 6V6-G audio output and 5Z4-G rectifier. Photo: Historical Radio Society of Australia, Inc.

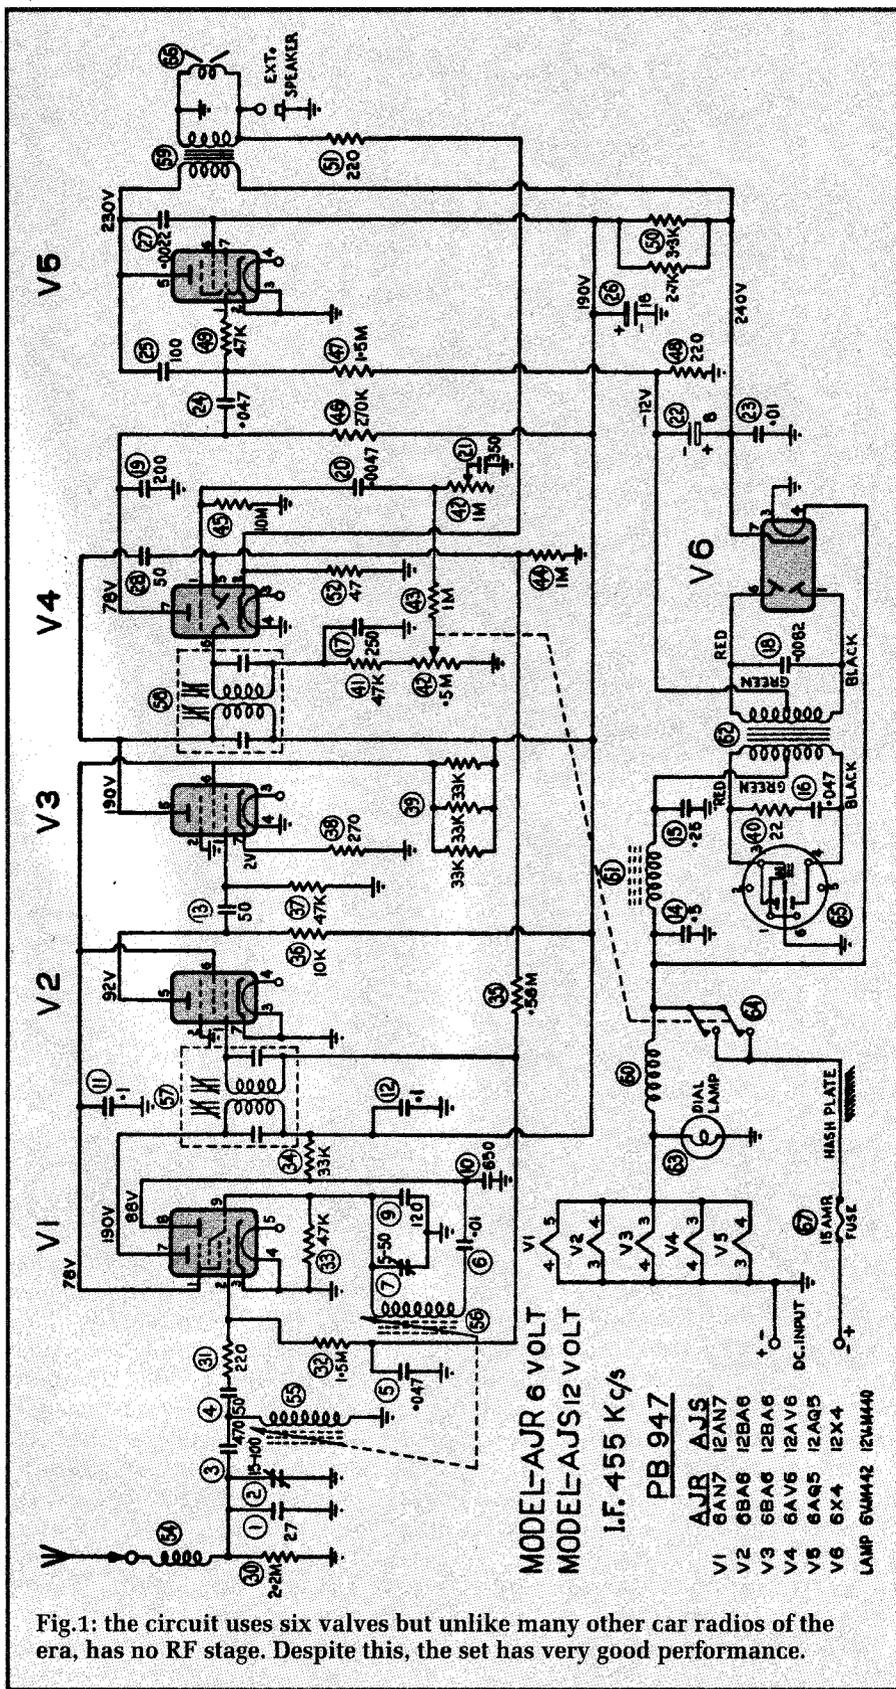
Fig.1: the circuit uses six valves but unlike many other car radios of the era, has no RF stage. Despite this, the set has very good performance.

The circuit for this receiver is somewhat different to most car radios of the era. That's because it has no radio frequency (RF) stage. Instead, the received signal feeds straight into the converter – a 12AN7 (or 6AN7 in the 6V version).

ceiver is also rather unusual, in that it has two valves (V2 and V3) between the two IF transformers. These valves are both 12BA6s (or 6BA6 for 6V) and are resistance-capacitance coupled. In fact, the circuit looks a bit like an audio stage except that the component values are different. It uses a 10k $\Omega$  plate resistor, a 47k $\Omega$  grid resistor and a coupling capacitor of just 50pF.

The signal detector and AGC diode both have a small delay before they operate. This means that the receiver is slightly muted between stations, as the diode detector has bias on it due to the fact that V4's cathode is a

fraction of a volt positive compared to the detector plate. This delay also provides the delayed AGC.

The audio amplifier stages are quite conventional and similar circuits are used in many mantel radios. Back bias is provided for the 12AQ5 by the voltage drop across resistor 48. Negative feedback is provided from the secondary of the speaker transformer to the cathode of V4 via resistors 51 and 52. These two resistors form a voltage divider, so that just the correct amount of negative feedback is applied. The audio top-cut filter/IF signal bypass capacitor (27) is wired from plate to screen, which reduces the voltage across this capacitor.

The power supply is a standard vibrator circuit, as used in almost all Astor vibrator car radios. Compared to those used in household vibrator power supplies, the filtering in this set is minimal.

A valve rectifier is used to convert the square wave AC from the vibrator into DC. The advantage of having a valve rectifier is that the active power lead from the set can be connected to

either +12V or -12V, depending on whether the car uses positive or negative earthing.

Components 18 and 16 are the buffer capacitors. As mentioned earlier, capacitor 18 can be troublesome but capacitor 16 rarely gives trouble as it is not highly stressed.

Another feature used to reduce interference into and out of the receiver is the "HASH PLATE", as seen on the lower left of the circuit. In this receiver, it consists of a metal strip along the side of the chassis, near the vibrator power supply, and is about 80mm long and 12mm wide.

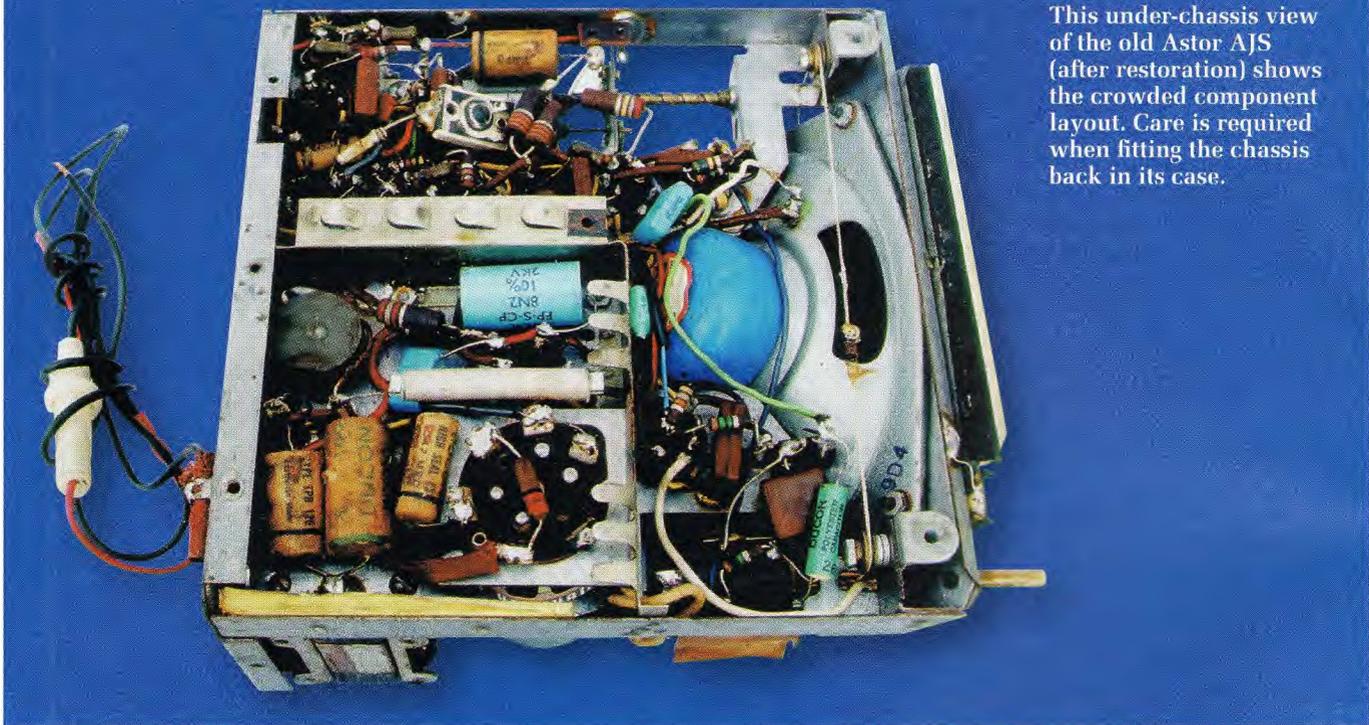
This under-chassis view of the old Astor AJS (after restoration) shows the crowded component layout. Care is required when fitting the chassis back in its case.

Reinstalling the chassis into the case proved to be quite a task. That's because the set is crammed into the available space and there is very little clearance between the chassis components and the cabinet. In practice, I had to flex the cabinet so that I could slide the chassis in.

In the end, I moved a few parts around to make sure that the clearances were adequate. The set was working out of the cabinet so I shoe-horned it back in and tried it again. This time, it worked so I had obviously shifted the right item to stop it from shorting.

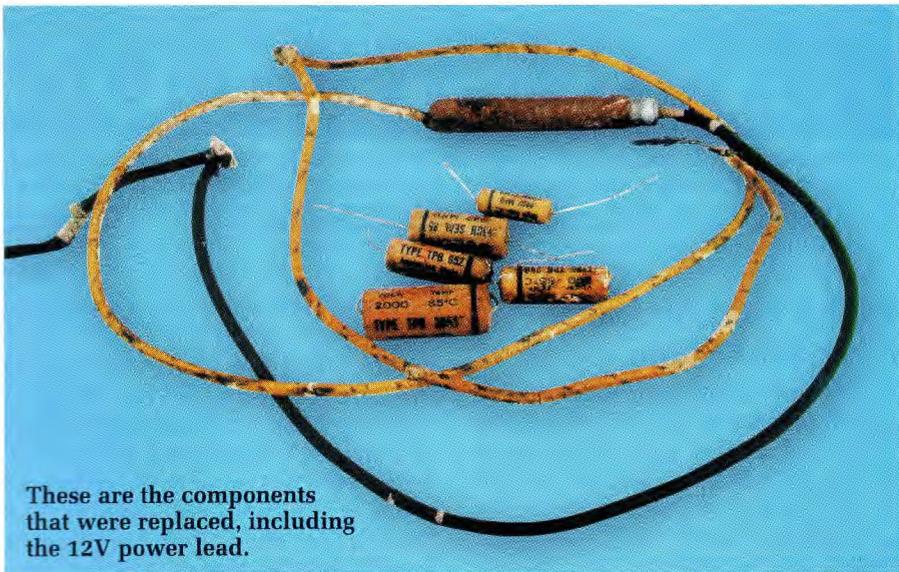
**These are the components that were replaced, including the 12V power lead.**

the set on. The power lead and the fuseholder were in very poor condition. The power lead was replaced with 3mm automotive cable, while the badly corroded fuseholder was replaced with a more modern plastic unit. This new fuseholder was spliced into the line using crimp connectors.

Astor car radios with vibrator power supplies had one component that caused considerable trouble and that was the 8.2nF (.0082 $\mu$ F) 2kV paper buffer capacitor across the plates of the rectifier valve. If this capacitor is not replaced, the vibrator may break down after only a few hours of operation. By contrast, some models used 4nF (.004 $\mu$ F) mica buffer capacitors which gave very few problems.

Finally, I checked all my usual suspect components and found that most were leaky. These were replaced, along with the buffer capacitor mentioned earlier. Basically, those components numbered (5), (20), (24) and (27) were replaced.
