# Vintage Radio

## Signal generators – what they are and how to fix them

An RF signal generator is a vital when it comes to servicing and accurately aligning vintage radio receivers. However, it's no good having a generator if it isn't working correctly or isn't calibrated.

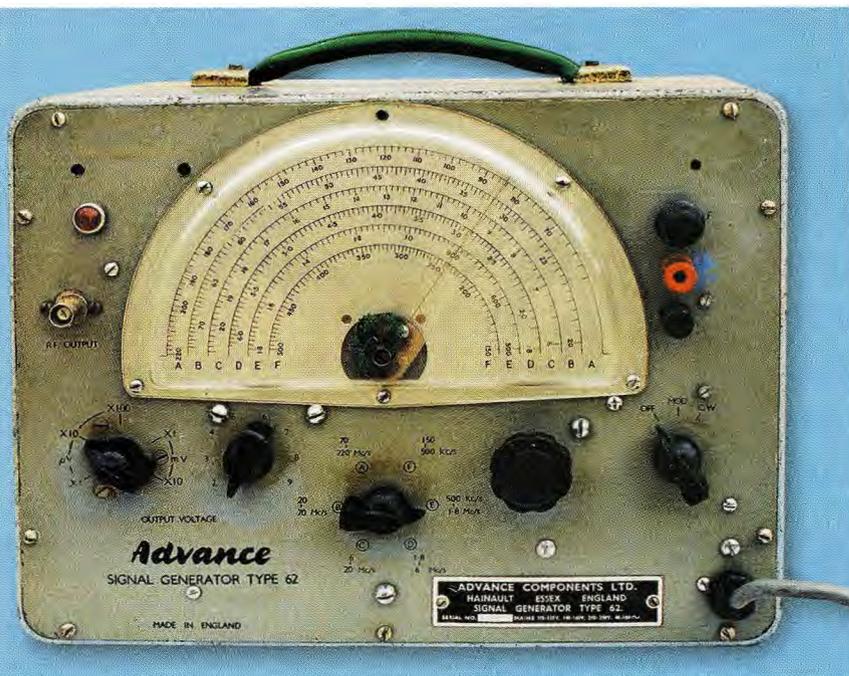
The Advance 62 signal generator is capable of generating frequencies from 150kHz to 300MHz over six ranges. It also features CW and tone modulation and is just the shot for aligning vintage radio receivers.

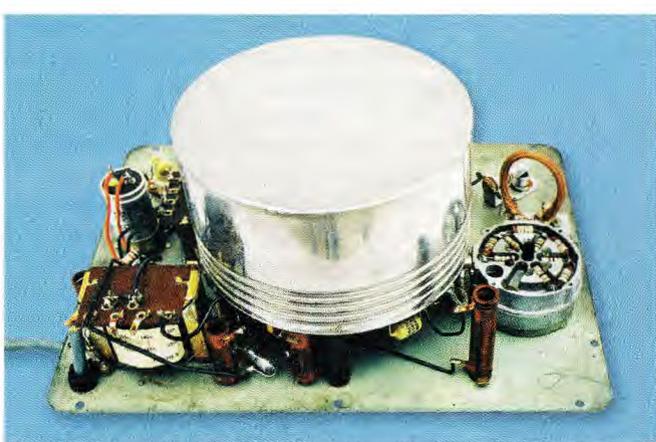
Above: inside the Advance 62 signal generator with the RF shield in place. The view at right shows the unit with the shield removed (ie, by unscrewing it).

The P1 and the 62 are also quite different in the amount of filtering and shielding that they use. The P1 has a bolt-on cover over the oscillator which lets some signal leak out along the edges, while the 62 uses a large aluminium can with a screw type lid. This forms a cheap but very effective shield to prevent radiation.

The switched signal attenuator in the P1 uses several resistors within "view" of each other. This allows the VHF signals to partially bypass the attenuator. By contrast, the 62 has a much better shielded attenuator that isolates each section of the attenuator from the next. Both of these attenuators can be seen with their rear shields removed in the photographs.

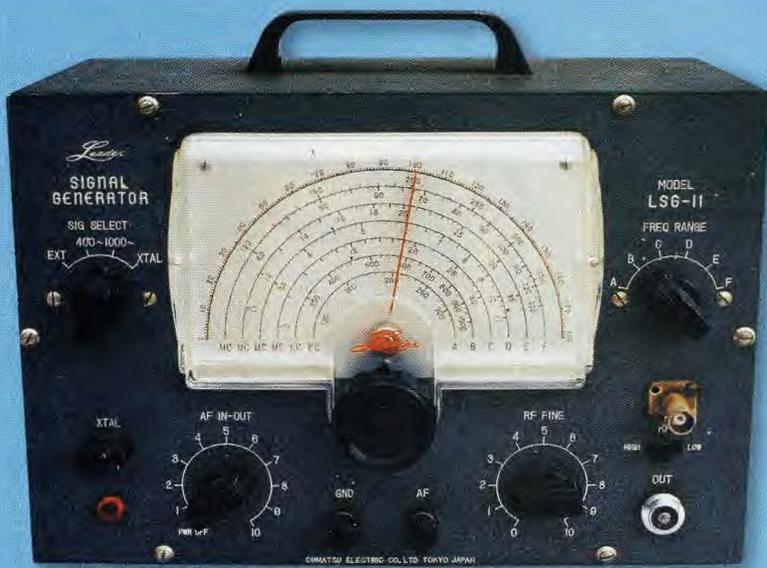
The Leader LSG11 is a low-cost generator but is still useful for aligning vintage radio receivers. It produces frequencies ranging from 120kHz to 130MHz.

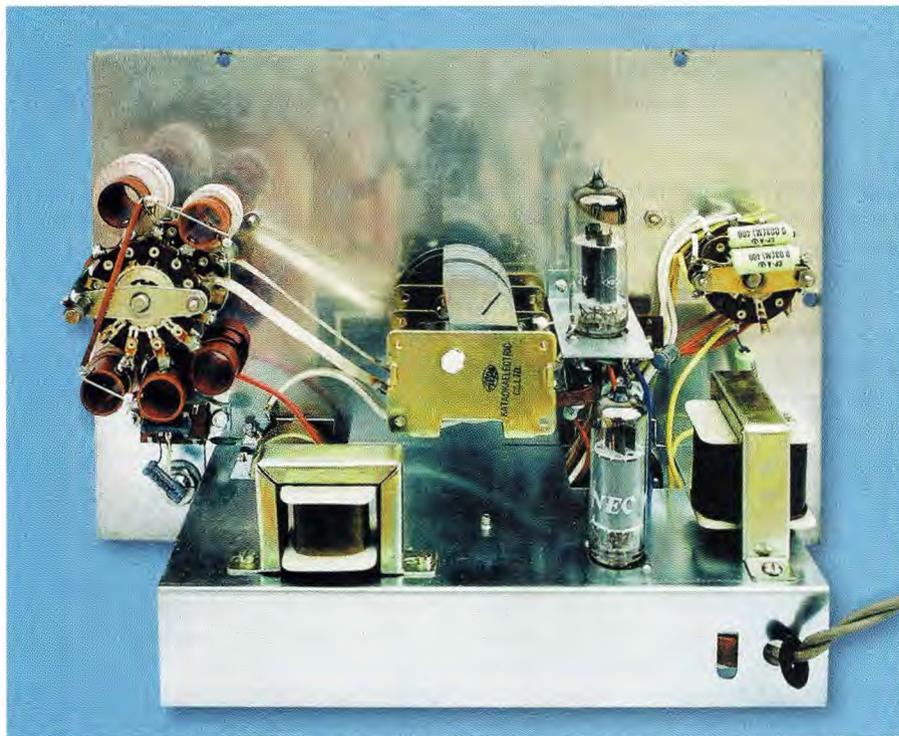
This is the view inside the Leader LSG11 signal generator. Note the switched coils and the tuning capacitor.

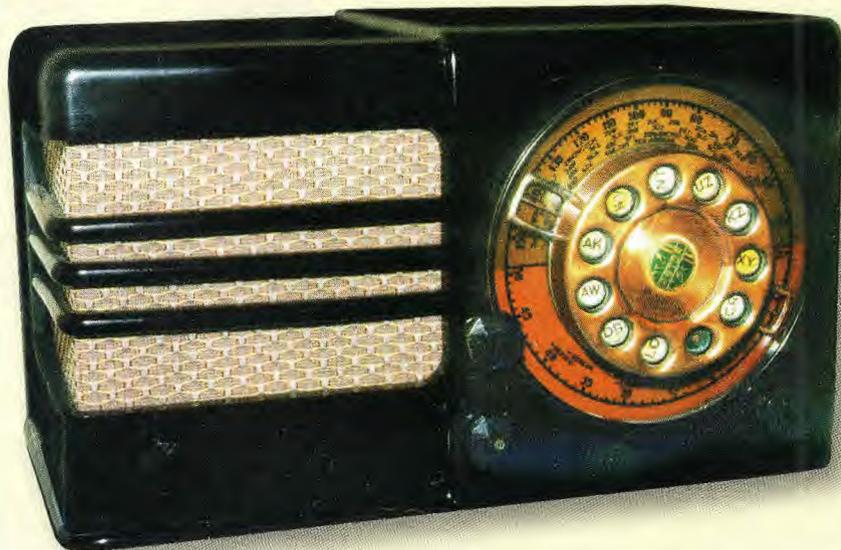
Manufactured by Radio Corporation, Melbourne, in 1938, the Astor Aladdin FH was designed for use in areas without mains power. The set used 2V battery valves and was fitted with a vibrator power supply running from a 6V accumulator. A distinctive feature was its "Presto" tuning (with telephone-style dial), which allowed for quick selection of preset stations. The valve line-up was as follows: IC7-G frequency changer; IF7-G first IF amplifier/AVC rectifier; IF7-G second IF amplifier/audio amplifier/detector; and IF5-G audio output. Photo: Historical Radio Society of Australia, Inc.
