# Vintage Radio

## The impressive AWA Radiola B32 transistor portable

Australian manufacturers produced several high-performance transistor radio receivers during the 1960s – an era that was to herald the end of local domestic radio manufacturing. One such set was the AWA Radiola B32 transistor portable.

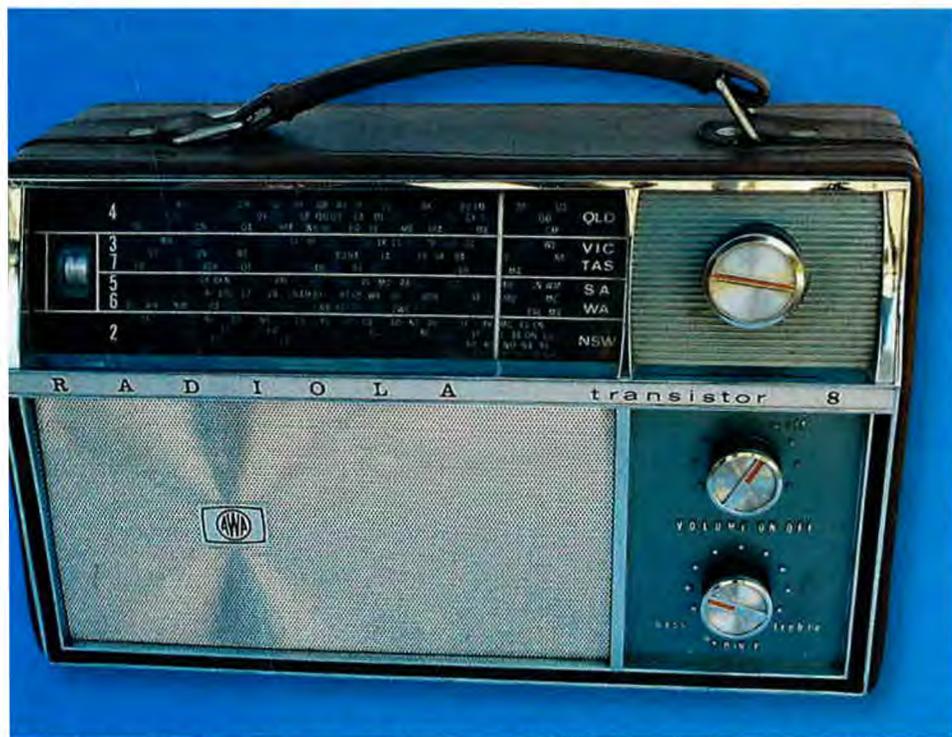
The AWA B32 transistor portable was a relatively large unit with a leather case and a metal front panel. This view shows the set after restoration.

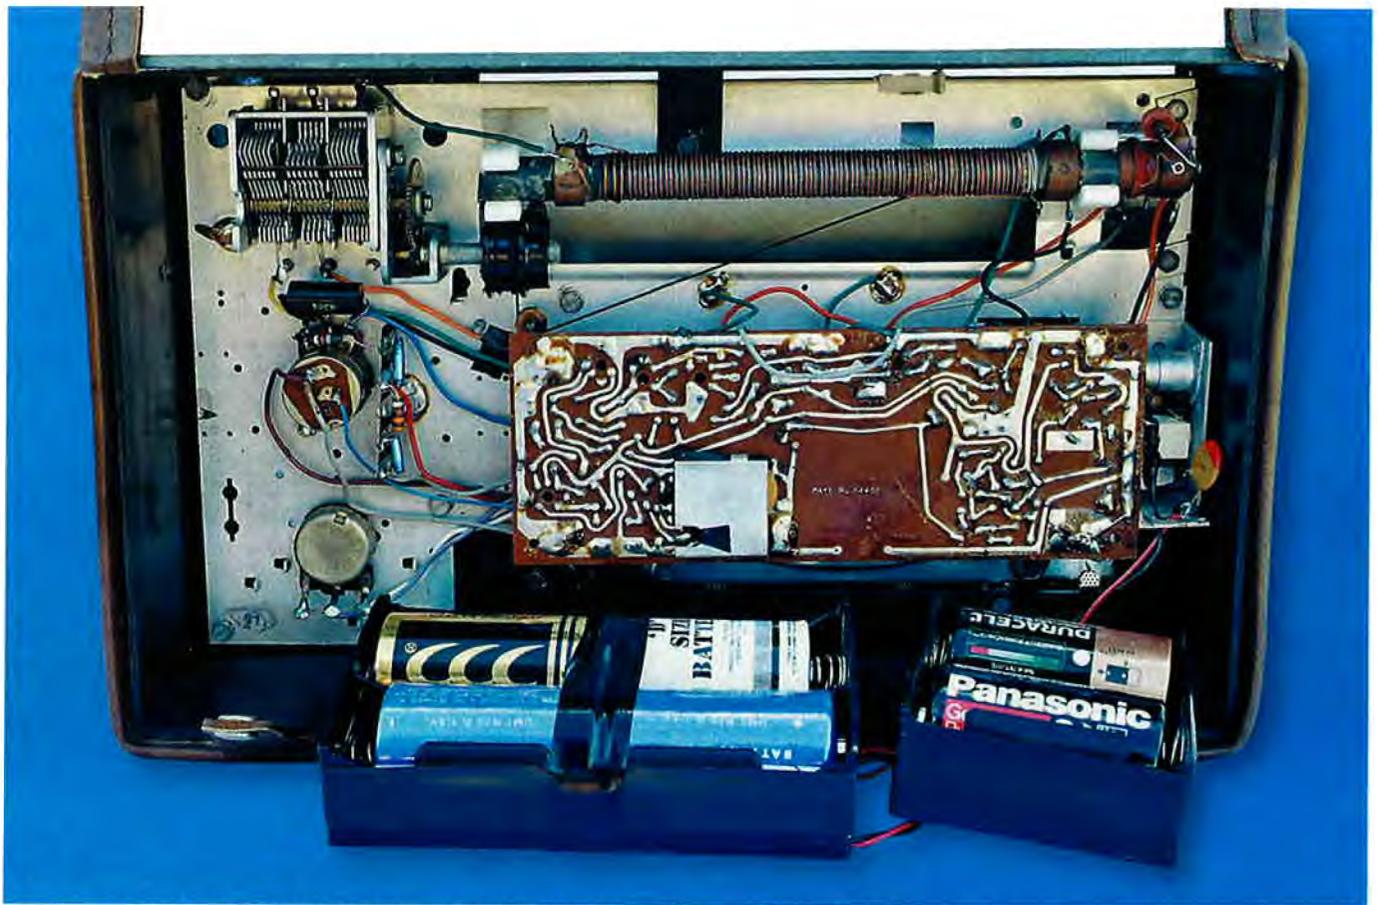
**This is the view inside the back of the set, with the modified battery packs in the foreground. The modified battery packs are necessary because the original 2761 type battery is no longer available.**

holders – one for four cells and the other for two cells – will fit into the space that the 2761 occupied.

In my case, I removed the battery plug and wired the battery leads to the two holders in series to obtain the required 9V. This arrangement works well and is the only “non-standard” work I needed to do in order to get the set working.

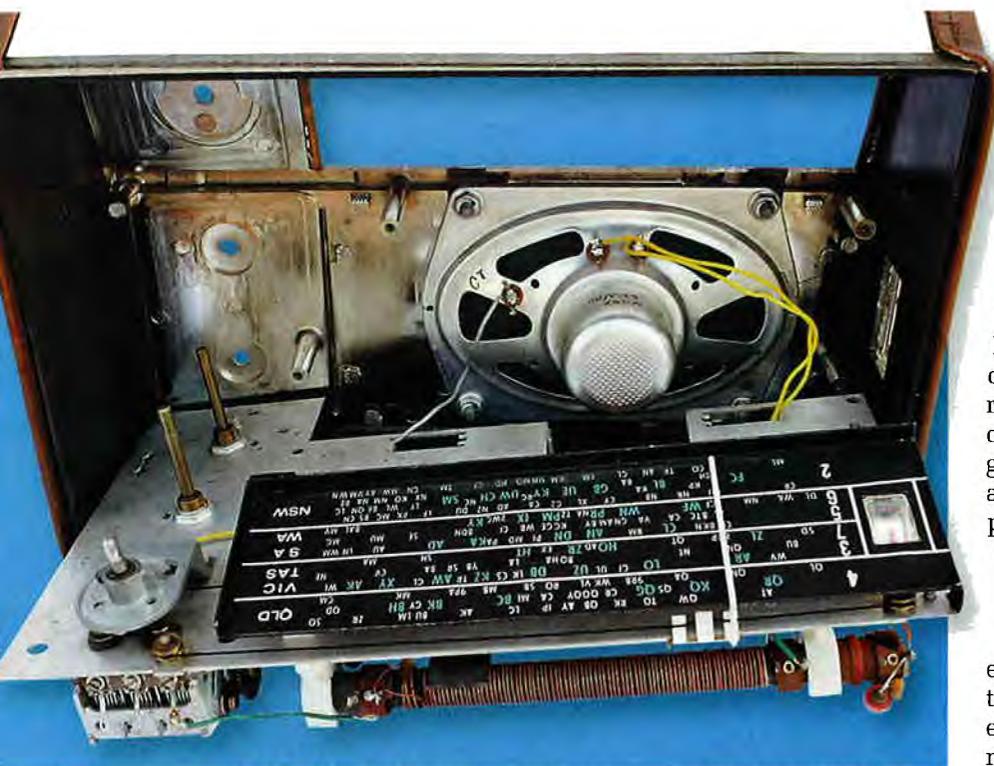
The set had quite bad distortion but I thought that this would be easy to fix. Well, the fault was easy to find – a bit of careful probing with the signal tracer revealed that the audio was fine up to the loudspeaker. A quick check with a multimeter then revealed that one half of the speaker voice-coil was open circuit.

This view shows the unit with the chassis out of the cabinet, as far as the loudspeaker leads will permit. The loudspeaker is a large oval-shaped unit, which contributed to the good sound.

Finally, the four nuts holding the speaker were undone and the speaker removed. But could I repair it? I could see the break in one of the voice-coil

leads, so I decided to attempt a repair using a small soldering iron, some thin solder and a short length of fine wire. I was in luck – the repair was successful.

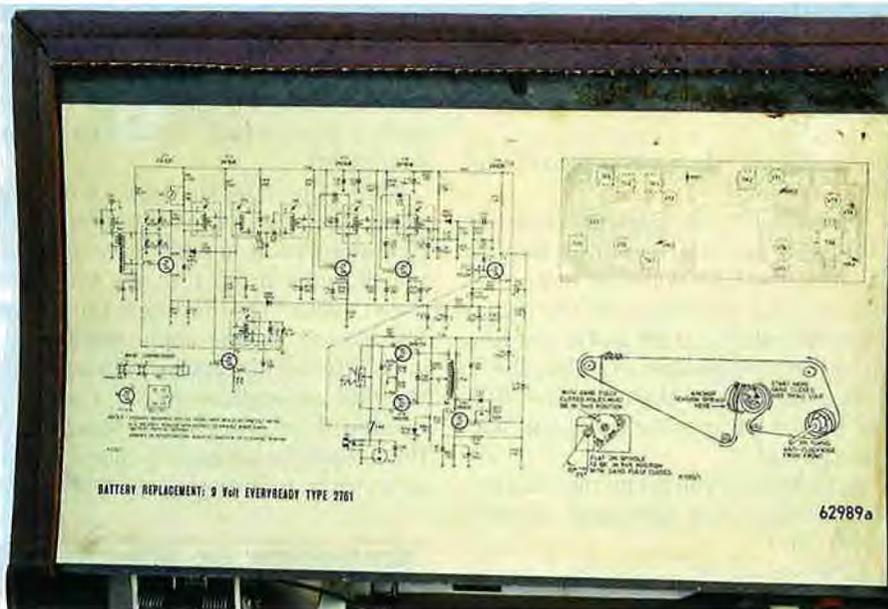
A full circuit diagram is pasted onto the inside back cover of the receiver, along with a diagram showing the dial stringing arrangement and a third diagram showing the locations of the major components (IF transformers & transistors).

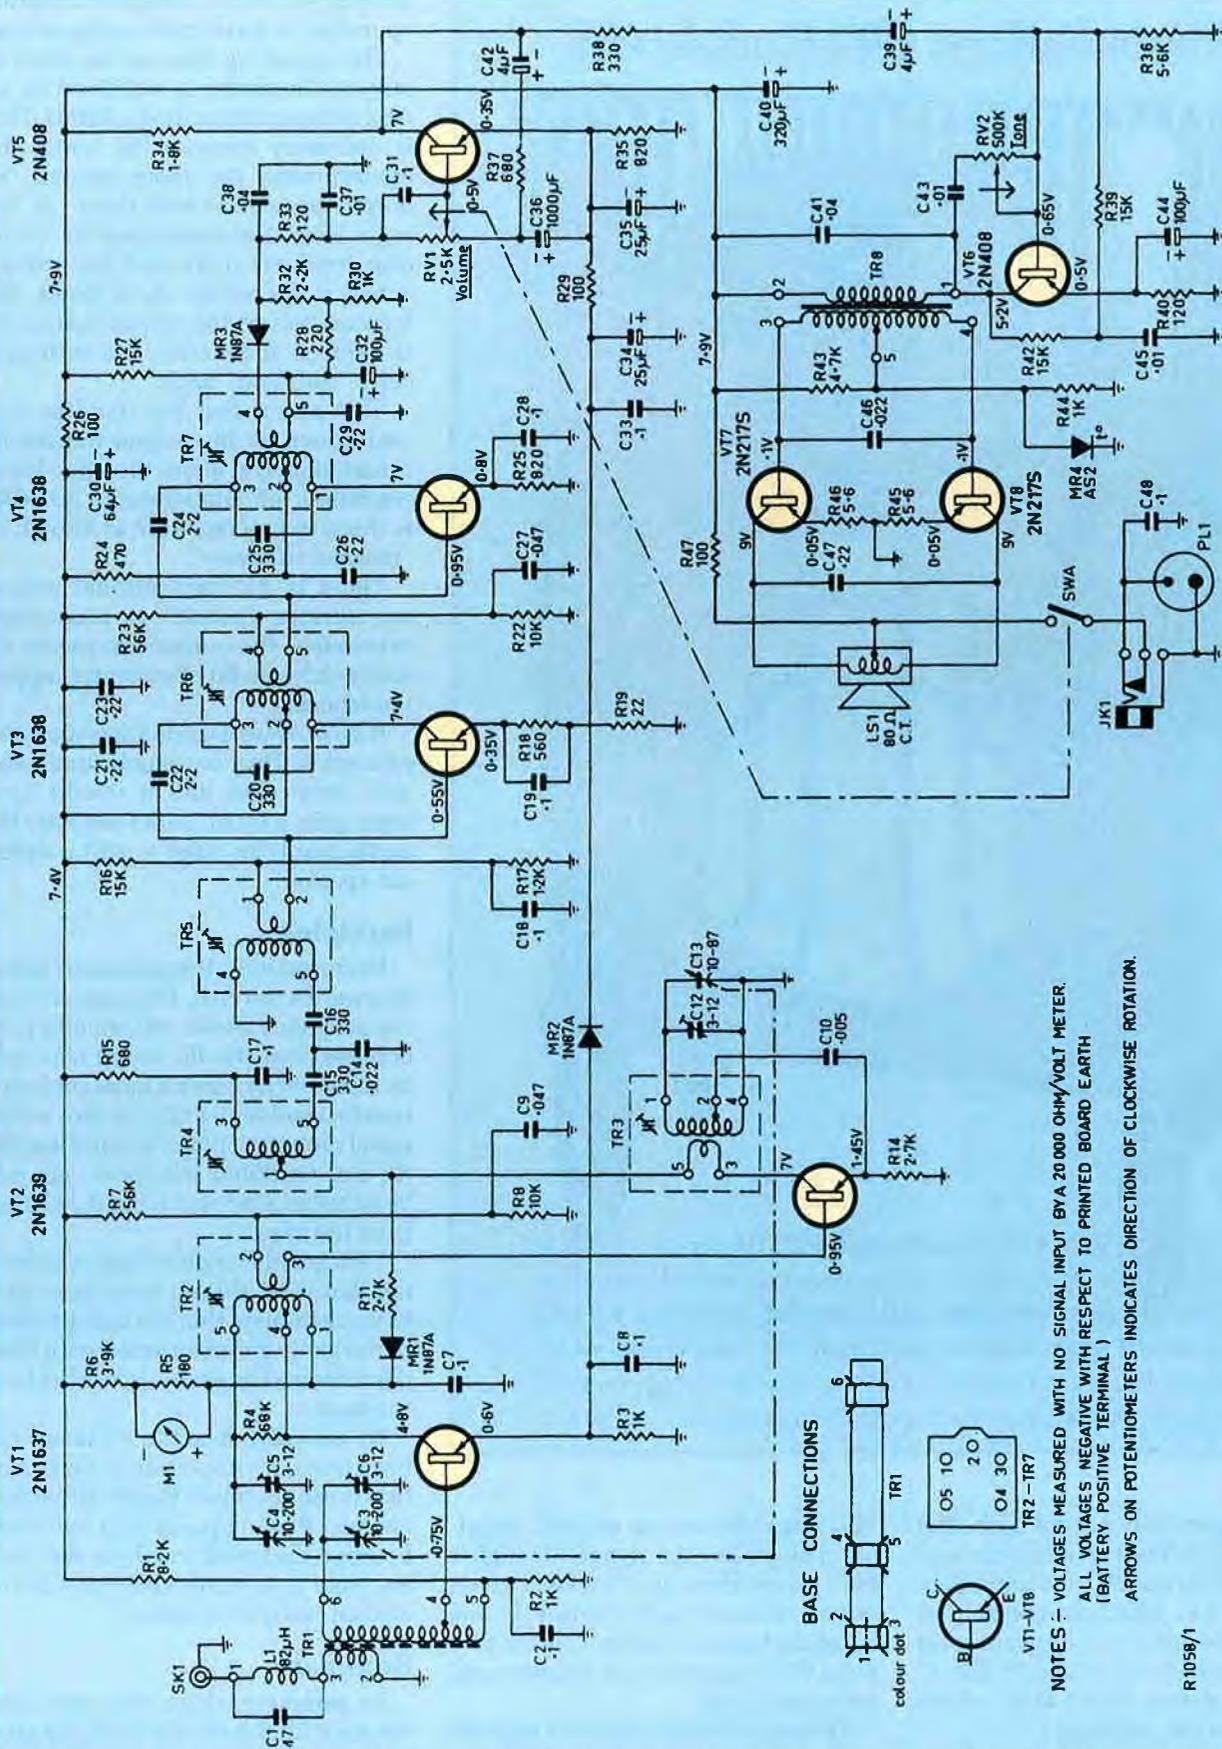
Fig.1 shows the circuit details of the B32. It uses eight transistors, all PNP germanium types, so all voltages are negative with respect to the chassis (ie, positive chassis).

The RF stage uses a 2N1637 transistor (VT1) which has automatic gain control (AGC) applied to it. A milliamp meter in the collector circuit displays the signal strength.

VT2 (2N1639) and TR3 function as an autodyne mixer. Its output signal is at the intermediate frequency (IF, 455kHz) and this is fed to a top-cou-

Fig.1: the circuit uses eight PNP germanium transistors in a conventional superhet configuration. Transistor VT1 functions as an RF stage, while the push-pull output stage (VT7 & VT8) drives an 80-ohm centre-tapped loudspeaker.

pled bandpass pair of tuned circuits (TR4 and TR5). The first and second IF amplifiers both use 2N1638 transistors (VT3 and VT4), which are neutralised C22 and C24 (after all, these are solid state equivalents of triodes)! The IF stage then drives diode MR3 which functions as the detector.

The detector output is fed to volume control RV1 and then to the base of the first audio stage (VT5, 2N408).

This stage also acts as an AGC amplifier. The greater the signal, the higher the current through VT5 for a given setting of the volume control (ie, the transistor turns on harder). This in turn pulls VT1's emitter more negative and reduces its gain.

The audio output from VT5 appears at its collector and is fed to VT6 (another 2N408) via a 4 $\mu$ F capacitor (C39). It's output is then transformer-coupled

to a pair of 2N217S output transistors operating in push-pull configuration.

The operating bias on the 2N217S output transistors is stabilised by an AS2 compensation diode (MR4). This is necessary because the hotter the environment, the more current the output transistors will draw. At the same time, the compensation diode also conducts more and the voltage across it decreases. As a result, the forward bias on the output transistors is reduced and so they are automatically "throttled" back.

This means that the standing current drawn by the output transistors is maintained at about the same level, regardless of temperature. So MR4 is there to prevent what is known as "thermal runaway".

There is no conventional output transformer. Instead, as mentioned previously, the output transistors directly-drive an 80-ohm centre-tapped loudspeaker.

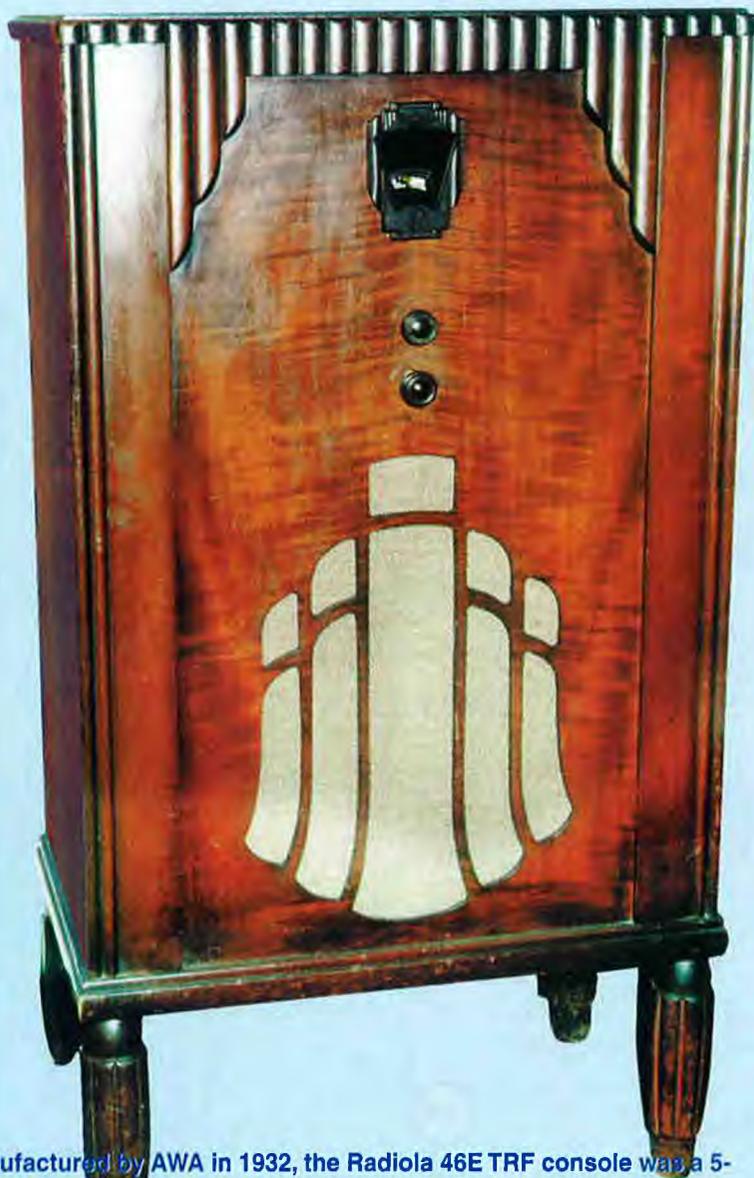
Manufactured by AWA in 1932, the Radiola 46E TRF console was a 5-valve "little brother" to the larger 55E console featured last month. In fact, its external appearance was almost identical to the 55E but it featured one less RF stage (and one less knob). The valve line-up was two 235 RF amplifiers, a 224A detector, a 247 audio output stage and a 280 rectifier. Photo: Historical Radio Society of Australia, Inc.
