Vintage Radio

The Harbros 12/54B transceiver

Designed specifically for rural fire brigade networks in the early 1950s, the Harbros 12/54B transceiver was a 12-valve unit with some interesting design features. It superseded army-surplus transceivers that had been adapted for the job and was much easier to operate.

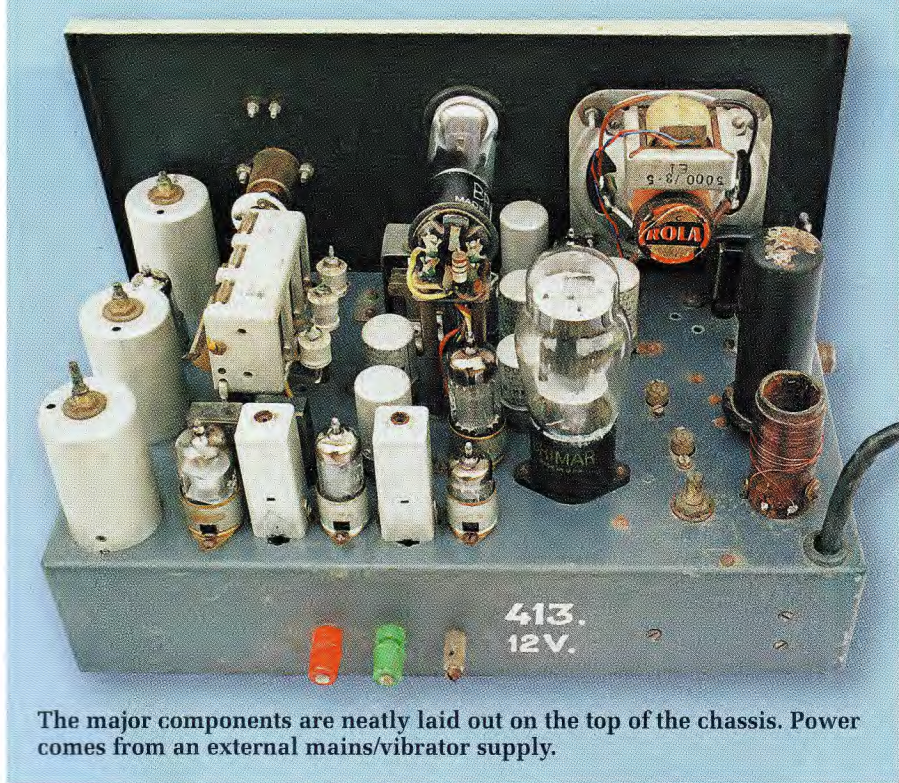
A combined 240VAC and 12V vibrator power supply is used in these units, and this one wasn't without its prob-

lems. A quick inspection revealed that the 2nF buffer capacitor in the vibrator section had been overheating and had leaked wax onto the bottom cover of the power supply.

I initially checked the capacitor with my 1000V tester and found it had a leakage resistance of about 30M Ω . I then decided to heat the capacitor with a hair drier and observe the change (if any) in its leakage resistance. When I did this, its resistance quickly dropped to just 1.5M Ω , so it was replaced immediately.

Unfortunately, I didn't have a suitable high-voltage (2000V) 2nF capacitor so I made one up using three 8.2nF 630V polyester capacitors in series across the secondary of the transformer. The higher resulting value (about 2.7nF) gives a lower standing current with no load, so the transformer is better tuned than it was with the original 2nF capacitor. The voltage rating of the three capacitors in series (about 1890V) is slightly lower than the rating of the original capacitor but this is unlikely to cause problems.

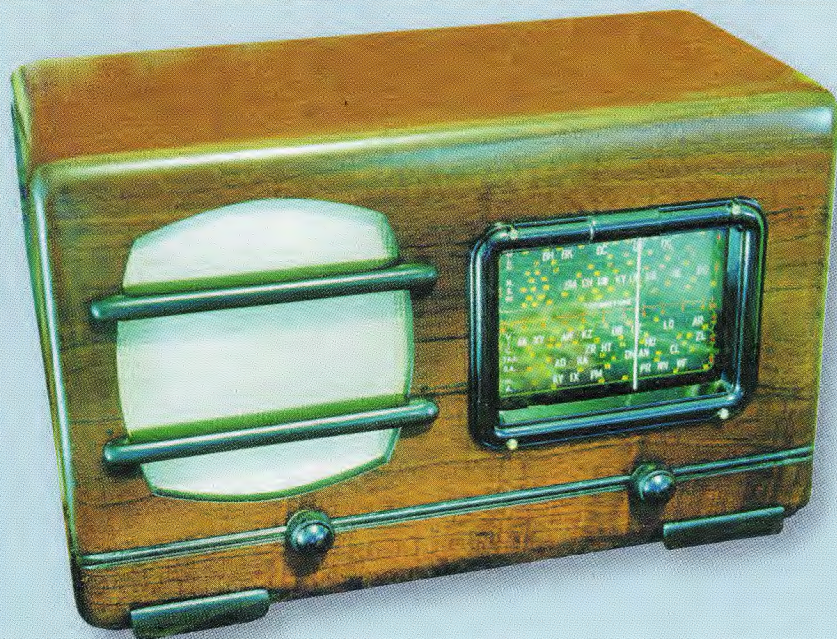
Photo Gallery: Kingsley Kit Set KFT-1

First marketed in Australia in 1946, this Kingsley receiver used “ferrotuning” to tune in stations (as opposed to the more conventional variable-capacitance tuning). This new system used a grooved brass spindle to actuate sliding iron-dust cores inside the tuning coils, thus varying their inductance. The set came with a colourful dial and circuits for three, four and 5-valve models were available. The unit shown here is a 5-valve KFT-1 medium-wave model using 6J8G, 6U7G, 6G8G, 6V6G and 5Y3G valves. Ferrotuning never gained widespread popularity and such sets are now a rarity. (Restored by Maxwell Johnson; photo by Ross Johnson).
