Vintage Radio

The AWA B25/6 Stereogram

Towards the end of the valve era, the local radio industry began producing stereo versions of what used to be (mono) radiograms. These usually had a power output of several watts per channel and their bass response was often curtailed to stop acoustic feedback via the cabinet to the stereo pickup cartridge.

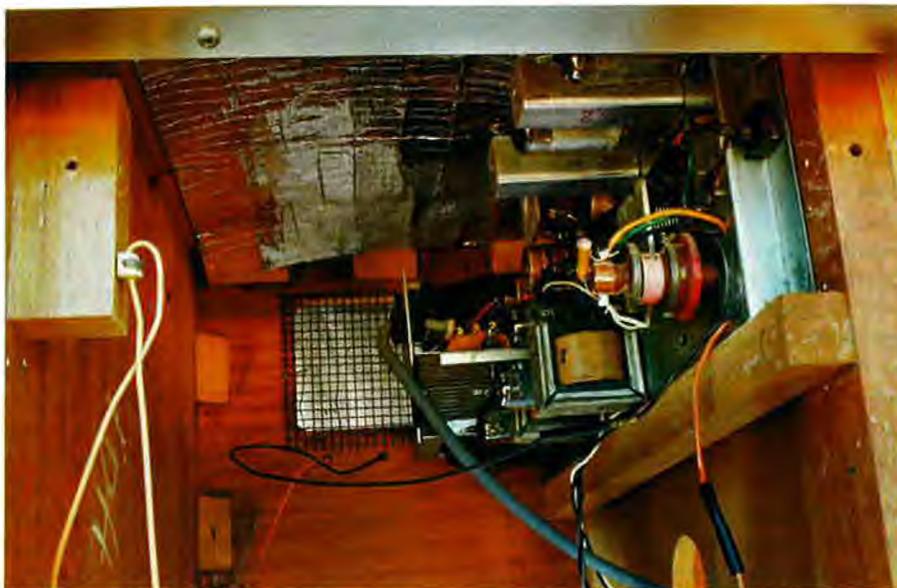
This view shows how the chassis is mounted vertically inside the cabinet (front speaker panel removed).

Thinking there had to be a better way of doing this, I noticed four screw heads on the front of the cabinet I hadn't seen before – part of a decorative trim. I removed these and the front baffle with the two speakers on it came away from the cabinet. This would make it much easier to remove the chassis.

Further investigation showed an even better method: lay the cabinet on its right hand end and remove the base panel and the front speaker baffle. Once this is done, the chassis is reasonably easy to get at.

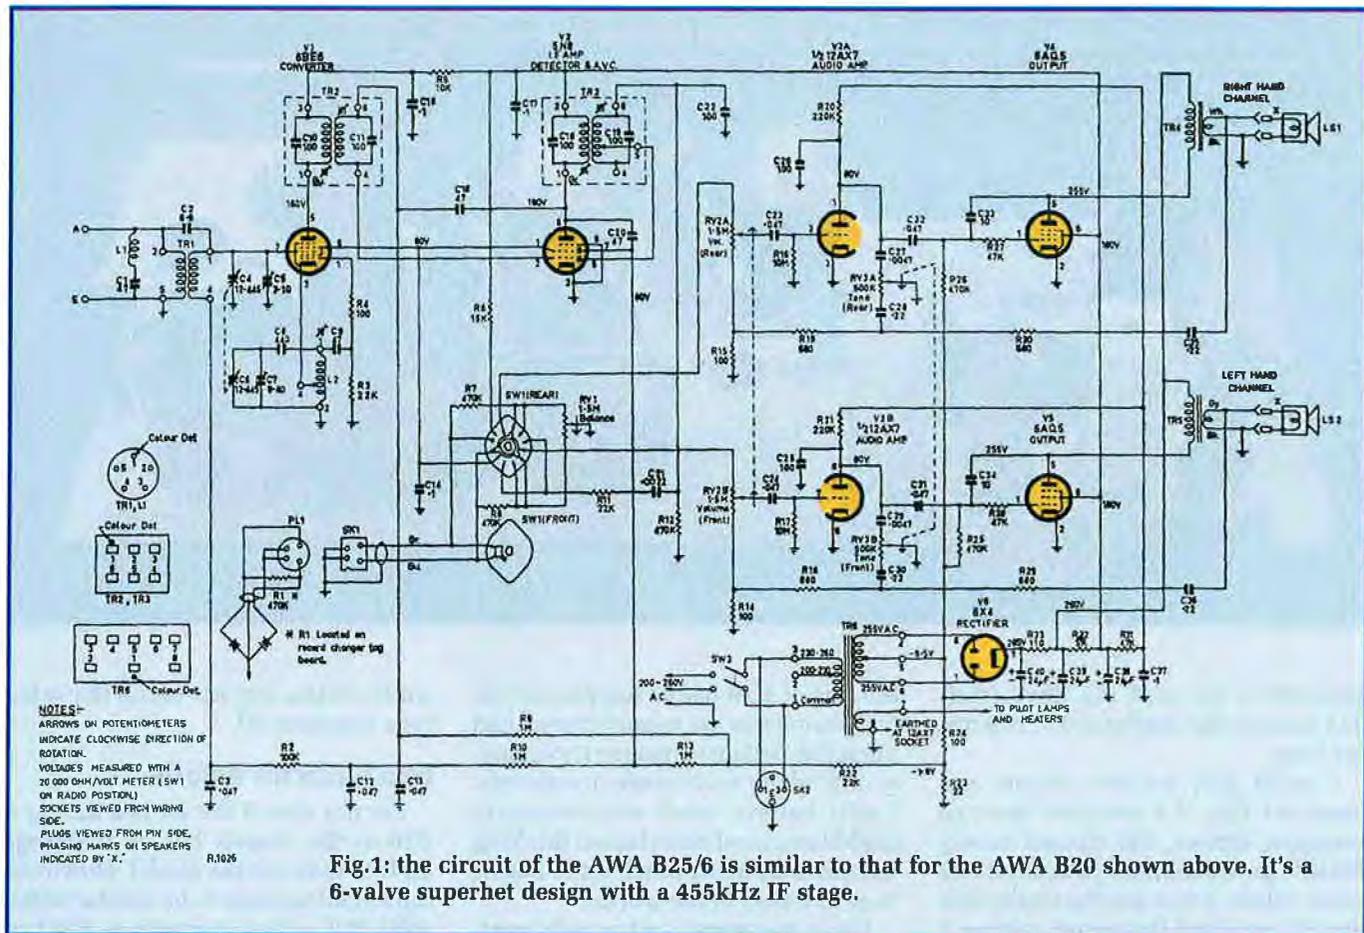
Fig.1: the circuit of the AWA B25/6 is similar to that for the AWA B20 shown above. It's a 6-valve superhet design with a 455kHz IF stage.

I'm not sure if the set is a B25 or a B26 as the chassis has no markings on it to indicate the model. However, the circuit appears to be similar to the AWA B20 which is shown as Fig.1 of this article.

The B25/6 is a 6-valve set and is quite conventional. The AM tuner section uses a 6BE6 as a converter and a 6N8 as the 455 kHz IF amplifier/AGC and detector. Each power amplifier uses one half of a 12AX7 twin triode and a 6AQ5 pentode as a single-ended

class-A output stage. A 6X4 acts as the power supply rectifier.

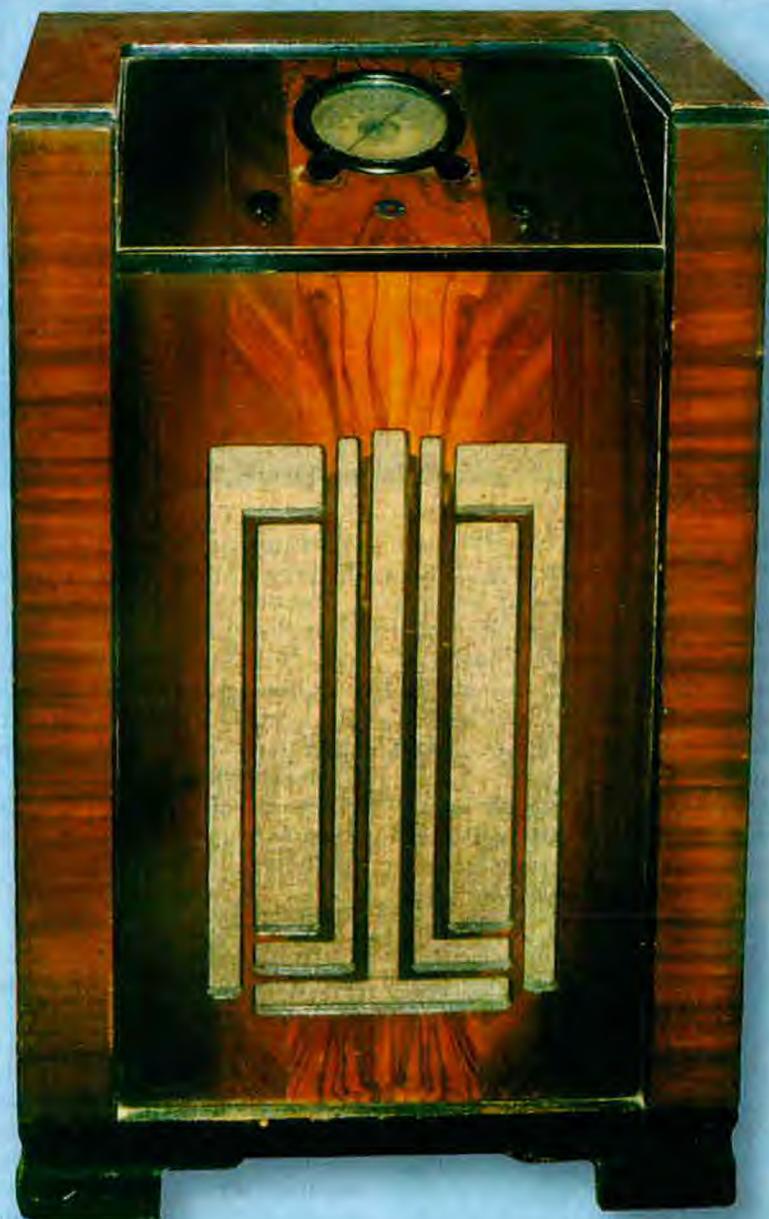
Photo Gallery: AWA Radiola 240 (1934)

Released by AWA in 1934, the Radiola 240 is a 7-valve superheterodyne console that tunes the medium-wave band and two shortwave bands. An interesting feature of the circuit was the use of two RF amplifier stages ahead of the mixer, with the first stage switched into use only when the higher-frequency shortwave range was selected. The valve line-up was as follows: 6D6 1st RF amplifier; 6D6 2nd RF amplifier; 6A7 frequency changer, 6D6 IF amplifier (460kHz); 6B7 audio amplifier/detector/AVC rectifier; 42 audio output; and 80 rectifier. Photo: Historical Radio Society of Australia, Inc.

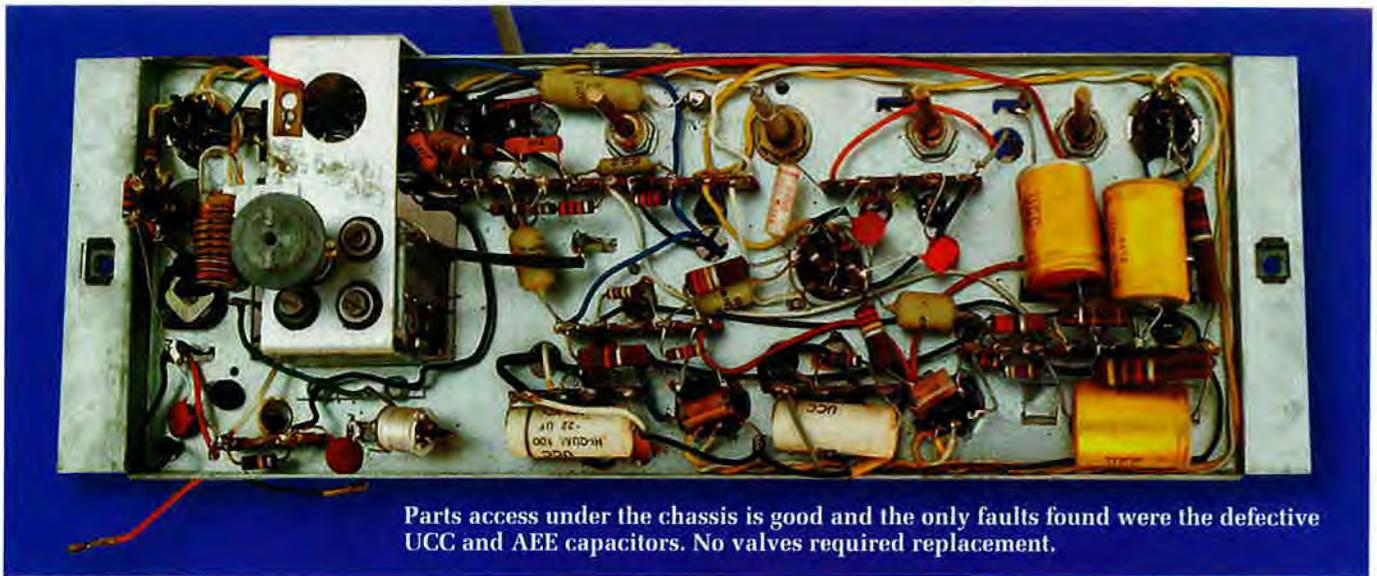
The next job was to check the resistors and capacitors. The resistors all tested within tolerance or if not, they were only a small amount out. The capacitors were a different matter. Tested at 500V, I found that all the AEE capacitors were much too leaky at 1MΩ to 5MΩ resistance and most of the UCC capacitors were no better.

Parts access under the chassis is good and the only faults found were the defective UCC and AEE capacitors. No valves required replacement.

circuit's operation, defective capacitors were replaced.

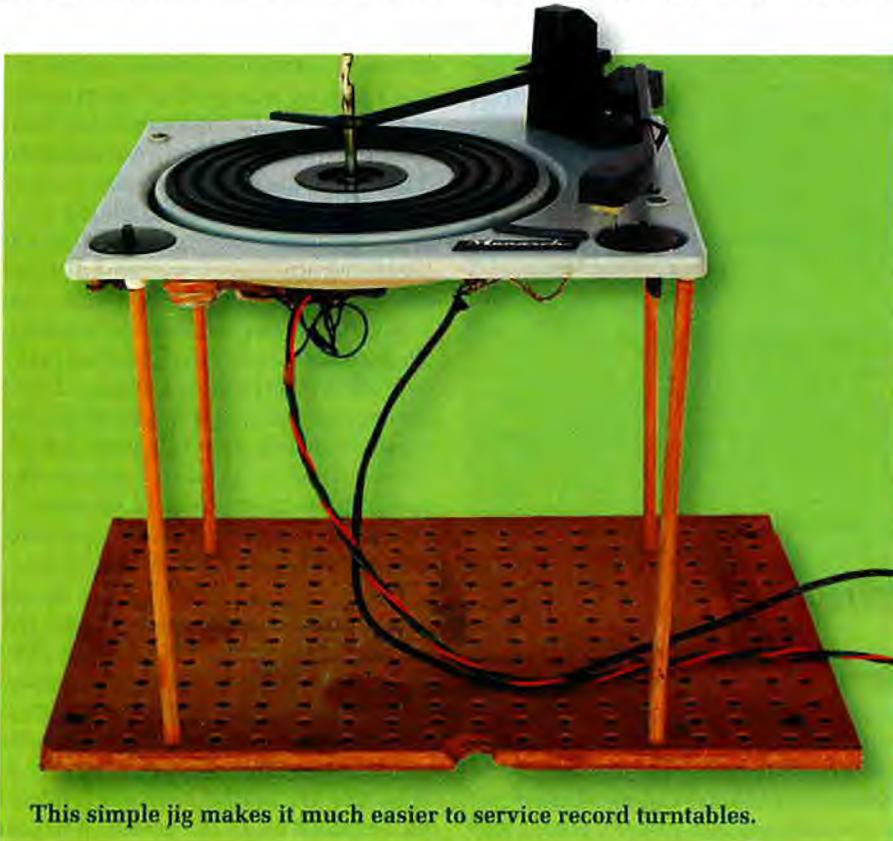
This simple jig makes it much easier to service record turntables.

I've found this brand of record changer very reliable, requiring little in the way of fault-finding. This unit was no exception. However, as it is between 35 and 40 years old, the lubricants had dried out and needed to be replaced. I mounted the changer onto my servicing jig and then commenced
