Vintage Radio

The Healing “Scales” 403E receiver

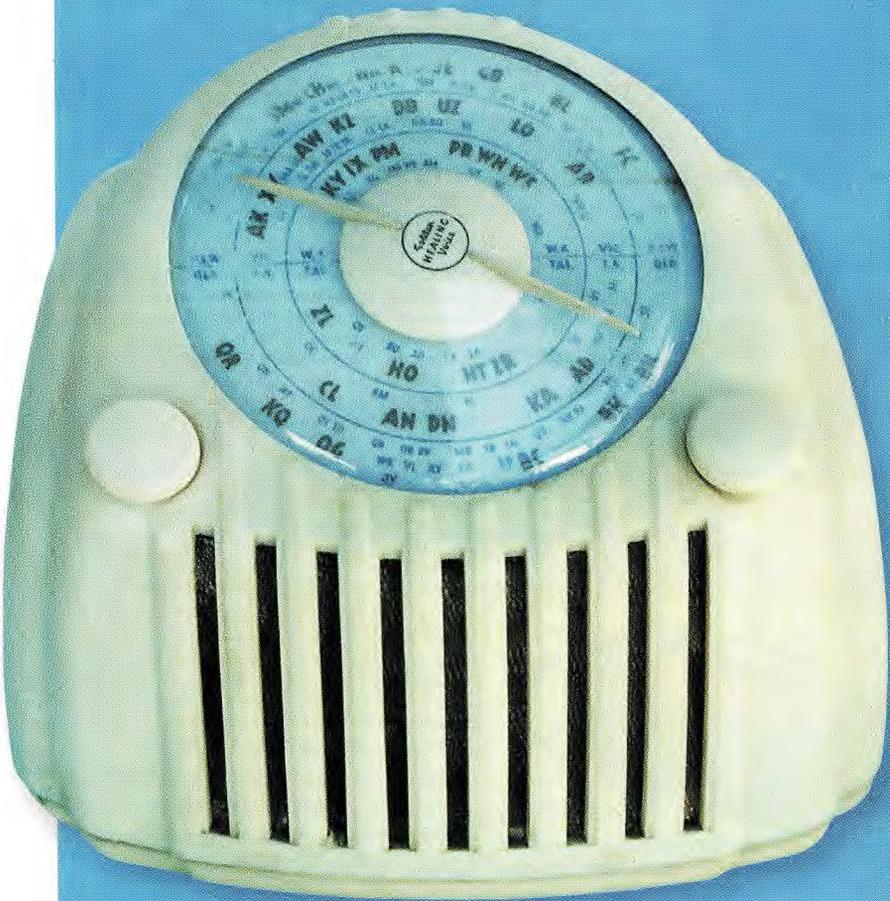
The Healing 403E – it looked rather like a set of kitchen scales and was often affectionately called the Healing “Scales”.

To meet the need for more than one set in the household, many manufacturers produced small low-performance 4-valve sets. Healing was one of those manufacturers and produced many sets. One that has taken the fancy of many collectors is the Healing 403E or as it is affectionately called by some, the Healing “Scales”, supposedly because it looks like a set of kitchen scales.

The set came onto the market around 1950. It would appear that it is designed to be placed on the kitchen bench as the dial scale is on the slop-

ing top of the set. It is then really a bench top or table set and not a mantel receiver. It was quite an innovative concept although in the kitchen environment it may have been splashed with water or food. However, despite the potential abuse, the sets survived quite well.

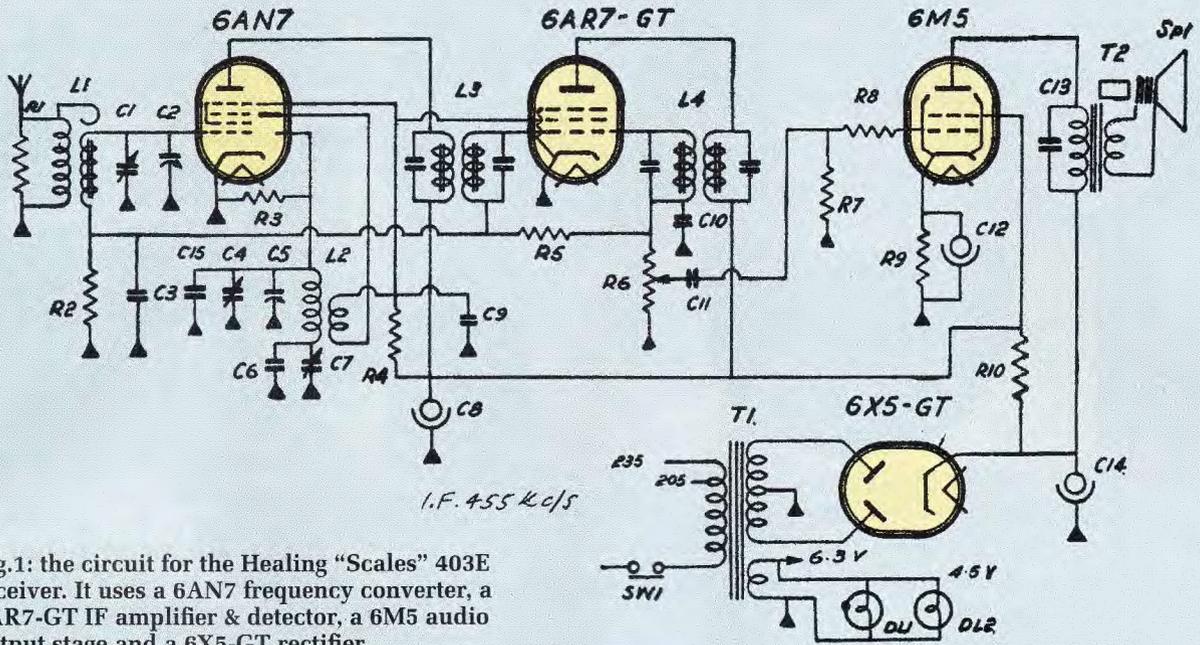
HEALING 403 E

Fig.1: the circuit for the Healing "Scales" 403E receiver. It uses a 6AN7 frequency converter, a 6AR7-GT IF amplifier & detector, a 6M5 audio output stage and a 6X5-GT rectifier.

A 6AN7 is used as a frequency changer with an output of 455 kilohertz (kHz) to an IF amplifier using the pentode 6AR7-GT as the amplifier. The two diodes in the 6AR7-GT enve-

lope act as the detector and automatic volume (gain) control (AGC). The AGC is simple and only a third of the AGC voltage is applied to the 6AN7 and the 6AR7-GT via the voltage divider of R2 (1MΩ) and R5 (2MΩ). The audio (and AGC) voltage is applied across R6 which is then applied to the grid of the 6M5 audio output valve.

The converter and IF amplifier are run with no bias on their grids but because their screen voltage is only around 50V, the current drain is not excessive. There will be a small amount of bias provided from the AGC line, even off-station, as any circuit noise and external interference will generate an AGC voltage, small though it may be. Tuned to a station, the bias is significantly higher. By only applying a third of the developed AGC voltage to the two controlled valves, more signal is able to be applied to the 6M5 to achieve a reasonable audio output level.

As a purist, I find only applying a third of the available AGC voltage is a poor design feature. However, when it is considered where the set was intended to be used – suburban areas not far from radio stations – it works quite satisfactorily. The 6M5 has the common cathode bias method, which provides around 6V of bias with a current drain of around 25mA in this receiver. The total current drain of the receiver is around 37mA from the 6X5GT rectifier.

Those with a sharp eye will have picked up drafting errors in the published circuit. The secondary winding of L4 (second IF transformer) appears to go to the grid of the 6AR7GT but should connect to a diode or both of the diodes within the 6AR7-GT. The oscillator grid is also not shown connected to the third grid. Labelling the valve pin numbers would also help servicemen and restorers. It is amazing the number of drafting errors that did creep in.

The only critical one is C3, the AGC bypass capacitor, and this should be replaced as a matter of course. The

audio coupler (C11) has only a small voltage across it (a maximum of around 20V). If this is leaky, all it will do is place a negative voltage on the grid of the 6M5 and progressively cut it off as the volume control is increased or a stronger station is tuned in. C13, if shorted, would just cause the audio to disappear but no damage would be done to the set.

Electrolytic capacitors C8 and C14 should be reformed if necessary, after being tested with an ohmmeter to ensure there are no short circuits between the high tension (HT) line and the chassis. My rough and ready technique is to place a voltmeter across C14, turn the set on and wait until the voltage across it starts to rise. Once it has risen to 50V or so, I switch off and then, about 30 seconds later, I repeat the procedure, this time letting the voltage rise to around 100V before switching off.

fitting some components. In this case, a 100nF (0.1 μ F) or similar value capacitor has not been put across C8 to effectively bypass any RF energy on the HT line. When first installed, capacitors like C8 are reasonably effective RF bypasses but as time goes by, their effectiveness deteriorates and the receiver will often develop an instability problem.

This is a comparatively easy set to align, with a total of eight adjustments. Basically, the four tuning slugs in IF amplifier transformers L3 and L4 are peaked for best performance on a relatively weak signal at 455kHz. It is not imperative that the frequency be exactly 455kHz as long as it is within about 10kHz of 455kHz.

First, tune to around 600kHz and adjust C6 (under the chassis) until the particular station selected appears at the correct spot on the dial. Then adjust the core of L1 for best volume on this station or a weak one nearby.

Now tune to a station near 1500kHz and adjust C4 (on top of the gang) so that the station tuned to appears at the correct spot on the dial, and then peak C1 (on top of the gang) for best performance. Go over the adjustments for 600kHz and 1500kHz several times, as they do interact with one another.

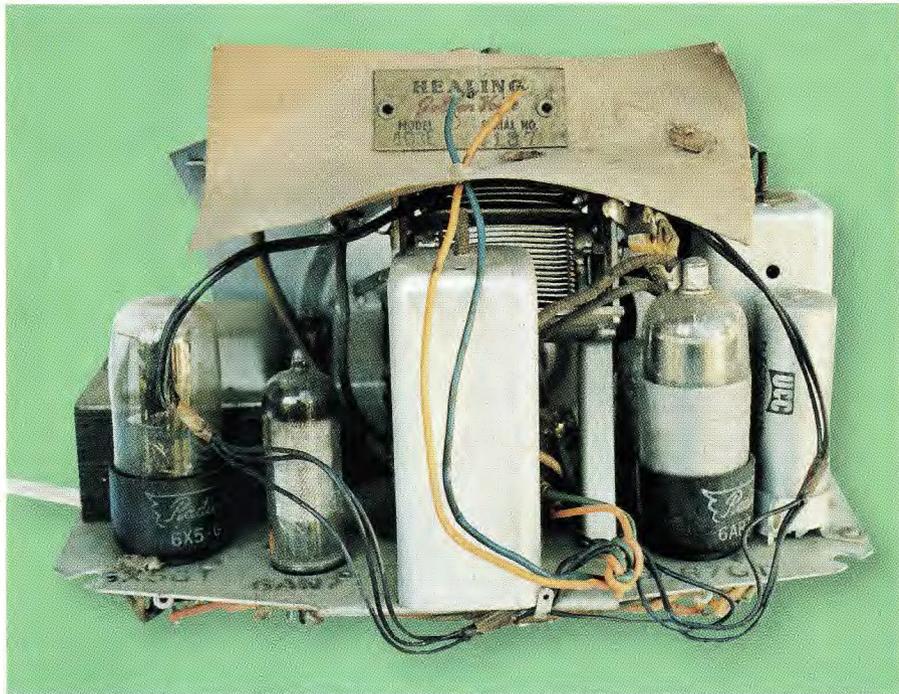
A rear view of the chassis out of its cabinet – note the very tight layout. The receiver uses just four valves.

The receiver is separated quite easily from its cabinet, requiring the removal of three screws in the Bakelite base, four screws attaching the chassis and the cabinet top together and the two control knobs.

Above the chassis, the components are tightly packed in and some dismantling would be required to work

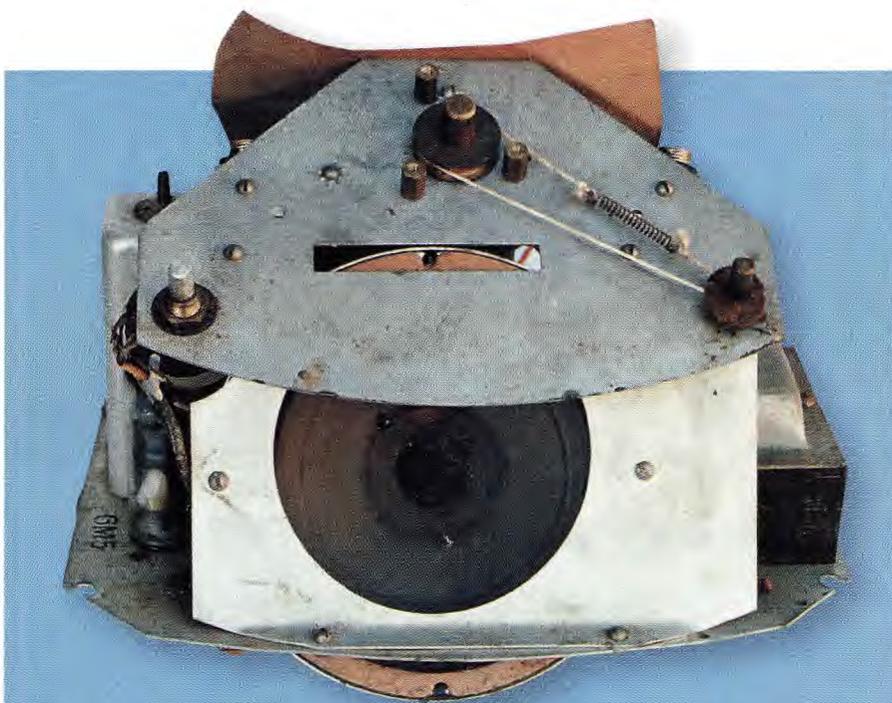
This view shows the chassis from the front. The parts on top of the chassis were rather tightly packed.

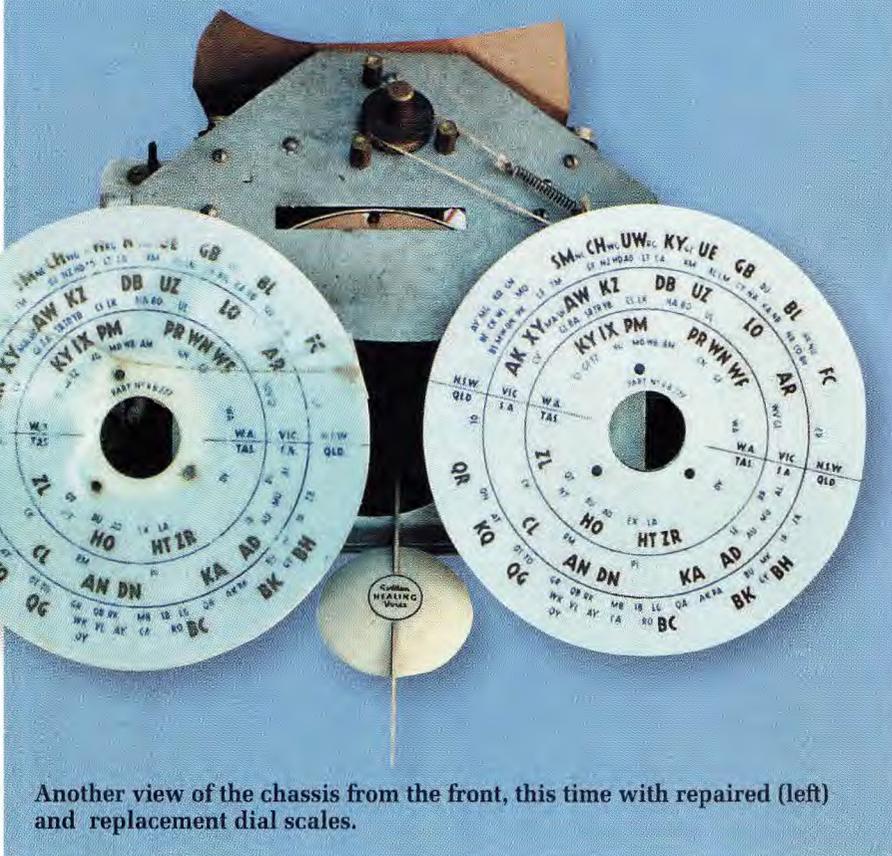
Another view of the chassis from the front, this time with repaired (left) and replacement dial scales.

Warning: once the set is removed from the cabinet, do not tip it upside down onto the dial scale, as it will break. To make sure the dial scale is not damaged, remove it and put it aside until alignment or reassembly is to take place.

are involved. The dial scale needs to be attached to the receiver so that the alignment can be done with accuracy. Take note of the warning earlier in the article about how easy it is to damage the dial scale.

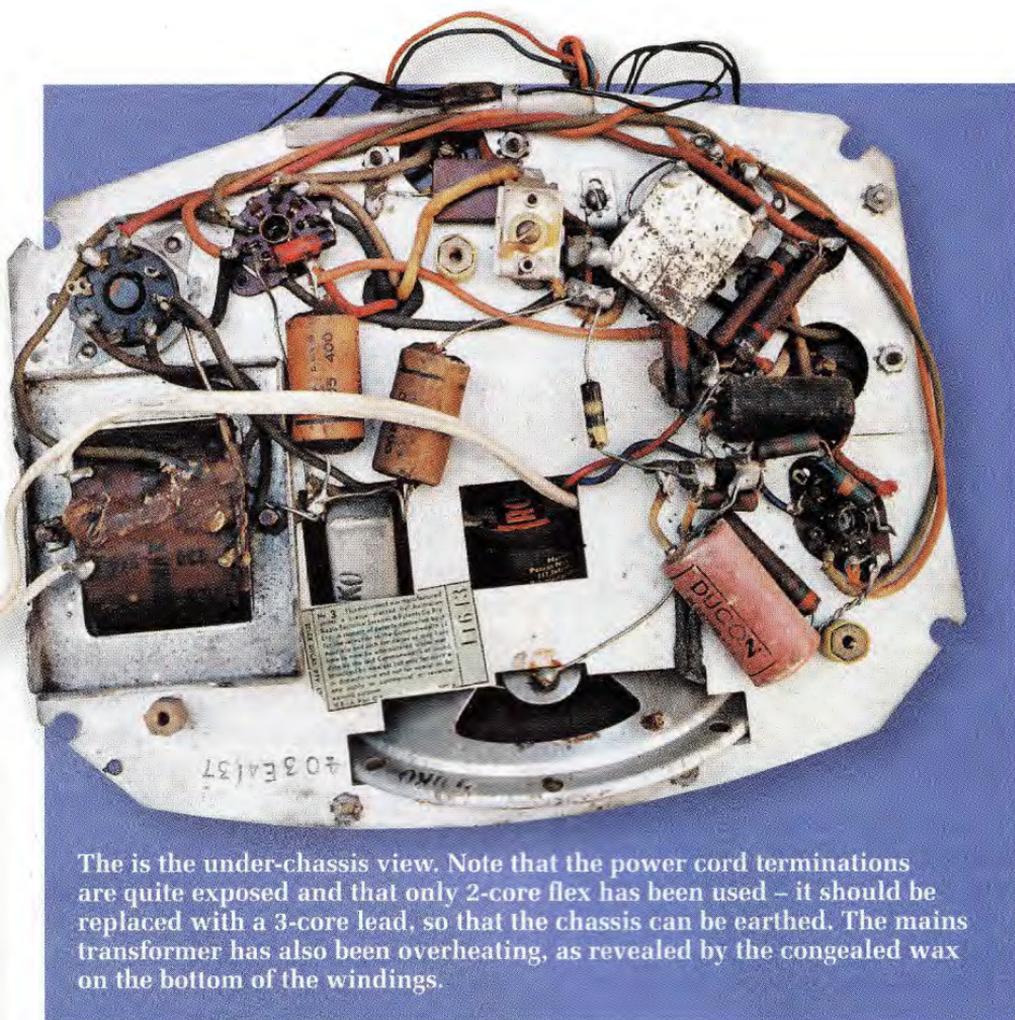
The is the under-chassis view. Note that the power cord terminations are quite exposed and that only 2-core flex has been used – it should be replaced with a 3-core lead, so that the chassis can be earthed. The mains transformer has also been overheating, as revealed by the congealed wax on the bottom of the windings.

This receiver had not been restored at the time of writing. Access under the chassis is quite good and any component there can be adjusted or replaced readily. However, caution is needed when operating this receiver out of its case as the mains terminations are exposed on the bottom of the power transformer. If the set were mine, I would put a protective insulated cover over these terminals. It would be all too easy to touch these exposed terminals while concentrating on other aspects of the restoration process.

Of course, the twin flex should be replaced with a 3-core mains lead, so that the chassis can be earthed. Suitable replacement power leads are available as extension cables of various lengths at most supermarkets. Just cut off the socket and you will have a lead ready to wire into the chassis.

In this set, it is obvious that the power transformer has dripped some wax, so it has been hotter than it should be. Before doing too much on this set, it would be advisable to do checks on the transformer for shorts and insulation integrity, as well as checking the rectifier and electrolytic capacitors for potential shorts or low resistance to earth (chassis).

Initially, the set should be run with the transformer lightly loaded, by taking out all the valves and leaving just the dial lamps in. If it gets other than slightly warm, the transformer may have a fault. If all is well, the general tests indicated in the previous paragraphs should be undertaken. The problem may have been fixed sometime in the past but it does pay to be very sure that there is no latent fault in the power supply area.

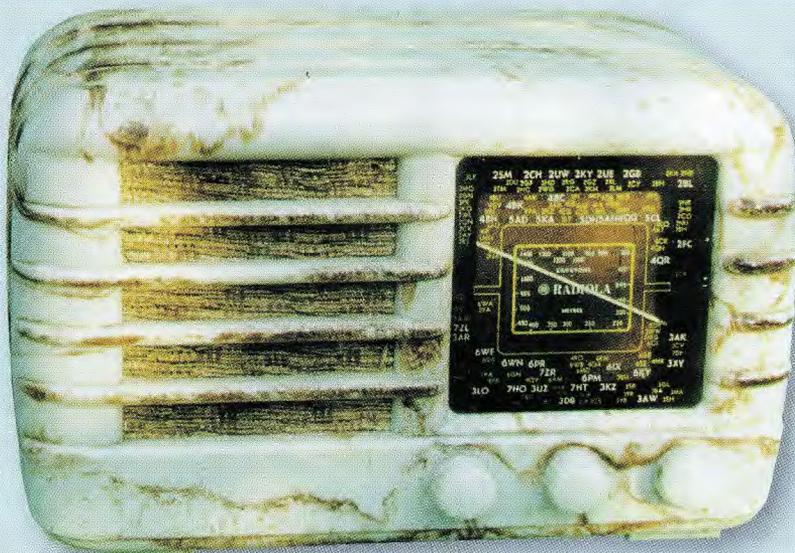
Photo Gallery: AWA 519M (1947)

Manufactured by AWA in 1947, the 519M is another example of a popular 5-valve mantel receiver of that era. It was fitted into a bakelite cabinet, the brown-white mottled unit shown here being one of the less common cabinet colours. The valve line-up was as follows: 6A8-G frequency changer; 6SK7-GT IF amplifier; 6SQ7-GT audio amplifier/detector/AVC rectifier; 6V6-GT audio output; and 6X5-GT rectifier. Photo: Historical Radio Society of Australia, Inc.
