# Vintage Radio

## AWA B33: the ultimate Australian-made transistor portable

**Designed for the well-heeled, AWA's Radiola B33 was a very impressive transistor portable that tuned the broadcast band and three shortwave bands from 1.6-30MHz. Restoring and aligning it is not the easiest of tasks, however.**

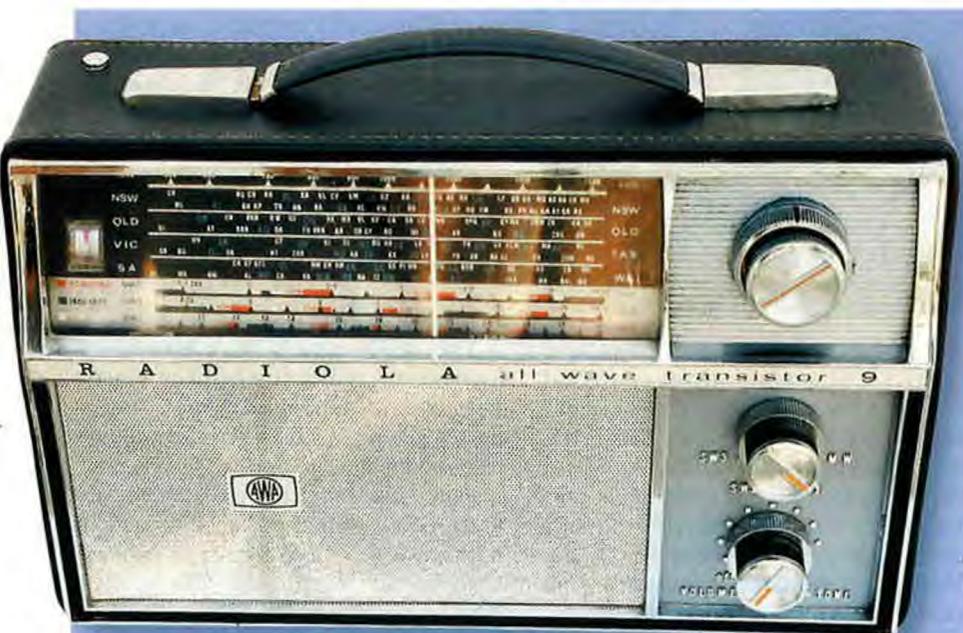
This is the fully restored B33 receiver. Scrounging parts from a second set allowed it to be restored to almost new condition.

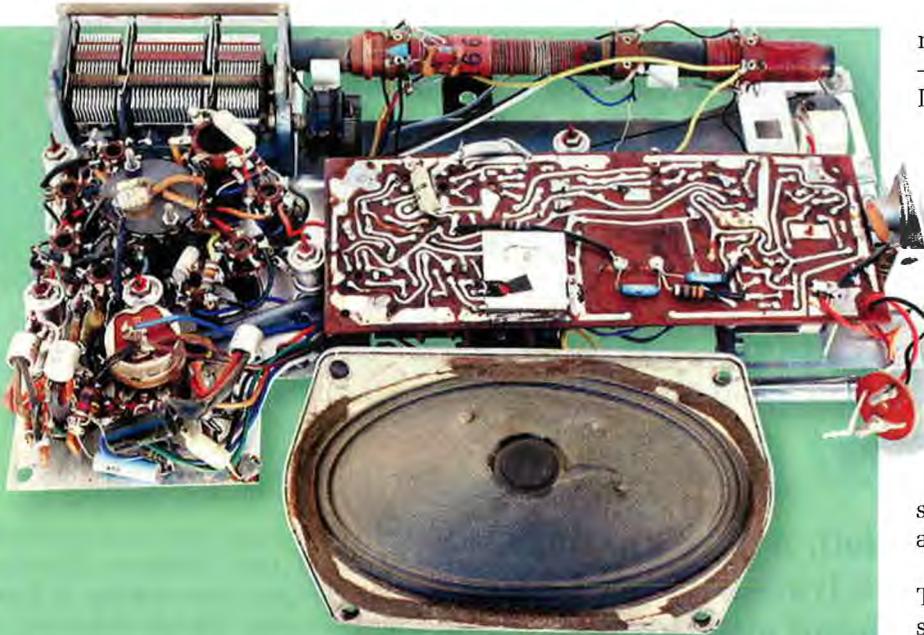
This view shows the rear of the chassis plate, after its removal from the cabinet. The PC board is mounted upside down on this plate.

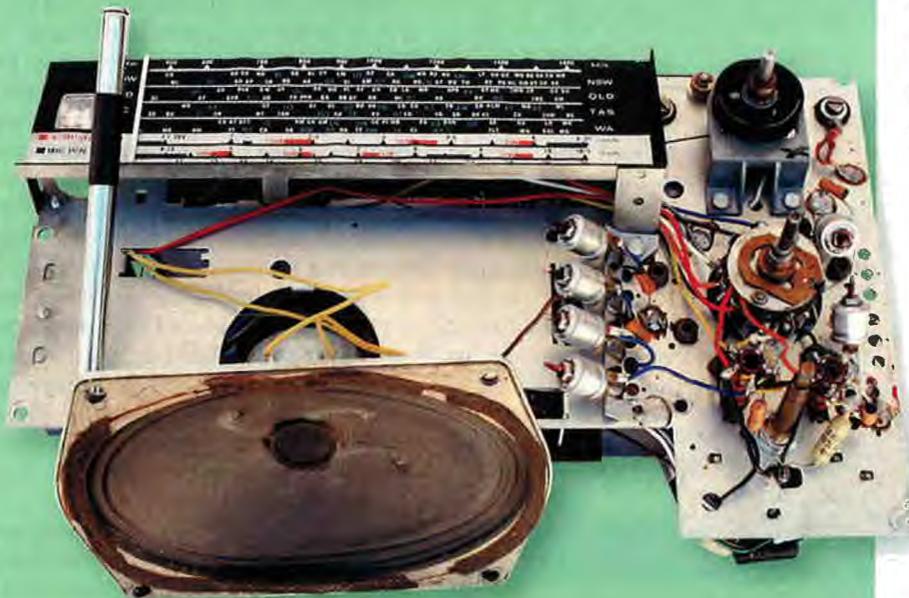
The front of the chassis plate carries the dial scale and various trimmer capacitors which are used for alignment. The faults in the receiver were all mechanical.

I lubricated all the moving surfaces on the dial tuning mechanism but the problem remained. A subsequent close examination revealed that a number of plates in the antenna and RF sections of the tuning gang were intermittently shorting together. This problem can usually be fixed by gently bending the offending plates but not in this case. In fact, it was quite likely that this tuning gang had been faulty from new, as the oscillator section was perfect.

One way around this problem was to use the gang from the other radio. It looked to be in good order and so it was worth a try. However, swapping in the new gang without having the dial cord end up in a mess would be a challenge.

the dial drum along the gang's shaft. I then removed the three screws holding the gang to the chassis although this wasn't exactly straightforward – the middle screw couldn't be accessed until I removed the screws from the dial drive assembly and gently swung it aside.

That done, I replaced the drive assembly and gently eased the drum off while I slid the gang out to the right. It came out without the dial cord coming off the main pulleys which was just what I wanted.

Finally, the replacement gang was mounted in position, the drum refitted and the dial cord refitted to the lefthand pulley.

It all worked and this time there were no crackles as I tuned across the band, with stations coming in as expected. However, with a new gang fitted, a complete realignment of all the front-end sections was necessary.

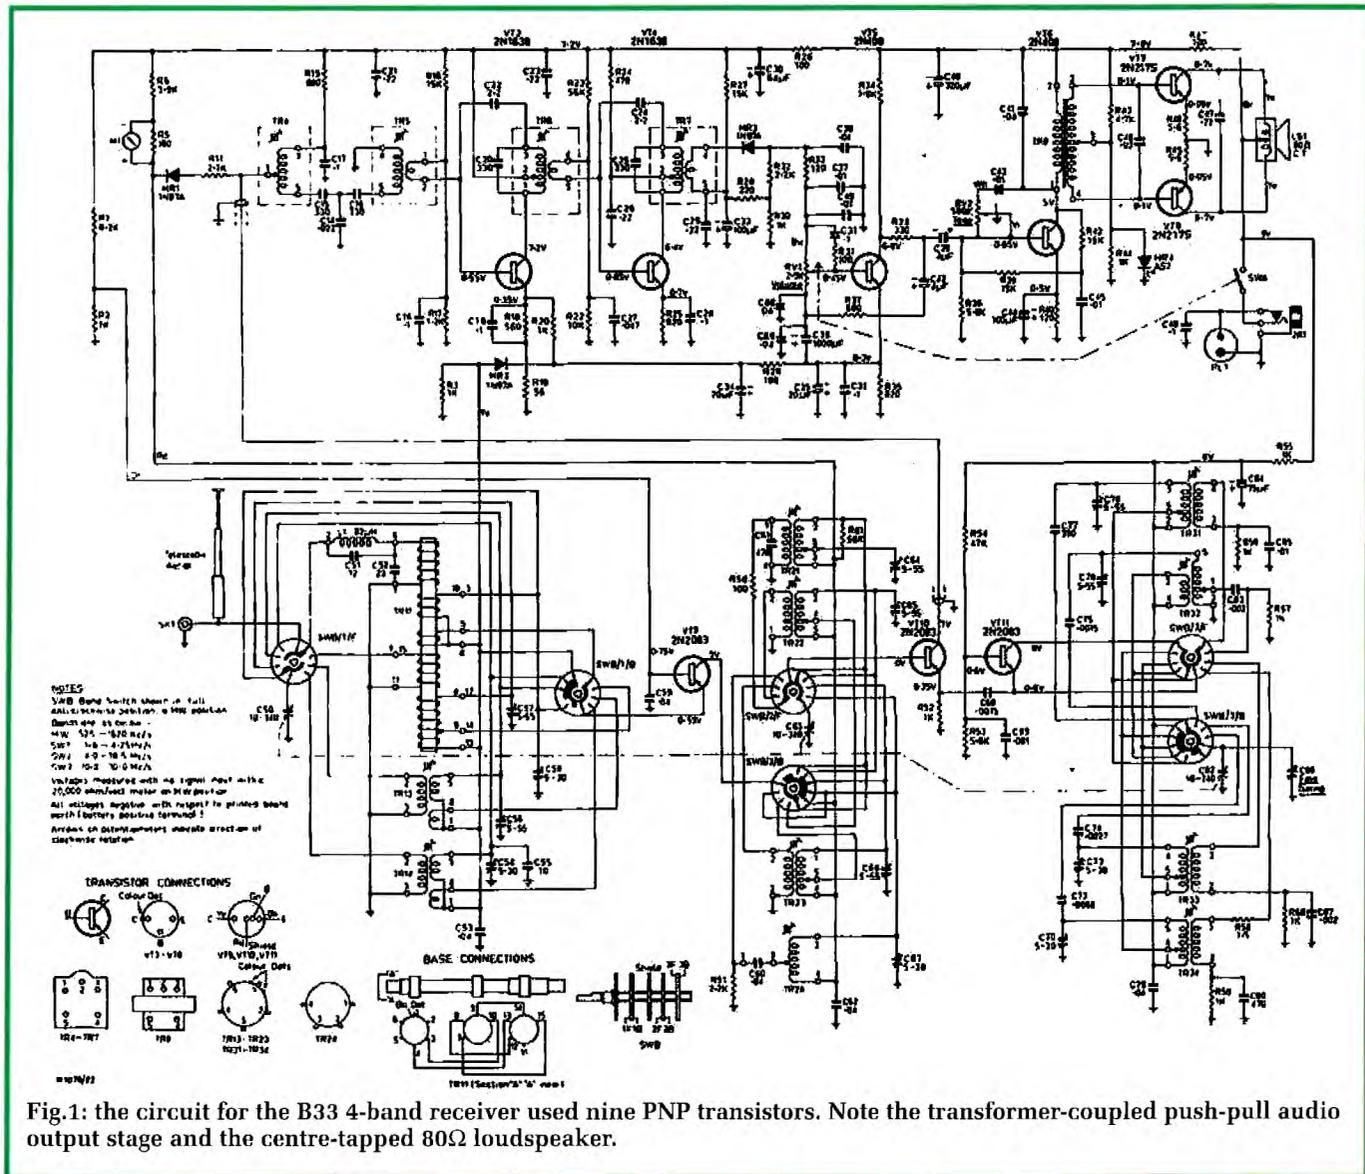
Fig.1 shows the set's circuit details. The first thing to note is that the band-switched input circuits are connected to an RF stage based on a 2N2083 transistor (VT9). Its collector signal is then fed via another bank of four tuning coils to a transistor mixer stage based on another 2N2083 (VT10).

Most transistor receivers use an autodyne converter stage but not so the B33 which uses a separate oscillator (VT11). This provides better performance and more stable operation. The output from the mixer (VT10) is then fed to a 2-stage 455kHz IF (intermediate frequency) amplifier based on transistors VT3 and VT4. The IF output in turn feeds diode detector MR3 which is then followed by three stages of audio amplification (VT5-VT8).

The audio amplifier includes a push-pull output stage and this is coupled directly to a speaker with an 80Ω centre-tapped voice coil. Hopefully, the speaker will never need changing, as obtaining a suitable replacement would be impossible unless salvaged from another similar receiver.

Fig.1: the circuit for the B33 4-band receiver used nine PNP transistors. Note the transformer-coupled push-pull audio output stage and the centre-tapped 80Ω loudspeaker.

In practice, it is normal for diode detectors to generate harmonics of the fundamental frequency (in this case, 455kHz). However, there is a design deficiency in this set in that the detector output goes to the volume control, which is located right alongside the broadcast-band RF amplifier. As a result, the harmonics from the detector are induced into the broadcast band coils.

To prevent this, I tried inserting a miniature 1.5mH RF choke between C37 and C49 and this noticeably reduced the problem. In fact, with a strong signal, the instability was no longer evident. By contrast, in the B32 broadcast-band only version, only C37 is needed. The front-end layout is somewhat different in that model and the IF harmonic problem is not evident.

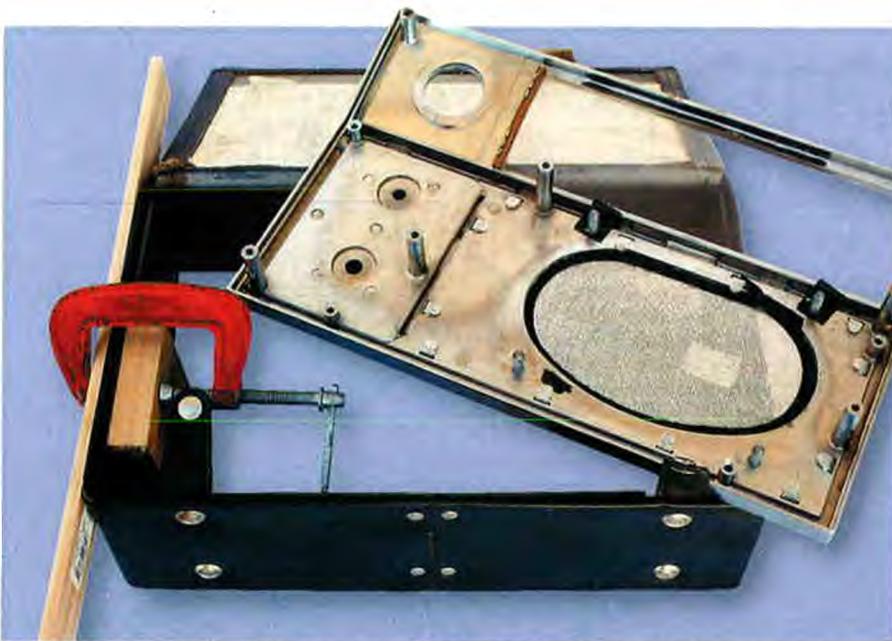
The leatherette covering was re-attached to the receiver's plastic inner case using contact adhesive, with a G-clamp and some small pieces of wood used to hold everything together while the adhesive dried.

Unfortunately, the leatherette covering had come away from the plastic inner case on one side and really looked tatty. This was repaired using contact adhesive, with a G-clamp and two small pieces of wood used to hold everything together while the adhesive dried.

This repair was quite satisfactory but in the end, I decided to use the cabinet from the second set, as it was in better condition overall. The dial scale also had to be re-glued to its frame and this was done using clear nail polish.

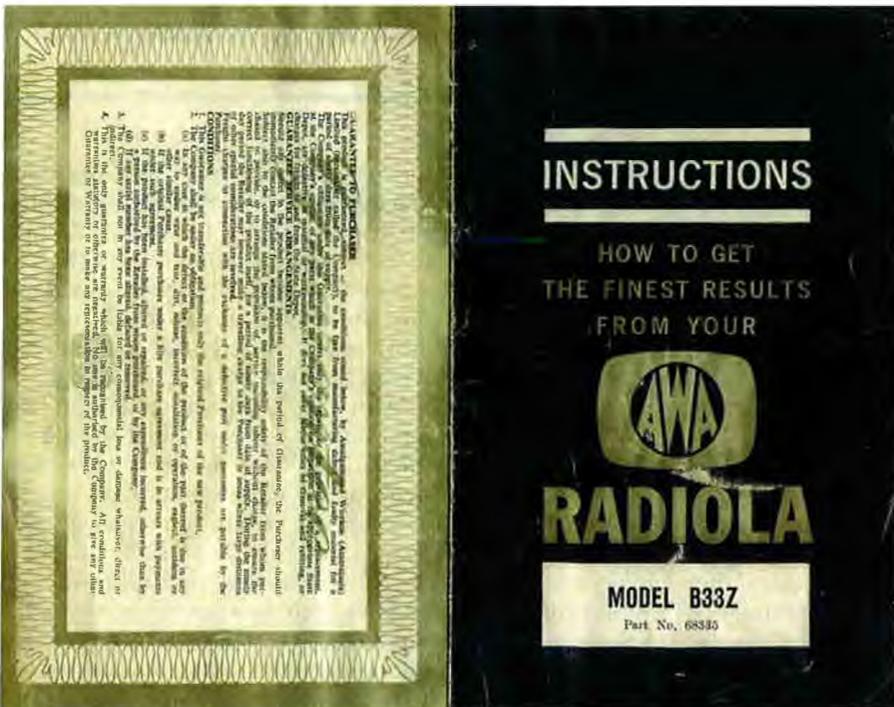
The B33 receiver came complete with its original instruction manual, as well as an external DC power supply.

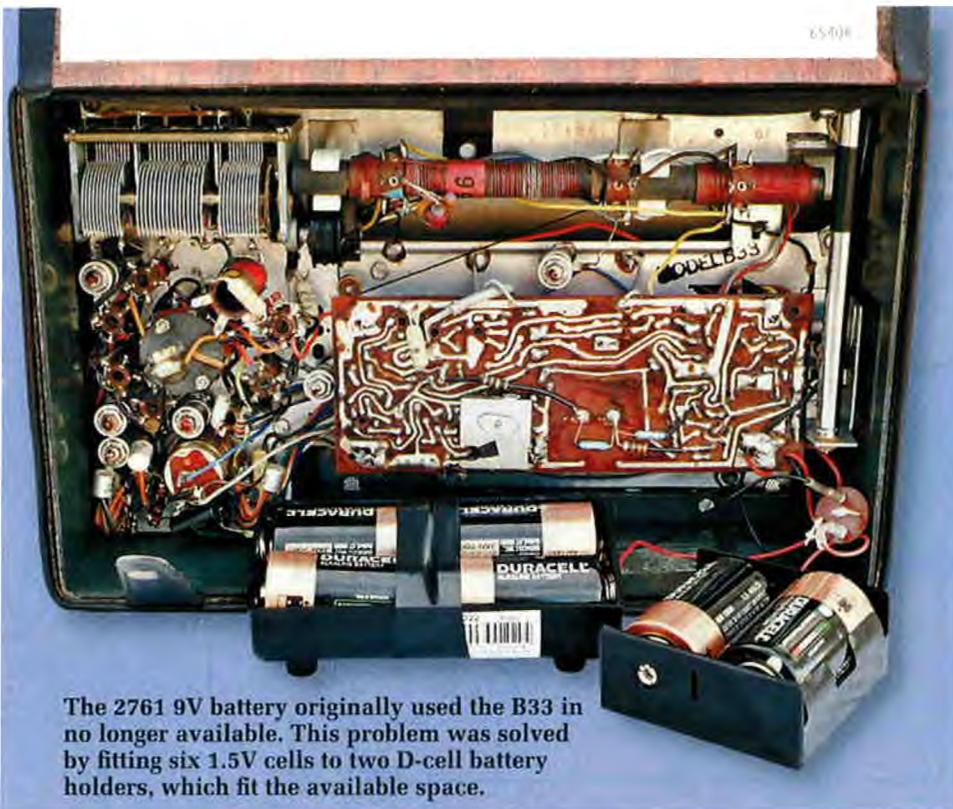
Due to its size, the set is quite heavy, weighing in at 3.6kg, or 4.6kg with its heavy-duty batteries. The set was designed to use the now unobtainable 2761 battery. However, two D-cell battery holders – one for four cells and the other for two cells – will fit into the space that the 2761 occupied, provided the speaker's terminals are orientated towards the top of the cabinet.

The 2761 9V battery originally used the B33 in no longer available. This problem was solved by fitting six 1.5V cells to two D-cell battery holders, which fit the available space.

In practice, the two holders were wired in series to give 9V. The "output" leads were soldered to the ends of the battery plug to keep things as authentic as possible, with heatshrink tubing fitted over the exposed plug prongs to prevent shorts.
