Vintage Radio

The AWA 976A Hybrid Car Radio

Developed during the 1960s, hybrid car radios combined a valve front-end with an audio output stage based on germanium transistors. They quickly replaced valve-based designs with vibrator power supplies but were themselves made obsolete within a few years.

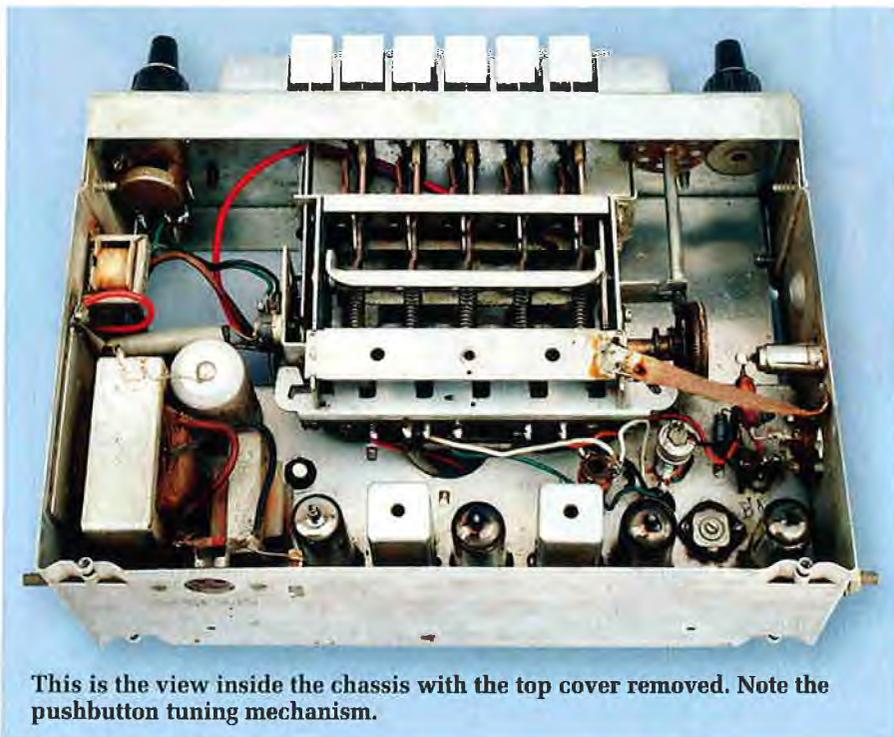
This is the view inside the chassis with the top cover removed. Note the pushbutton tuning mechanism.

Nothing else appeared to be defective other than that the oscillator coil slug had come adrift from the tuning mechanism. The slug adjustment shaft had a bright area on it, which indicated that it had been shielded from corrosion in the tuning adjustment mechanism. As a result, I slid the adjustment shaft into the mechanism so that the bright area disappeared and then glued it into position using contact adhesive. Once dry, it appeared to work well and the slug moved freely in and out of the coil when the tuning mechanism was operated.

This check also revealed that the tuning mechanism was rather "sticky" and wouldn't tune across the whole broadcast band. This problem was fixed by judiciously cleaning the sliding mechanism and lubricating it (sparingly) with Inox. It's quite possible that the original owner had trouble with the tuning mechanism sticking and consequently oiled it quite heav-

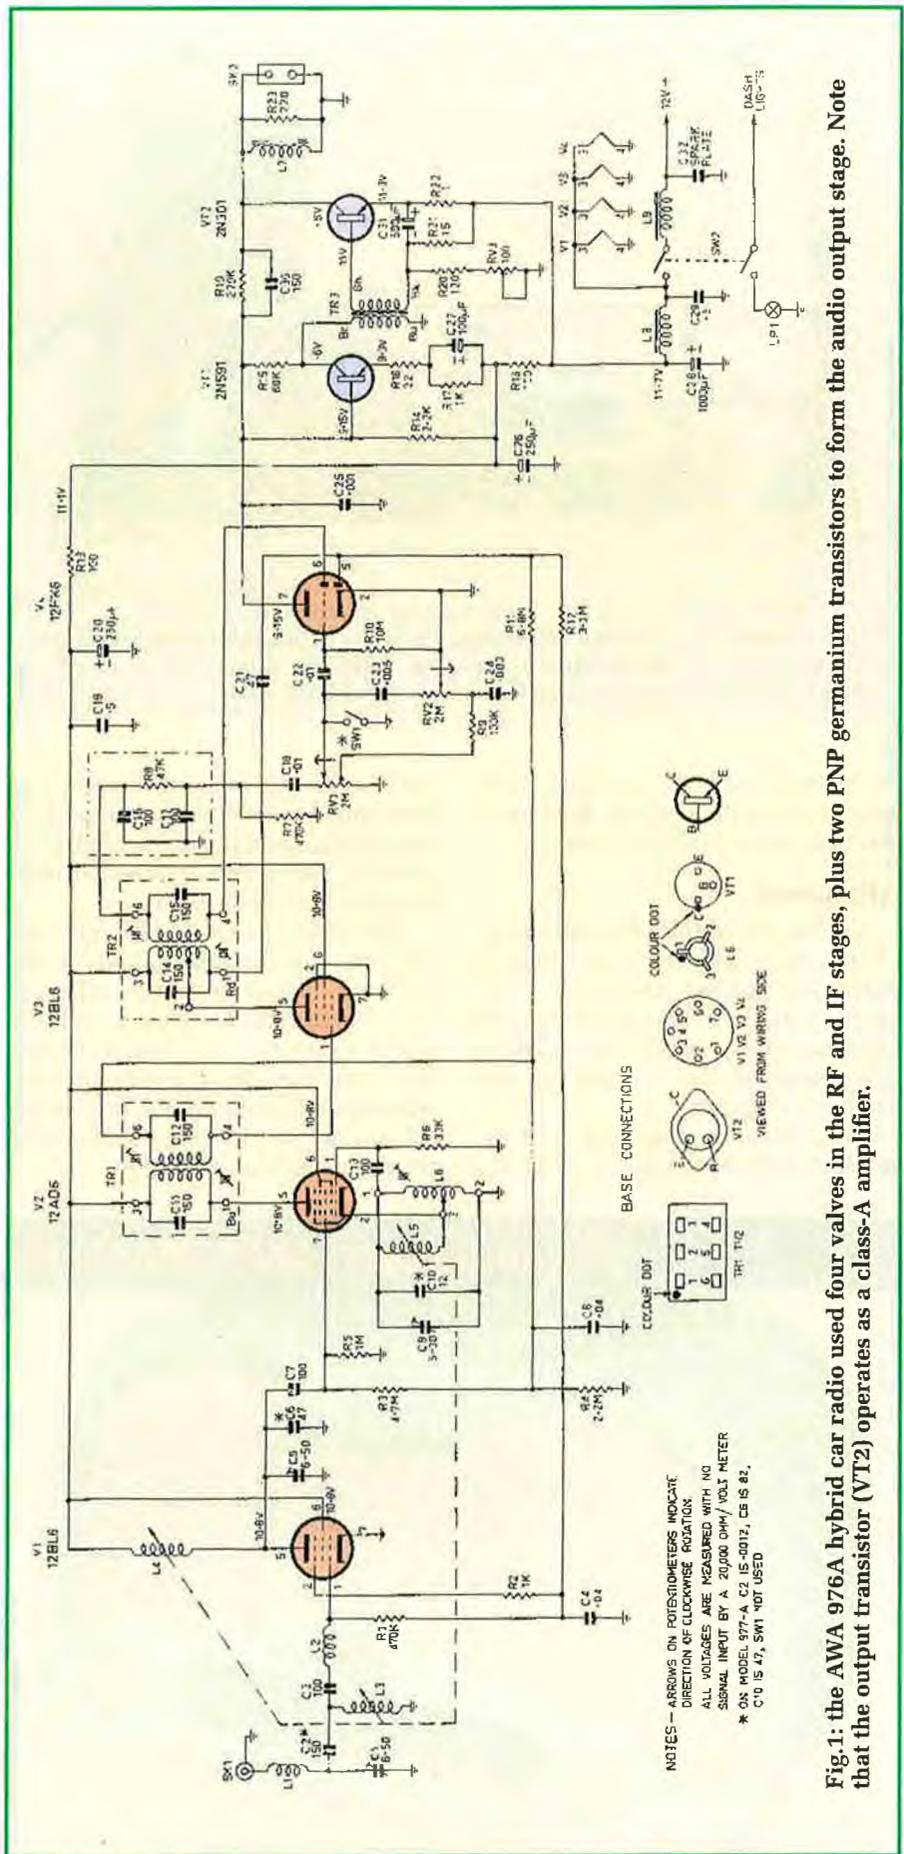
Fig.1 shows the circuit details. The antenna input is typical of most car radios from the early 1950s until the end of the valve era. The tuning is not done with a variable ganged tuning capacitor but with a variable-inductance (permeability) tuning mechanism. What is different about the input cir-

As shown in Fig.1, the triode audio amplifier's plate is directly connected to the base of VT1 (2N591), the first transistor audio stage. The amplified output from VT1 is then fed via audio transformer TR3 to the base of audio output transistor VT2 (2N301).

In this circuit, the 2N301 is used as a class-A audio amplifier. Its forward bias is set to give a standing current of 0.5A and this is achieved by adjusting RV3. Note that there is very little collector current flowing through the speaker when it is connected via socket SK2. This is because inductor L7's DC resistance is extremely low, so most current flows through this inductor.

Fig.1: the AWA 976A hybrid car radio used four valves in the RF and IF stages, plus two PNP germanium transistors to form the audio output stage. Note that the output transistor (VT2) operates as a class-A amplifier.

As usual, I began by checking the most critical capacitors for electrical leakage and found that they were all faulty. As a result, I replaced AGC bypass capacitors C4 & C8 with 50V disc ceramics, as well as audio coupling capacitor C22.

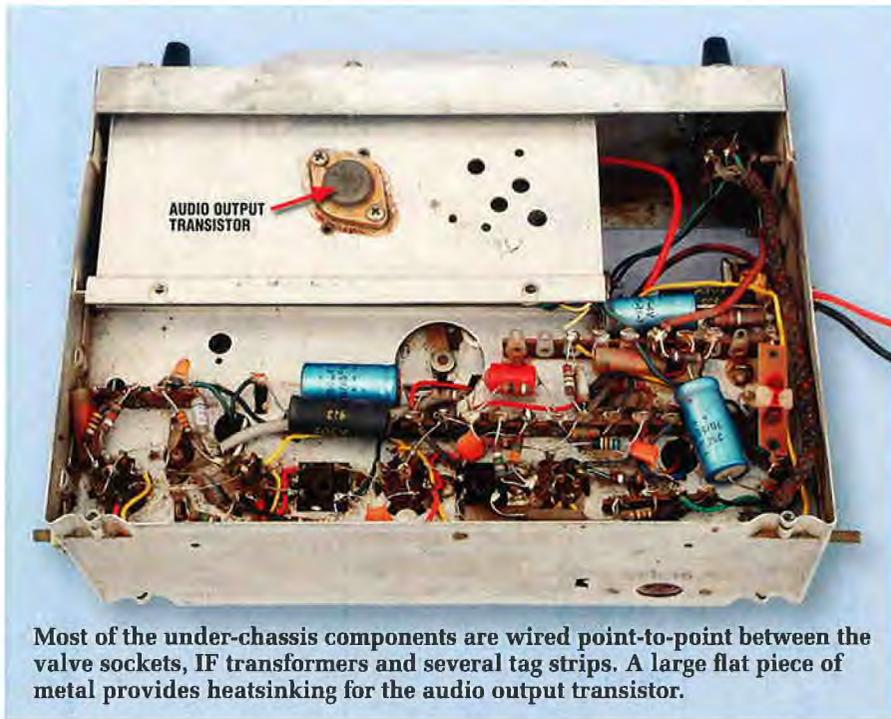
Most of the under-chassis components are wired point-to-point between the valve sockets, IF transformers and several tag strips. A large flat piece of metal provides heatsinking for the audio output transistor.

screws holding each cover in place. The heatsink and the 2N301 transistor can then be removed by undoing three screws along the front edge of the receiver case. The transistor and heatsink are then left "swinging" but still attached by the three transistor leads – well not quite, as the collector lead broke off in this particular set. The lead was single conductor and had fatigued and broken, so I replaced it with a multi-strand lead.

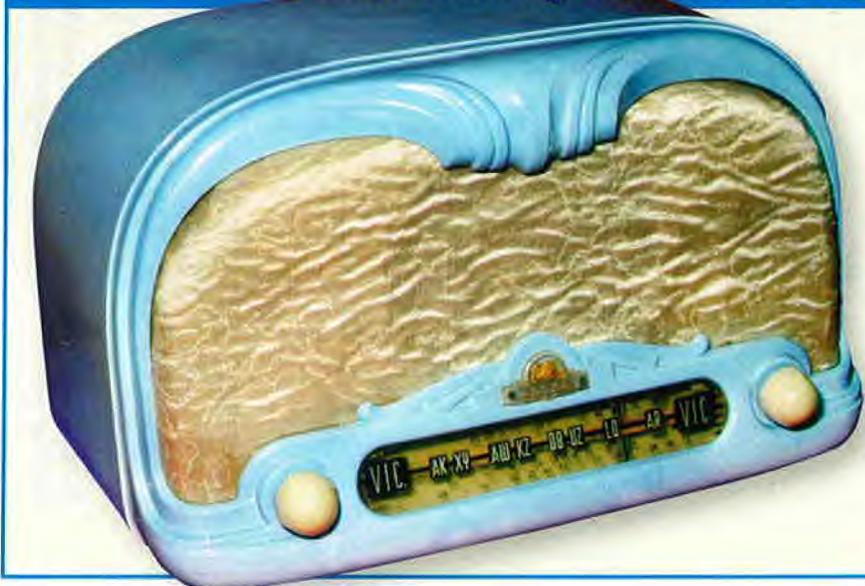
MANUFACTURED BY Radio Corporation, Melbourne, in 1949, the Astor Model GS was housed in a stylish bakelite cabinet and was available in a range of colours. This blue example was rare and is now very collectable.

This set used the same basic reflex circuitry that was common to a number of 4-valve Astor models. The valve line-up was as follows: 6A8-G frequency changer; 6B8-G reflexed IF amplifier/1st audio amplifier/detector/AVC rectifier; 6V6-GT audio output; and 5Y3-GT rectifier.
