# Vintage Radio

## The Phillips RF5 Stereogram

Now considered to be relics of a bygone era, stereo radiograms (or stereograms) were common during the 1960s. The Philips RF5 stereogram was typical of this new breed of entertainment systems.

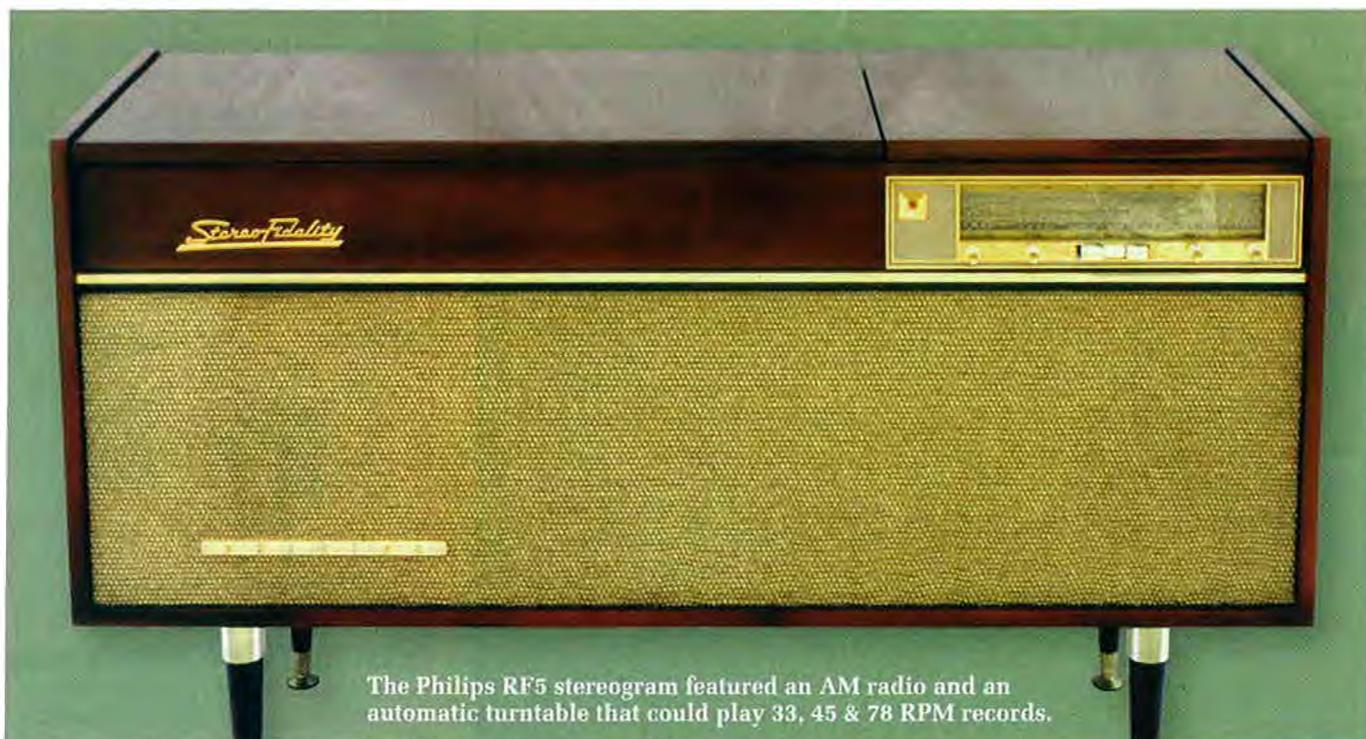
The Philips RF5 stereogram featured an AM radio and an automatic turntable that could play 33, 45 & 78 RPM records.

As shown in the lead photo, this particular unit's cabinet is in quite good order. However, the electronic circuitry wasn't working (the set was as dead as a dodo) and the record changer had a few mechanical problems. In fact, the record changer would not go through any of its automatic routines and stayed running until it was manually switched off.

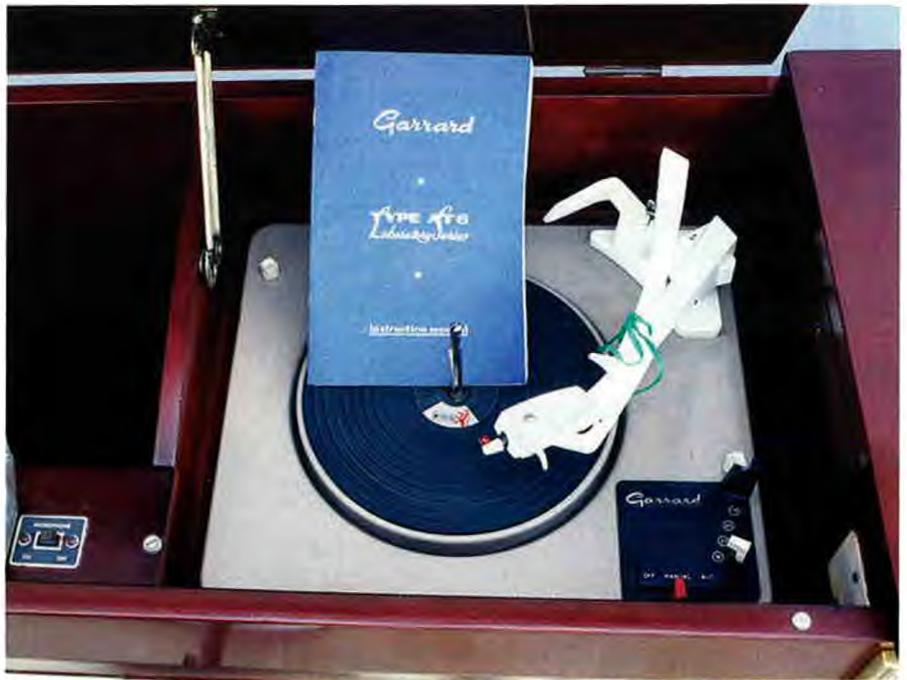
**This view shows the Garrard record changer and its instruction manual. Not many manuals survive this long. The inbuilt microphone can be seen at the bottom left of the photograph.**

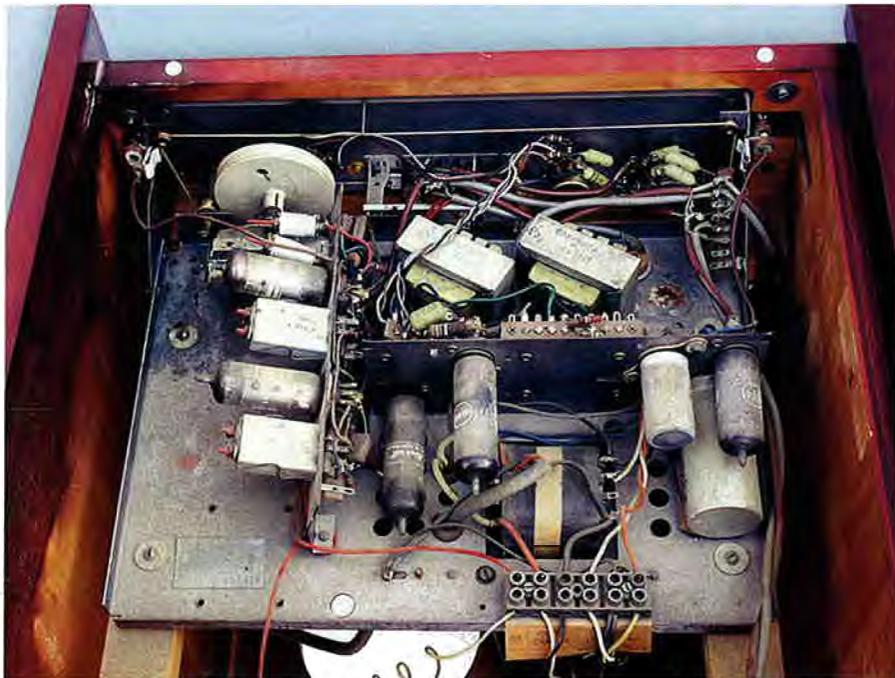
**This radio chassis, shown here before restoration, is accessed by removing the top wooden cover from the cabinet before restoration. Note that the terminal block at bottom right catered for the 240VAC leads to the record changer, as well as the antenna and speaker leads. This means that care must be taken to rewire it correctly if any leads are removed during servicing.**

After looking around the set, I eventually spotted a screw which went from the record changer section and into the side of the section housing the circuitry. I removed it and found that I could then lift the top timber panel

up and unhook it from two lugs on the inside of the side panel.

This showed that the circuitry is mounted on two brackets rather than on a conventional chassis. The RF section can be removed but this also means that the dial drive assembly has to be dismantled. As a result, I decided to leave it in place and work on it using a small-tipped soldering iron. The audio amplifier and power supply are similarly difficult to work on but again I decided to leave it in place.

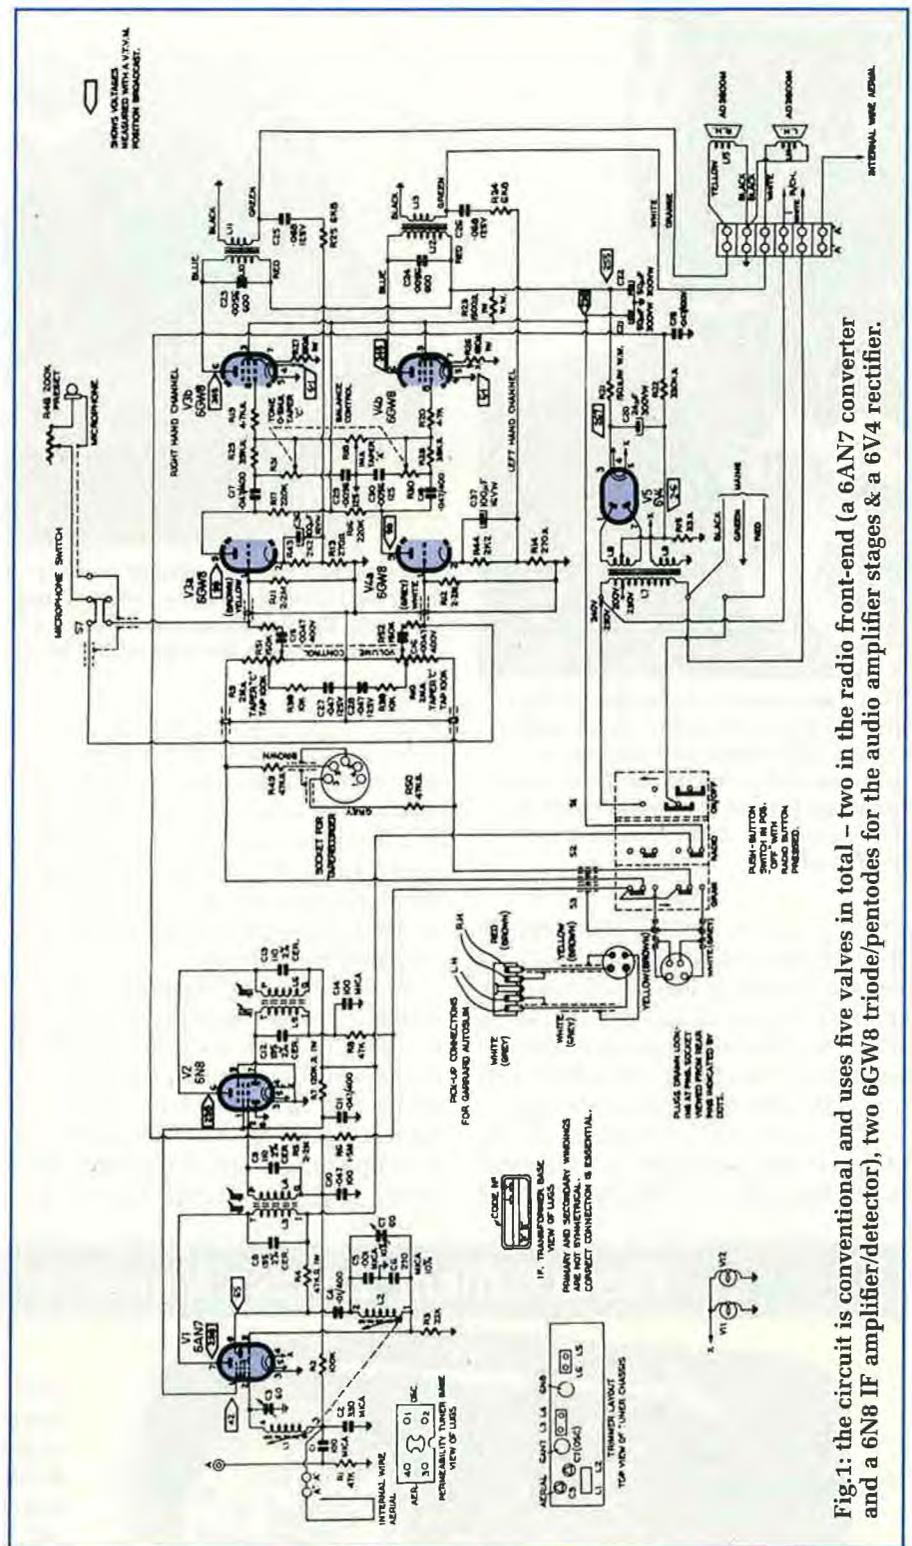
Let's now take a look at the circuit for the Philips RF5 – see Fig.1. It used five valves in total, with two in the radio front-end – a 6AN7 converter and a 6N8 IF amplifier/detector.

The stage based on the 6AN7 converts the received broadcast band signal to the IF (intermediate frequency) which is at 455kHz. This stage is a little unusual in that tuning is accomplished using an inductance tuner instead of the more usual variable capacitor system.

The following 6N8 functions as a combined IF amplifier, detector and automatic gain control (AGC) system. From there, the signal is fed to a 2-section pushbutton-type switch which selects between “Radio” and “Gram” (or gramophone). A third pushbutton switch provides power On/Off selection.

In the “Radio” position, both audio amplifiers have their inputs connected in parallel. By contrast, in the “Gram” position, the two amplifiers are connected to the respective left and right channel outputs from the pick-up cartridge. The amplifier stages are each capable of about 3.5W (RMS) output power.

The two audio amplifier stages are identical and use two 6GW8 triode/pentode valves – one for each channel. The volume control (R51 & R52) is dual-ganged and each section has a tapping which is connected to an RC network. This modifies the tone of the output according to the volume setting.

Potentiometer R18 functions as the balance control, while dual-ganged potentiometer R30/R31 functions as the tone control.

Note that each amplifier stage has an unbypassed cathode resistor on pin 7 of the output valve. This gives a small amount of negative feedback for that stage, with additional feedback for the whole amplifier taken from the speaker transformer and applied via C25, R25 & R13 in the right channel and C26, R24 & R14 in the left channel.

The power supply is quite conventional and uses a 6V4 rectifier to provide a HT rail of around 255V DC. The filtering is better than normal, with a 3-stage filter made up of C20 (24μF), C21 (50μF) and C22 (50μF).

Fig.1: the circuit is conventional and uses five valves in total - two in the radio front-end (a 6AN7 converter and a 6N8 IF amplifier/detector), two 6GW8 triode/pentodes for the audio amplifier stages & a 6V4 rectifier.

That done, the set was connected to power and turned on. The dial lights and the valve heaters worked but nothing else. A quick check with a multimeter revealed HT voltage on capacitor C22 but there was nothing on C21. It wasn't hard to find the reason – series resistor R23 was completely open circuit.

A replacement resistor was quickly fitted and that fixed the problem – HT voltage now came up across C21 and the set burst into life. It sounded good too and the overall sensitivity of the receiver was quite reasonable.

This set uses polyester capacitors in most critical areas but not for the AGC bypass capacitor (C10). Instead, this was a paper capacitor and it tested leaky (5M $\Omega$ ), which meant that it had to be replaced. This involves undoing three screws on the underside of the RF sub-assembly and then tilting the assembly sufficiently to gain access to the capacitor's leads. However, this must be done carefully, as the dial assembly is also attached to this sub-assembly. A 50V ceramic capacitor was installed in place of the original unit.

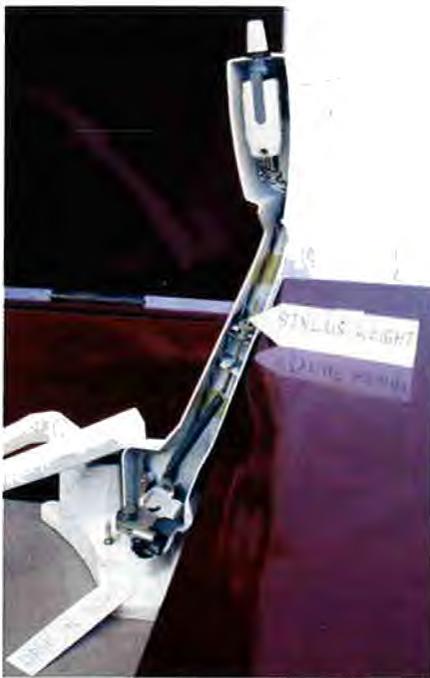
This underneath view of the pickup arm shows the locations of the stylus weight adjustment and the stylus drop position adjustment. A turnover cartridge is used so that both 33/45 RPM records & 78 RPM records can be played.

place, I gave it a quick checkout on the test jig, to ensure everything was working properly. First, I adjusted the tracking weight of the stylus (this is done by adjusting a spring under the tonearm), then checked that it tracked a record correctly without skating.

stylus dropped down onto the record in the correct position; ie, in the middle of the run in track (if it doesn't, this can be corrected by adjusting a horizontal screw near the tonearm pivot). I also checked that the tonearm lifted off correctly when it reached the run out at the end of the record and returned to its stand.

Finally, I decided to replace the two styli for the turnover cartridge. Microgroove records require a 1 mil (.001-inch) radius stylus, while 78s require a 2.5 mil stylus. Unfortunately, I'm having trouble tracking down the 78 RPM stylus, so I've simply replaced the microgroove (33/45 RPM) stylus for the time being.

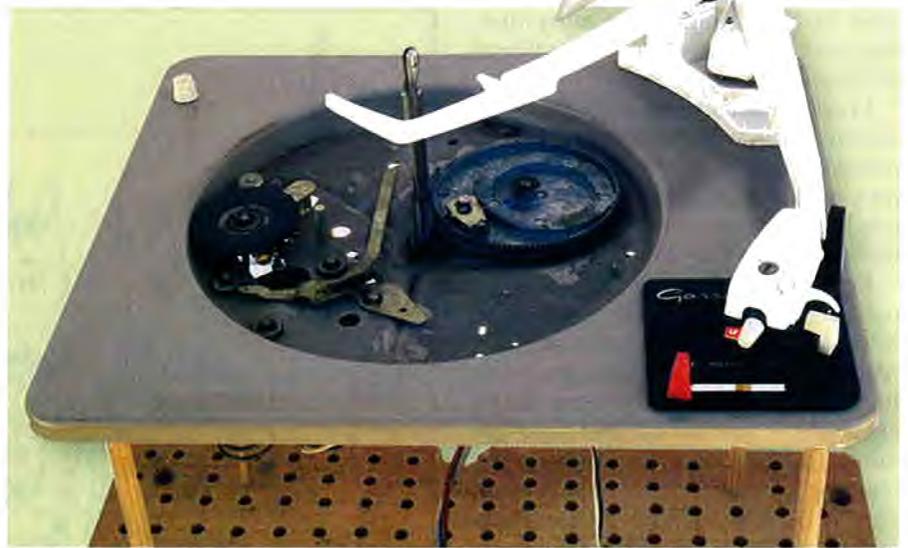
The record changer used in the Philips RF5 is a Garrard Autoslim unit. As mentioned above, it would not go through any of its automatic operations and the reason for this was quite simple. Over time, much of the oil and grease that's used to lubricate the mechanical parts had either congealed into sticky "globs" impregnated with

dust or had disappeared altogether, leaving a lot of moving parts without lubrication.

The Garrard record changer is shown here mounted on a simple servicing jig, with its turntable platter removed to give access to part of the mechanism. The servicing jig is nothing more than a drilled wooden base which accepts wooden dowels to support the turntable's base.

Having done this, I removed the platter and turntable. The latter is released by first sliding off the retaining circlip, then twisting the turntable gently clockwise while lifting it upwards until it clears the centre post. There is virtually nothing that can go wrong with this and it was simply cleaned and the phosphor bronze bearings oiled.

Next, I removed the motor from its resilient mounts by removing the three circlips holding it in place. The motor freely rotated, so there was no problem here. However, the felt wicks which hold oil for the phosphor bronze motor bearings were dry so I filled them with oil using a syringe-type "oiler". The motor was then reinstalled.

That done, a drop of oil was applied to the top of the phosphor bronze bearing on the idler (jockey) wheel. This is the large rubber wheel on the left of the photograph on the following page. Its purpose is to make contact with the inside rim of the turntable, to drive the turntable at the appropriate speed. In operation, the speed control varies its position vertically against a stepped-diameter pulley attached to the motor, depending on the speed of the record to be played (ie, the speed of the turntable depends on the pulley-diameter selected by the idler wheel).

Next, a large gear on one side of the mechanism was removed, again by removing its circlip (this is the gear on the righthand side of the photograph of the turntable's "works"). In this case, the grease on the cam on the underside of the gear had congealed and one of the small ancillary levers had seized due to lack of oil. I soaked this gear assembly in household kerosene, then

cleaned the muck off and removed the small lever from its shaft by removing two more circlips. I then cleaned and oiled the shaft and replaced the lever, which now operated freely.

Finally, I greased and oiled the remaining cams as appropriate and reassembled the unit. The turntable and platter were the last parts to go on.

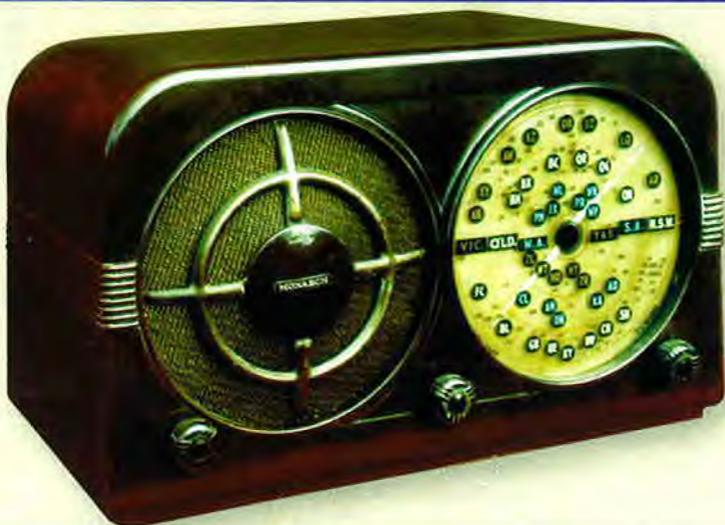
**MANUFACTURED BY** Eclipse Radio, Melbourne in 1946, the Monarch AN is a 5-valve superhet and is similar to the companion Astor model that uses the same chassis. It was housed in a stylish bakelite cabinet with a large circular dial towards the right and the three control knobs spaced along the bottom.

The valve line-up was as follows: 6A8-G frequency changer; 6U7-G IF amplifier; 6B6-G, audio amplifier/detector/ AVC rectifier; 6V6-G audio output; and 80 rectifier.
