Vintage Radio

The quirky Breville 801 personal portable

Based on miniature 1.4V filament valves, compact portable radios such as the Breville 801 enjoyed a brief period of popularity during the late 1940s and early 1950s. Their performance was rather mediocre, however.

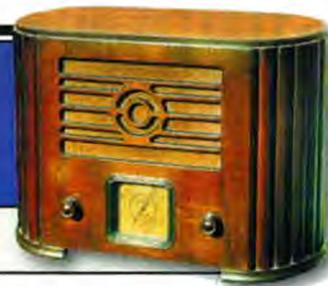
This view shows the Breville 801 prior to restoration. The "D" cell gives some idea of its size.

Unfortunately, the set featured here had had a hard life. The case was cracked at the top and a set of batteries that had been left in had leaked corrosive muck over quite a bit of the set.

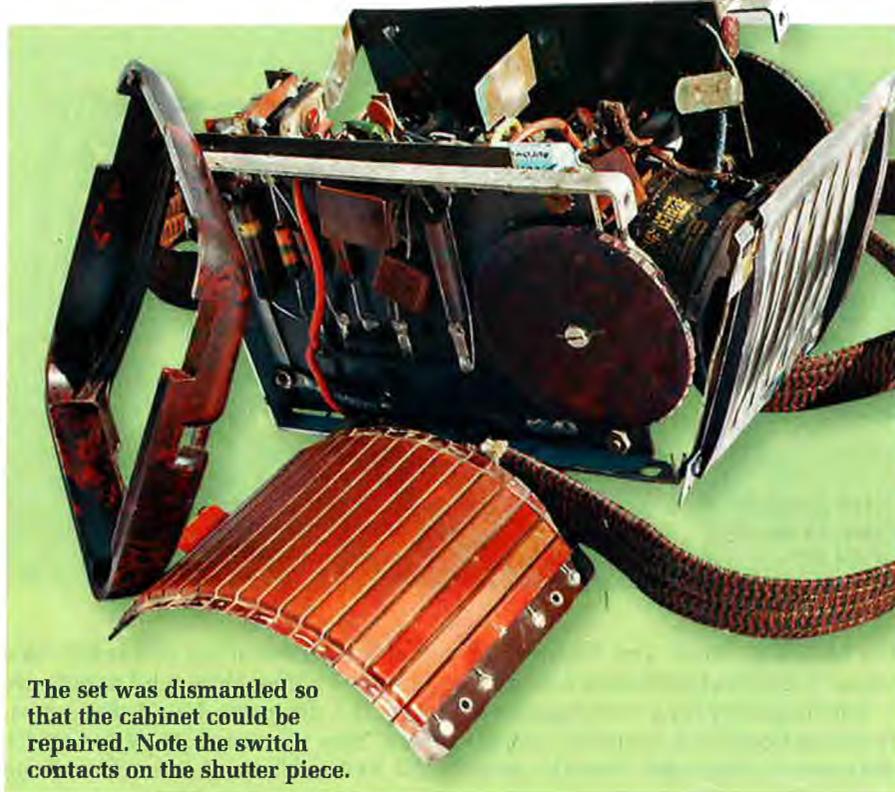
The set was dismantled so that the cabinet could be repaired. Note the switch contacts on the shutter piece.

To operate the set, the shutter was moved away from the speaker and when the loudspeaker was fully exposed, the edge of the shutter closed two sets of contacts which applied power to the receiver's filament and plate circuits. One of the accompanying photographs shows how this was done.

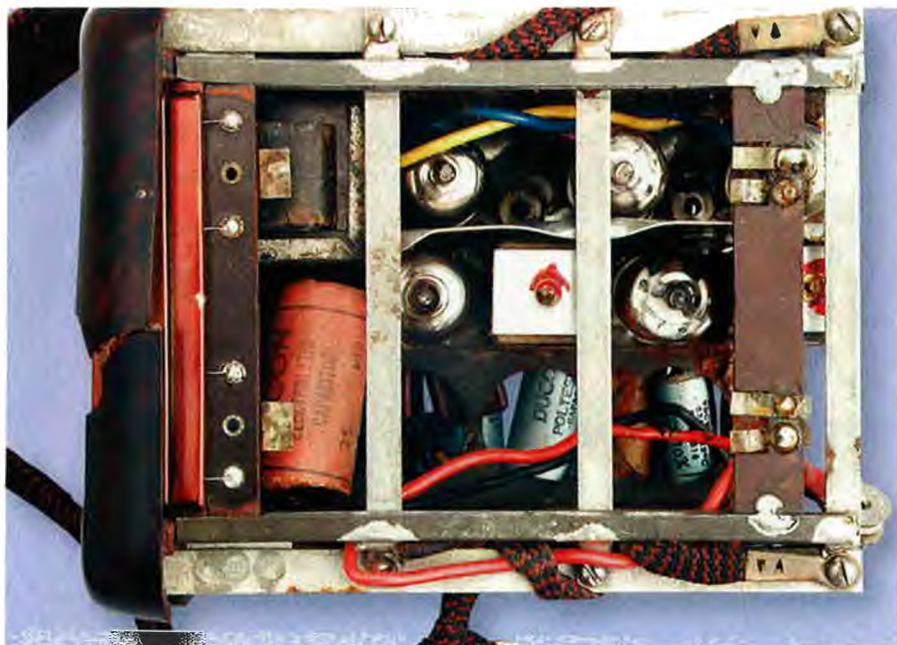
This above-chassis view shows just how tightly the various parts are packed together, making the valves difficult to remove.

The next step was to get the set working. First, the valves were removed and a multimeter used to check that their filaments were intact. That done, I sprayed each valve socket with Inox and then replaced the valves. Once again, the compact nature of the set makes valve removal and replacement a difficult job.

In fact, to remove the valves, I had to first wriggle them in their sockets to ease them out slightly and then

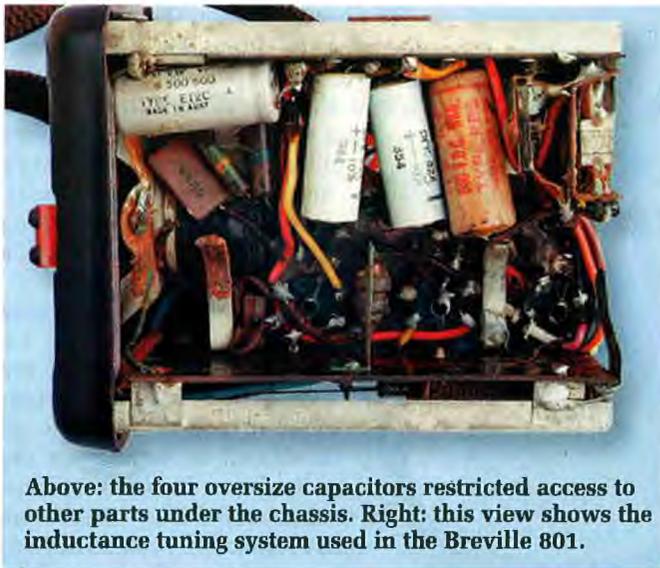
Above: the four oversize capacitors restricted access to other parts under the chassis. Right: this view shows the inductance tuning system used in the Breville 801.

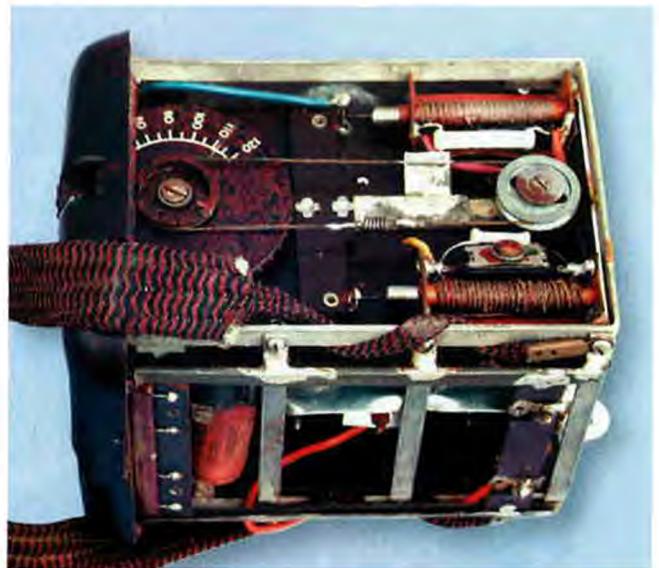
which doubles as a carrying strap. The output of this loop is coupled into the first tuned circuit. This tuned circuit is also different in that both it and the local oscillator (1R5) are inductance tuned.

The frequency converter stage (1R5) is conventional and, as stated, uses inductance tuning rather than the more commonly used capacitance tuning. The IF amplifier has two double-tuned IF transformers and the 455kHz IF signal is amplified by the 1T4. As mentioned earlier, the detector and AGC diode is located in the 1S5. AGC is applied to the RF and IF stages but not to the converter.

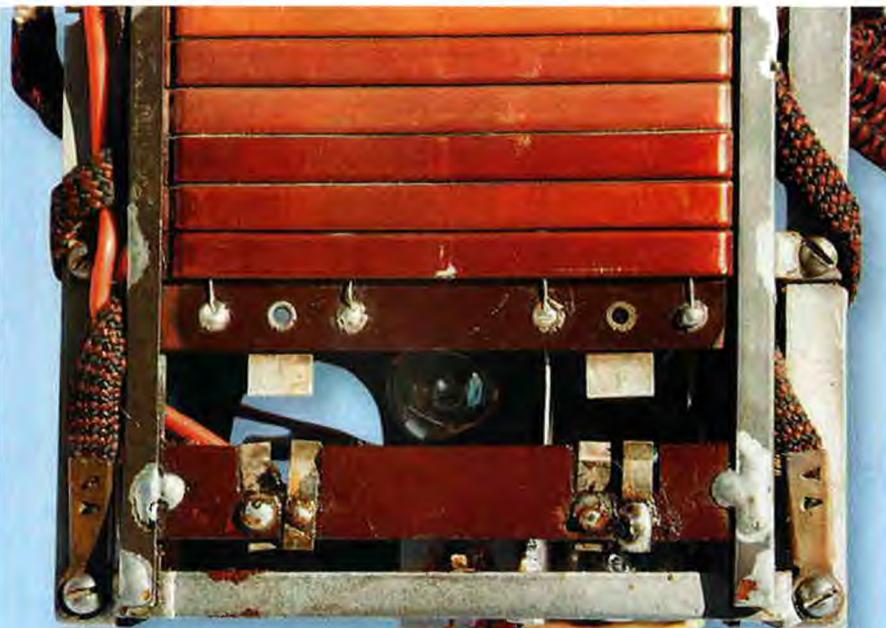
This close-up shows the switch contacts at the end of the roller shutter. They close when the shutter is fully open.

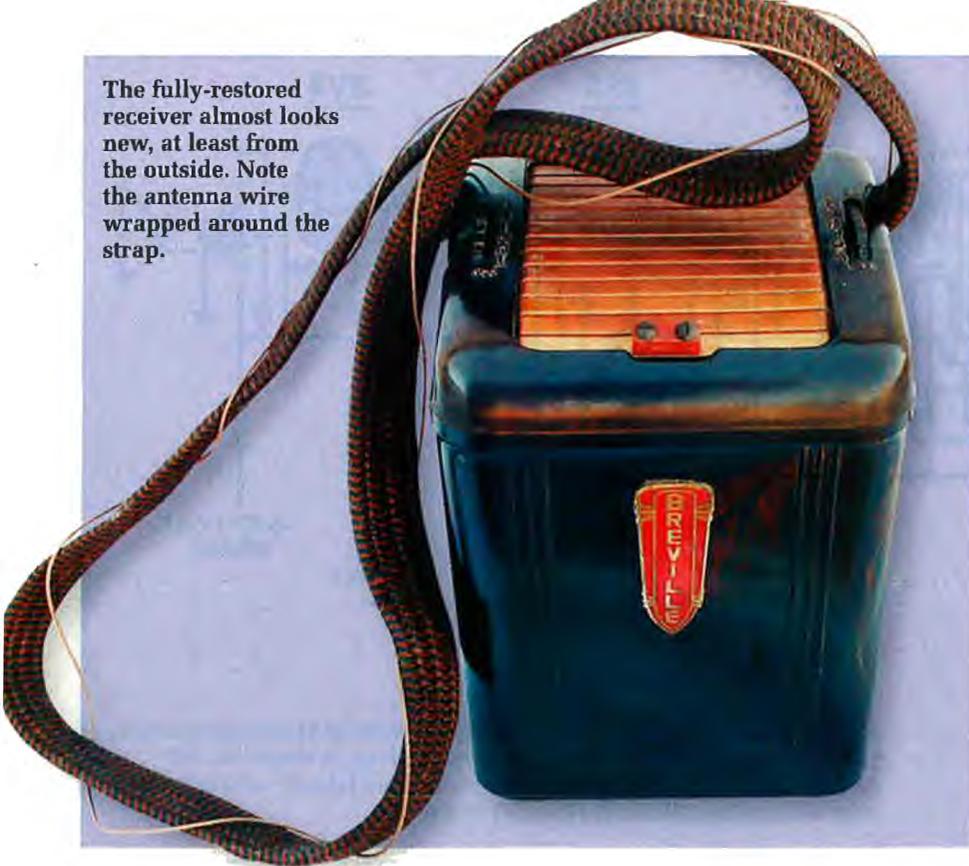
The fully-restored receiver almost looks new, at least from the outside. Note the antenna wire wrapped around the strap.

Because the loop was open circuit I decided the best thing I could do was to loosely wind a piece of thin hook-up wire over the antenna strap and connect it into circuit the way

it should have been connected. I'm not sure how the strap was originally made other than the fact that it uses "tinselled" wire. Whether it was woven as a flat strap or just used as a circular wire I don't know (the set isn't mine, so I didn't feel inclined to cut into the strap).

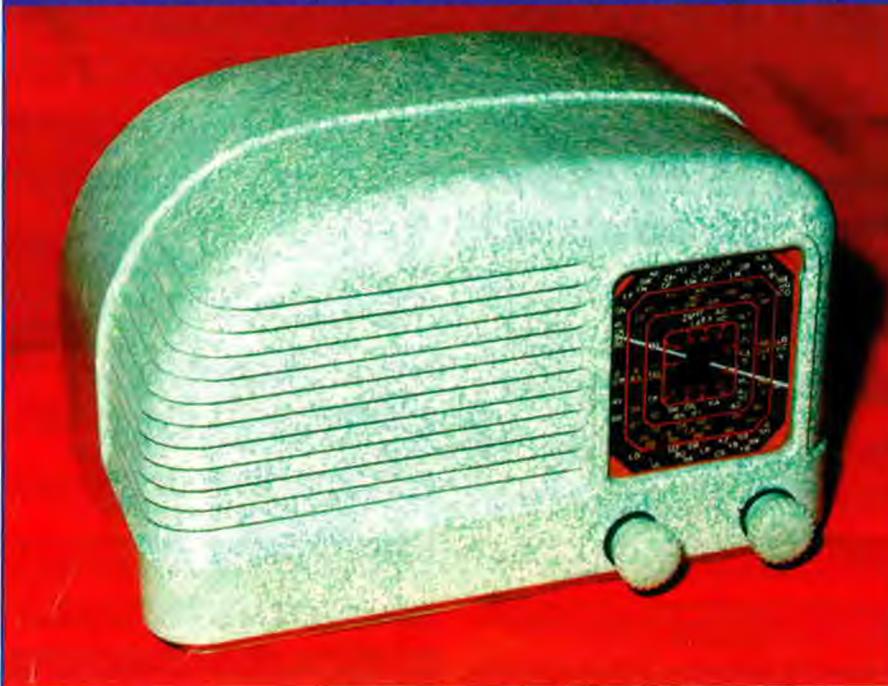
Photo Gallery: STC A141 Bantam (1947)

RELEASED BY STANDARD TELEPHONES & CABLES PTY LTD in 1947, the Bantam A141 was a miniature 4-valve superhet that measured just 230mm wide by 150mm high. In fact, it was so compact that it was necessary to remove the chassis in order to replace the 6AG6 output valve! The mottled green cabinet example illustrated here is uncommon.

The valve line-up was as follows: 6K8-G frequency changer; 6G8-G IF amplifier/detector/AVC rectifier; 6AG6 audio output; and 6X5-GT rectifier.
