Vintage Radio

Restoring an AWA 948C car radio

First introduced back in the 1930s, car radios have been popular with motorists ever since. Here's a brief look at how they evolved, along with the restoration details for an AWA 948C dual-polarity car radio.

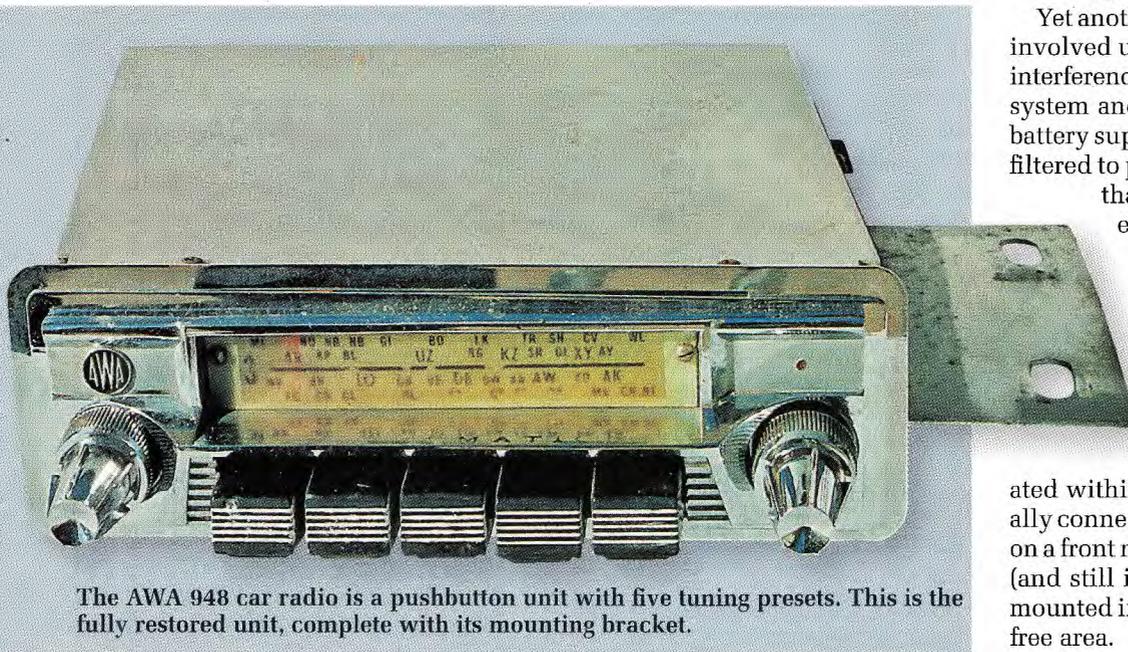
The AWA 948 car radio is a pushbutton unit with five tuning presets. This is the fully restored unit, complete with its mounting bracket.

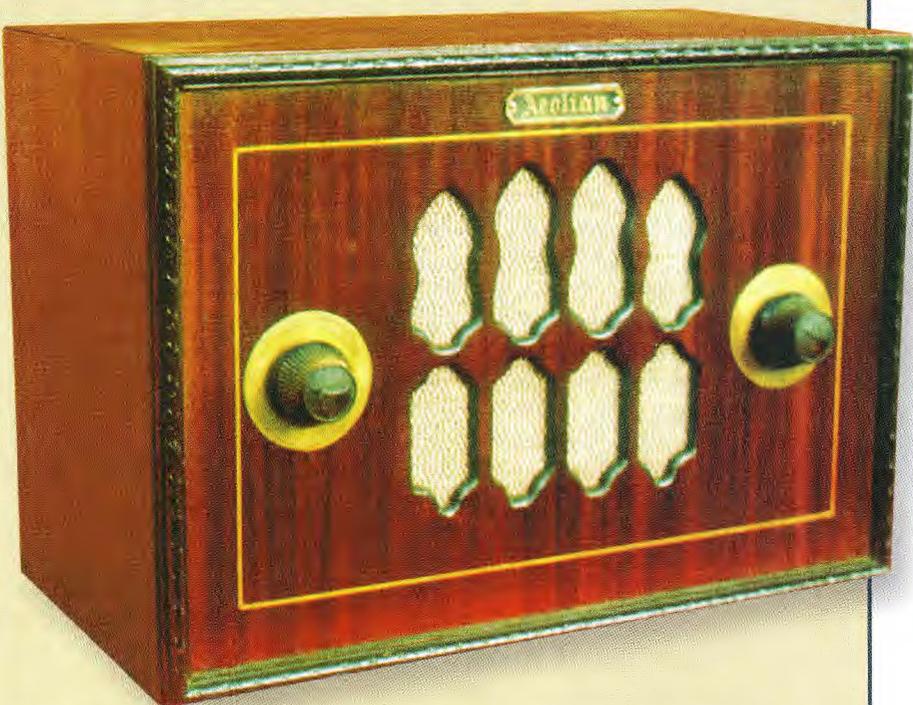
Aeolian 5-Valve Autodyne Superhet (1933)

THE ORCHESTRAL COMPANY OF MELBOURNE was a well-known supplier of music and musical instruments and the company also marketed radios under the “Aeolian” brand name during the early 1930s. The unit shown here is a 5-valve autodyne superhet from 1933. The valve line-up was as follows: 57 autodyne mixer, 58 IF amplifier, 57 anode bend detector, 59 audio output and 80 rectifier. Photo: Historical Radio Society of Australia, Inc.

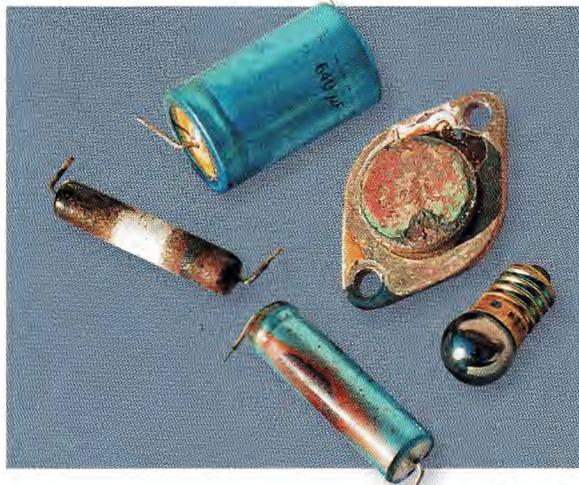
So what caused all the damage to the output stage of this set? My suspicions are that it had been connected to a power supply with reversed polarity

– probably not long before it was given to me to overhaul. This is a mistake that can easily occur with a dual-polarity set such as this.

These are the parts that were replaced. Note the corrosion on the transistor and the charring on the resistor and one of the electrolytic capacitors. The damage was probably caused by reversed supply polarity.

I replaced the 1Ω resistor and the two electrolytic capacitors, as I believed they might have been damaged. I then reconnected all leads and tested the set again, starting with a low supply voltage and slowly increasing it while monitoring the current.
